Old Perth Road Street Tree Audit

Town of Bassendean

Report No. J19384

29 May 2019

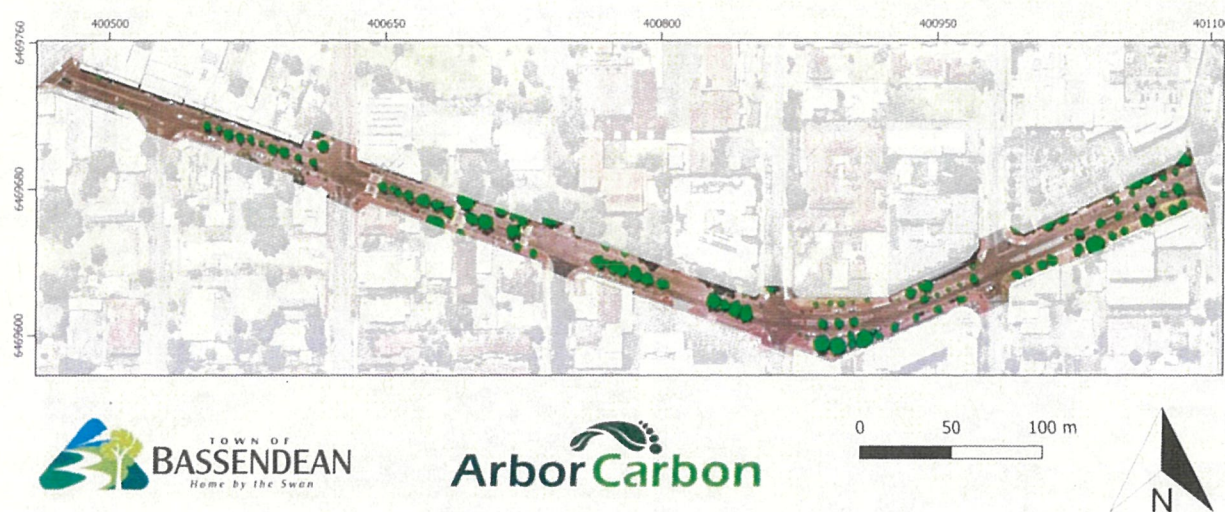
An estimate of canopy (vegetation more than 3 m in height) was calculated by delineating the crowns of trees using aerial imagery sourced from Nearmap (Figure 1). The analysis includes trees on Town of Bassendean owned land, as well as crowns of trees planted on private land that contribute to the streetscape. The current canopy area within the street area assessed was 2140.9 m² (Table 1). This equates to a 13.4 % canopy cover if the total area of interest is 15,994.2 m². The Town of Bassendean have suggested a target of 70% canopy cover is desired to enhance the aesthetics and amenity of the street.

Figure 1: Current canopy cover of Old Perth Road.

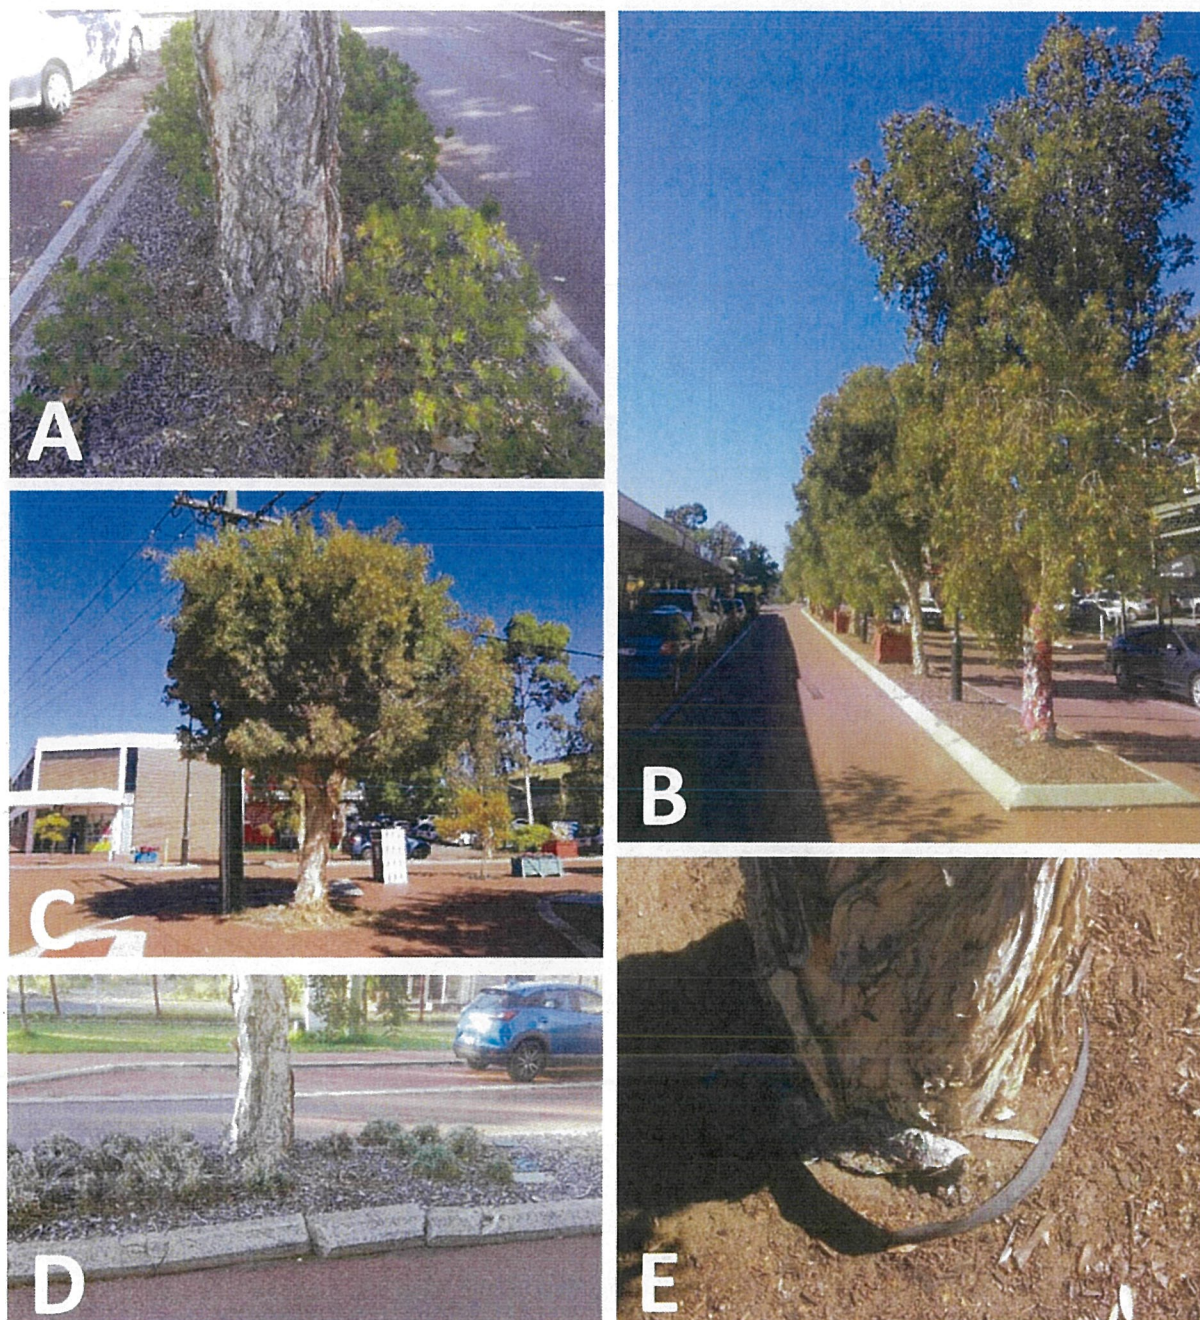
Melaleuca quinquenervia make up 39.7% of the total number of trees contributing to the streetscape of Old Perth Road, and provide 47.3% of the canopy cover (Table 1). The *M. quinquenervia* are planted single file down the median strip (approximately 1.8 to 2.2 m wide) (Figure 2A) of the majority of Old Perth Road, and are well established (planted over 10 years ago). They have an generally narrow growth form (Figure 2B)

with dense canopy, which makes them well suited to their position in the median strip. However, they do not provide as much canopy as a tree with broader growth form. They can be structurally pruned to have a broader growth form (Figure 2C). *Melaleuca quinquenervia* roots are known to cause structural damage to their surrounds when planted in similar scenarios. There was minor cracking and uplifting of the median strip curb and surrounding road (Figure 2D). Root barriers were observed around the root systems of some of the *M. quinquenervia* (Figure 2E), which may have reduced or delayed such root damage.

Figure 2: *Melaleuca quinquenervia* along old Perth Road, showing (A) their position in the median strip, (B) their narrow growth form, (C) their broad growth form, (D) damage to curbs from their invasive roots, and (E) root barriers.

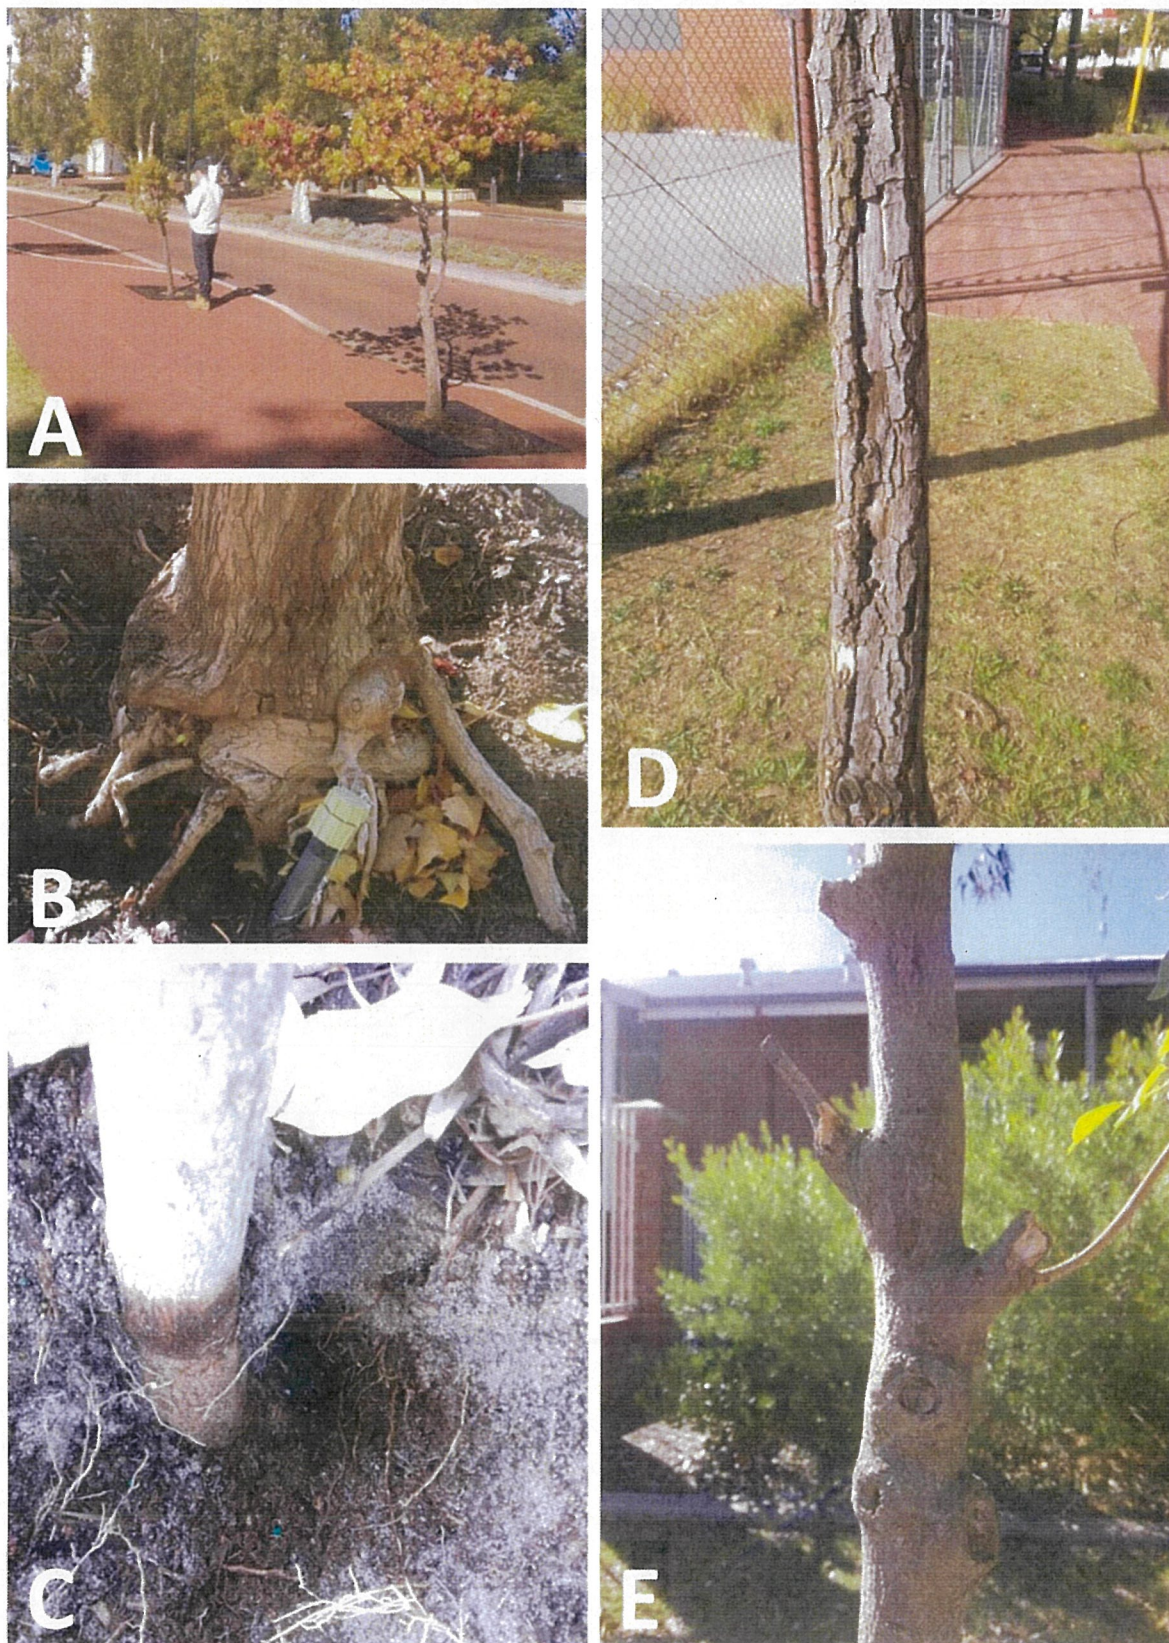
majority of these appeared to be planted between 2013 and 2014. The health of these recently established trees was generally poor. Several individuals displayed a stunted growth form (Figure 3A). Symptoms included frequent branch dieback, foliar chlorosis, sunscald (Figure 3D) and vandalism (Figure 3E). Many trees displayed an unstable root plate indicating poor root system development, and below-ground investigation revealed evidence of girdling roots (Figure 3B). These symptoms are often found in poor quality planting stock reflective of their sub-optimal growth and management in the nursery. In many cases, trees lacked a visible basal stem taper and appeared to be planted too deep or had received fill over their basal stem subsequent to planting (Figure 3C).

The use of planting pits of approximately 1m² is a fairly standard approach to establishment of trees in urban areas (Figure 3A). However, the soil conditions outside the direct planting pit are often very hostile to tree root establishment. Soil under roads and footpaths are generally highly compact, often including the use of high pH limestone sub-base material. The type of surface treatment also can prevent water infiltration into the soil. It is true that some trees are able to exploit these harsh soil environments. However, the number of species is limited and the rates of growth and mature tree dimensions will ultimately be restricted (Urban 2008). Where possible planting spaces should be increased to fill the available space and minimise footpath area. The remaining area of the planting space can be filled with ground level plants and shrubs, providing additional opportunity for greening and reducing radiant heat and physical damage to the basal stem which can be associated with tree pit covers. Alternatively, structural cells containing high quality imported soils with suspended hard surfaces provide good results, although these comes at a high cost.

Figure 3: Examples of *T. sebigera* in poor condition: (A) stunted growth form, (B) girdling roots, (C) fill over basal stem, (D) sun-scald damage to the trunk, and (E) broken branches due to vandalism.

Many *T. sebifera* on the eastern end of Old Perth Road had severe sun-scald and mechanical damage to their trunks and branches, presumably from vehicles. This was particularly evident in specimens growing in roadside diamonds. The trees growing in roadside diamonds were relatively healthy when compared to many of the trees established in footpath planting pits. However, the extent of sunscald, and vehicle damage will likely reduce the lifespan of these tree in the future. Evidence of girdling roots was also observed in several specimens, which is likely to further reduce the life expectancy of these trees.

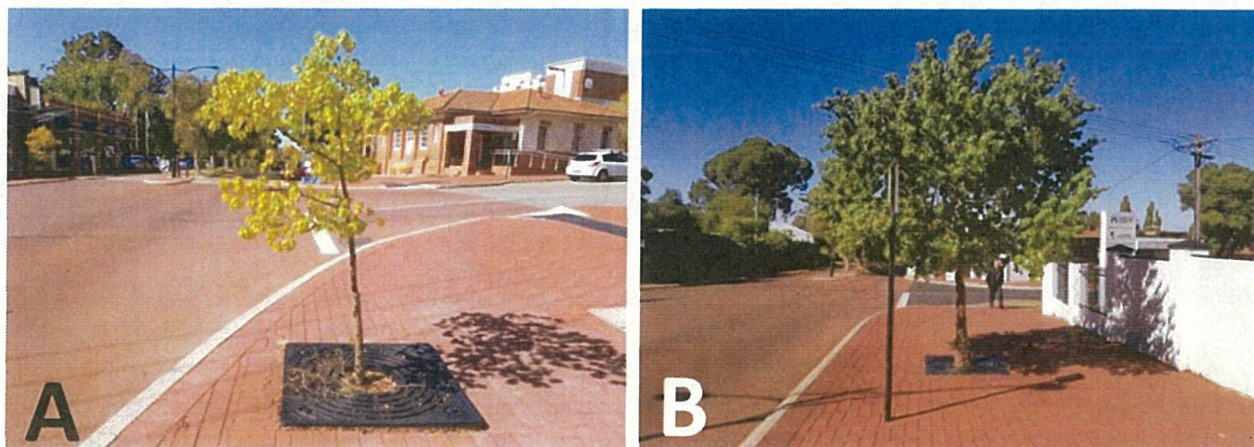
Relatively healthy *T. sebifera* were observed on Old Perth Road between Wilson Street and James Street. Examination of historical aerial photography showed these trees were planted in the same period as many of the other *T. sebifera* in 2014. Comparison of healthy and unhealthy *T. sebifera* established in the same year are presented in Figure 4.

Figure 4: Examples of unhealthy (A) and healthy (B) *Triadica sebifera* on Old Perth Road, both planted at the same time (2014).

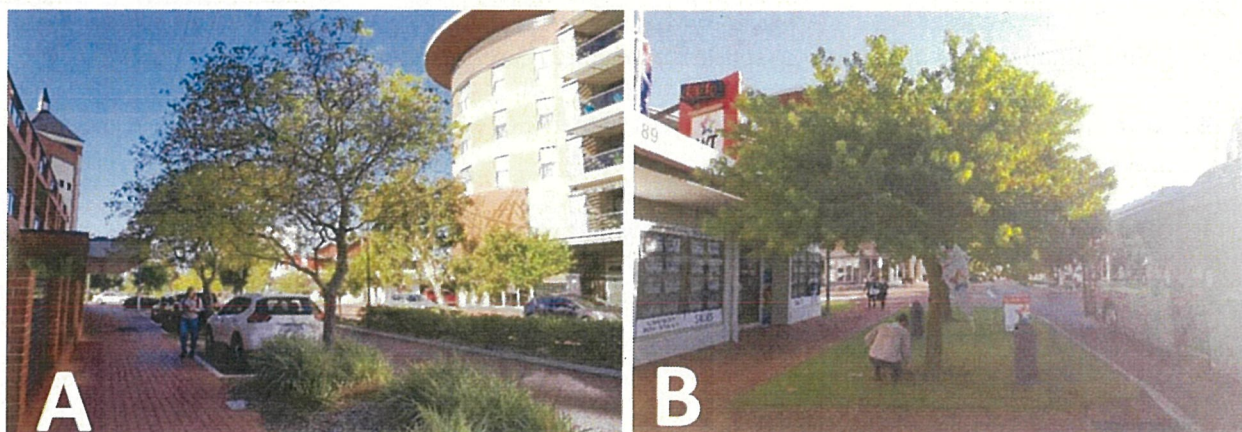
A stand of mature *T. sebifera* were present on the south eastern end of Old Perth Road. These trees were greater than 10 years of age and appeared to be relatively healthy, with some evidence of minor branch dieback observed. Tree condition was, however, difficult to ascertain as the foliage was becoming senescent as the trees entered their dormant stage. These trees had a much larger soil area in which to grow which likely contributed to the success of these plantings (Figure 5).

Figure 5: Example of mature *Triadica sebifera* in good condition on south eastern end of Old Perth Road, planted in (A) larger carpark bay and (B) turfed area.

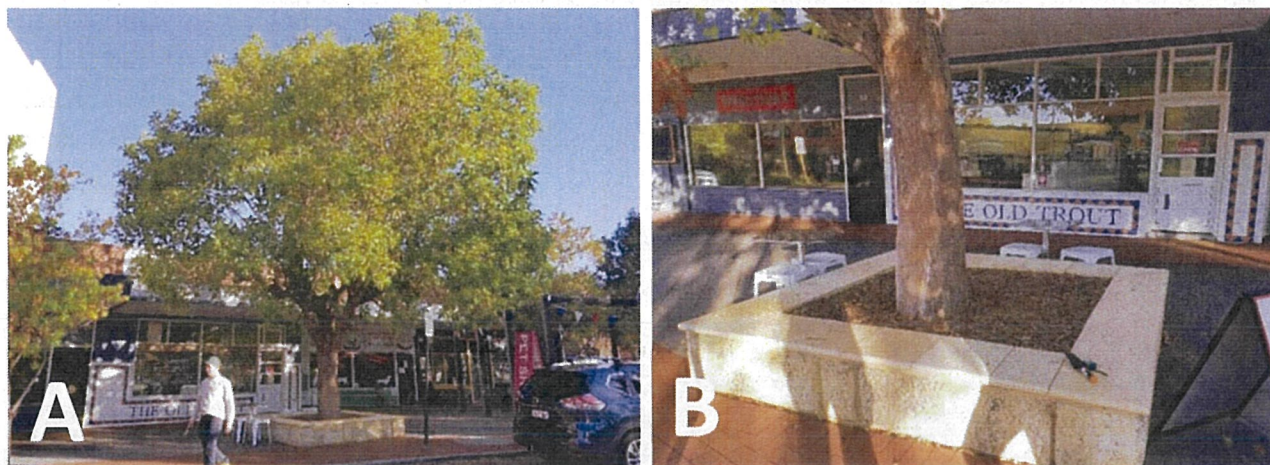
There were five mature, healthy *Lophostemon confertus* located on the eastern half of Old Perth Road. The trees had large, broad crowns (Figure 6A), and while they only made up 4.3% of the total number of trees, they contributed to 12.6% of the total canopy cover of Old Perth Road. Some individuals had raised garden beds built around them, bringing the soil level up around the base of the tree (Figure 6B), however, this has not appeared to have had a negative impact on the condition of the trees.

Figure 6: Healthy, mature *Lophostemon confertus* with (A) large, dense crown and (B) raised garden bed around base.

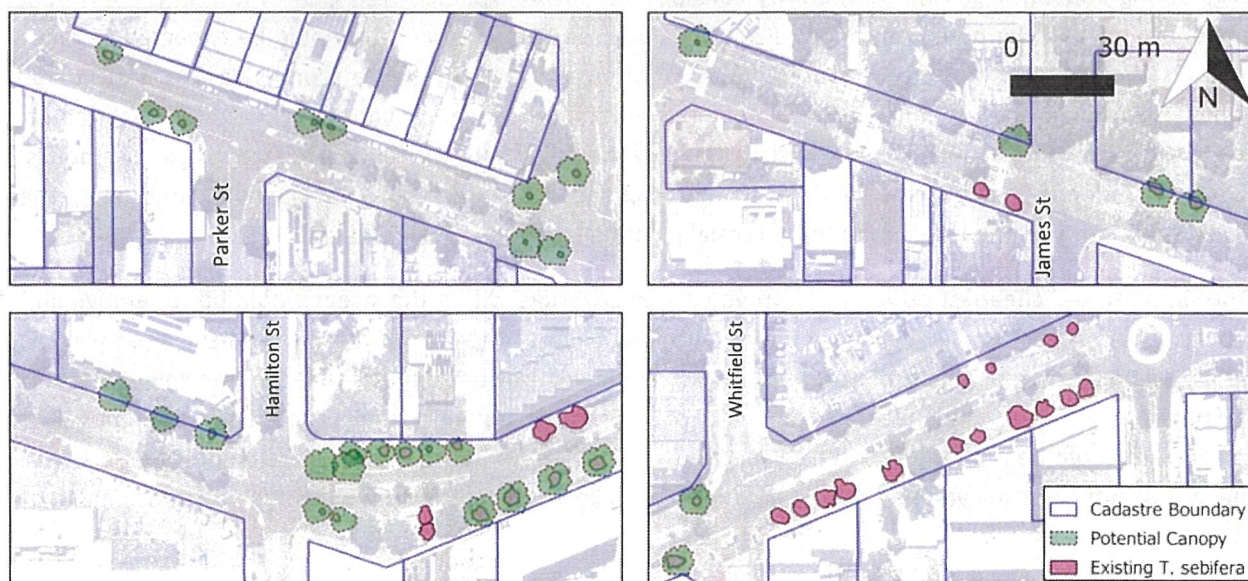
Figure 7: Replacement of poor performing *Triadica sebifera* with a species that has bigger potential crown size. The purple polygons are existing *T. sebifera* crowns, and the semi-transparent green polygons indicate potential canopy of poor performing *T. sebifera* are replaced with broader crowned trees. Note that some *T. sebifera* are could remain.

The simplest and cheapest option to improve canopy coverage within the street would be to remove and replace all poor performing *T. sebifera* (Chinese tallow) (Figure 7). Many of these trees have been planted for 4-5 years and are in a declining state of health. Our investigation suggests that the principle reason for the poor performance is the quality of the initial planting stock, for which there is no remediation possible. These trees could be replaced with a tree species with a greater potential crown size at maturity. However, the lack of sufficient soil volume of suitable quality will likely restrict the crown volume possible in many of the planting spaces.

Remove current poor performing Chinese tallow and replace with high quality stock.
