TOWN OF BASSENDEAN

NOTICE OF A MEETING OF THE RIVER PARKS COMMITTEE

SUCCESS HILL SPILLWAY INVESTIGATION

March 2018
For The Town of Bassendean

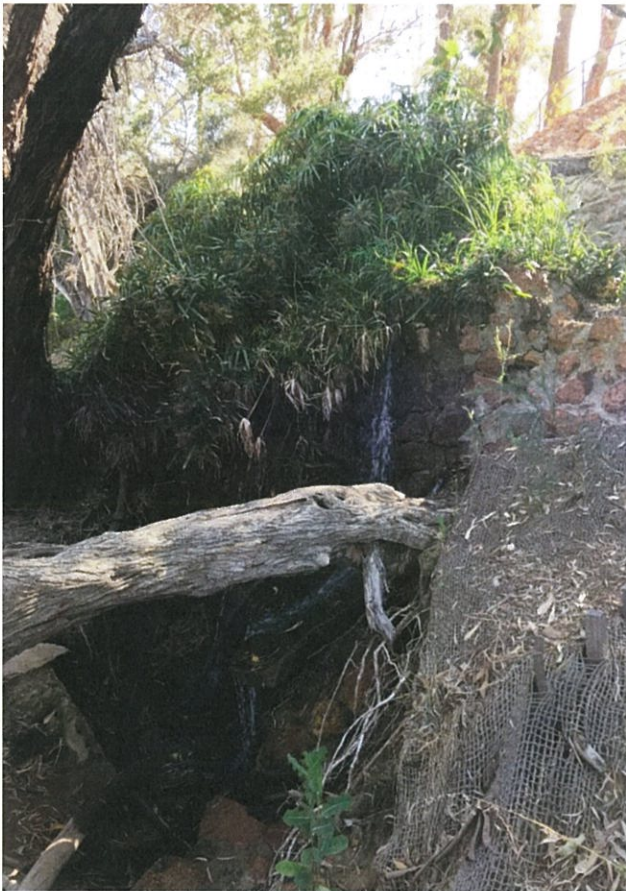
Figure 1 Degraded Spillway Structure

In November 2016, the Town of Bassendean (the Town) became aware that the Spillway structural conditions were severely deteriorating based on reported visual evidence. These included cracks in concrete, soil erosion, and rocks that had dislodged from the concrete structure. The Town undertook minor repair works as part of their maintenance regime to prolong the longevity of the Spillway.

Despite all efforts of the Town's maintenance team, the Spillway has succumbed to its structural inadequacy and collapsed over time, resulting in an unstable and unsafe environment.

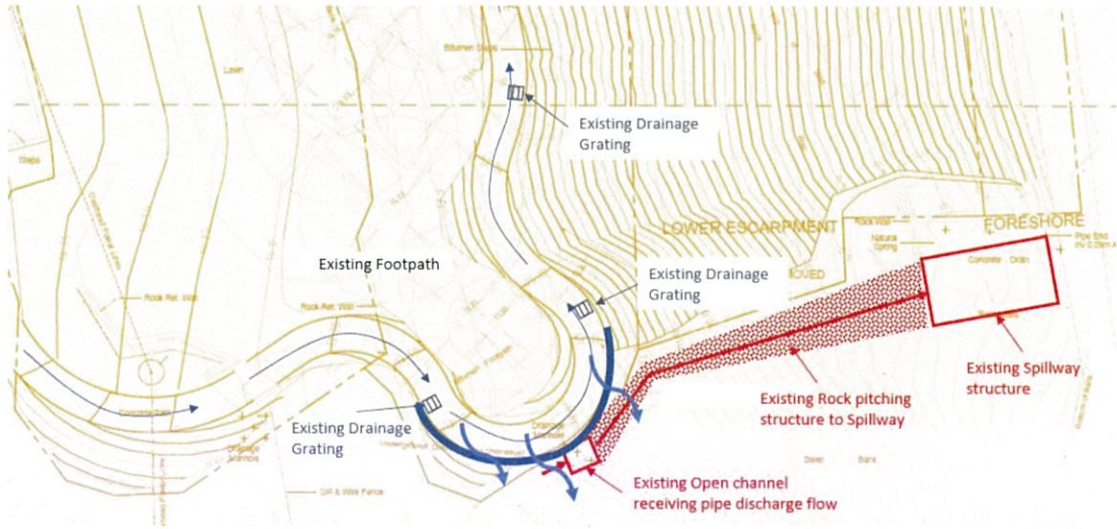
Figure 8 Overflows from existing footpath bend

It appears on site that the embankment erosion and underwash of the Spillway structure have been caused by overland flows, especially at localised sections where the structure intercepts the overland flow path. Currently, the existing pedestrian footpath acts as a preferential flow path where runoff would be channelled. However, based on the height of the footpath curb (approximately 100 mm), the footpath would only be able to facilitate conveyance of the more frequent storm events. During the larger storm events, the footpaths steep hydraulic gradient and high inertia runoff volumes make it is possible for the runoff to spill over at the edge of the footpath bend as shown in Figure 8 below.

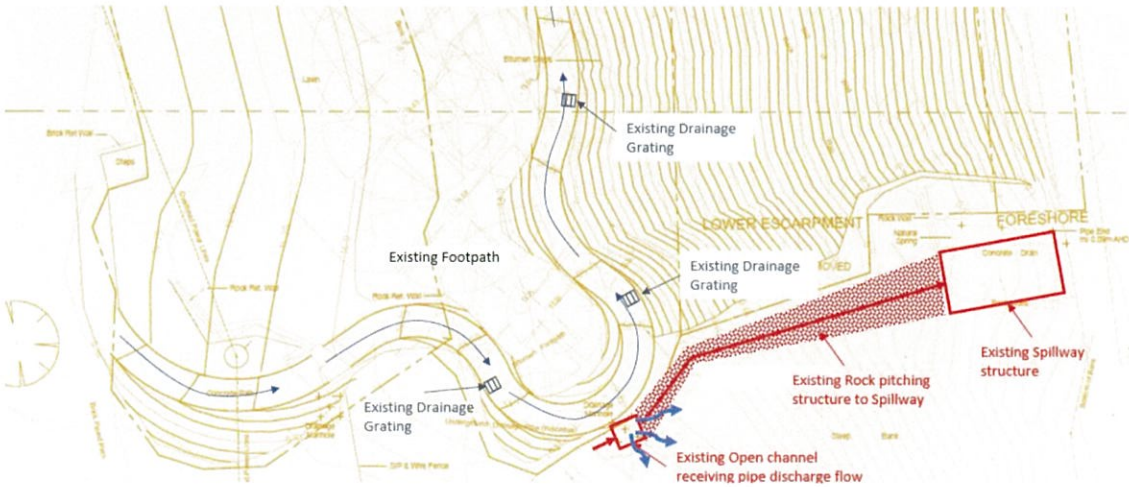
Figure 9 Inadequate Open Channel size serving existing 450 mm dia discharge pipe

The existing open discharge channel (Figure 10) that is directly receiving a discharge from the 450 mm pipe appears to be insufficient to serve the upstream drainage catchment. From hydraulic calculations, the catchment would have an approximate discharge rate of 1.53 m³/s through the pipe

under submerged conditions. These volumes would cause the open channel to overflow as the existing channel has less than the required cross-sectional flow area. In its condition, the open channel would have filled up quickly during a storm event and overflowed down the embankment thus contributing to the erosion of the embankment materials around the structure toe instead of along its designated flow path toward the Spillway.

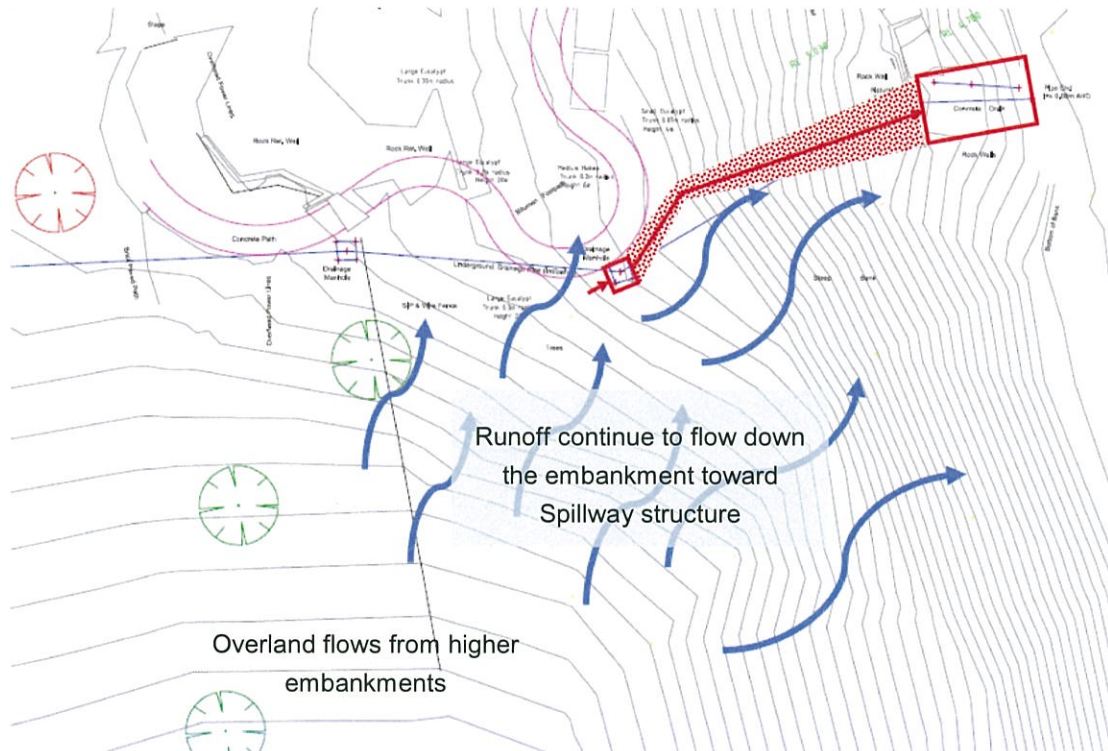
Figure 11 Un-intercepted overland flows from higher embankments

In addition, a runoff interception gap beside the pipe discharge point has been identified where the footpath would not sufficiently intercept runoff from the higher embankments. This means that even during the frequent storm events, flows would have made its way down the embankment freely thus contributing to the erosion at the Spillway structure toe (refer to Figure 11 below).

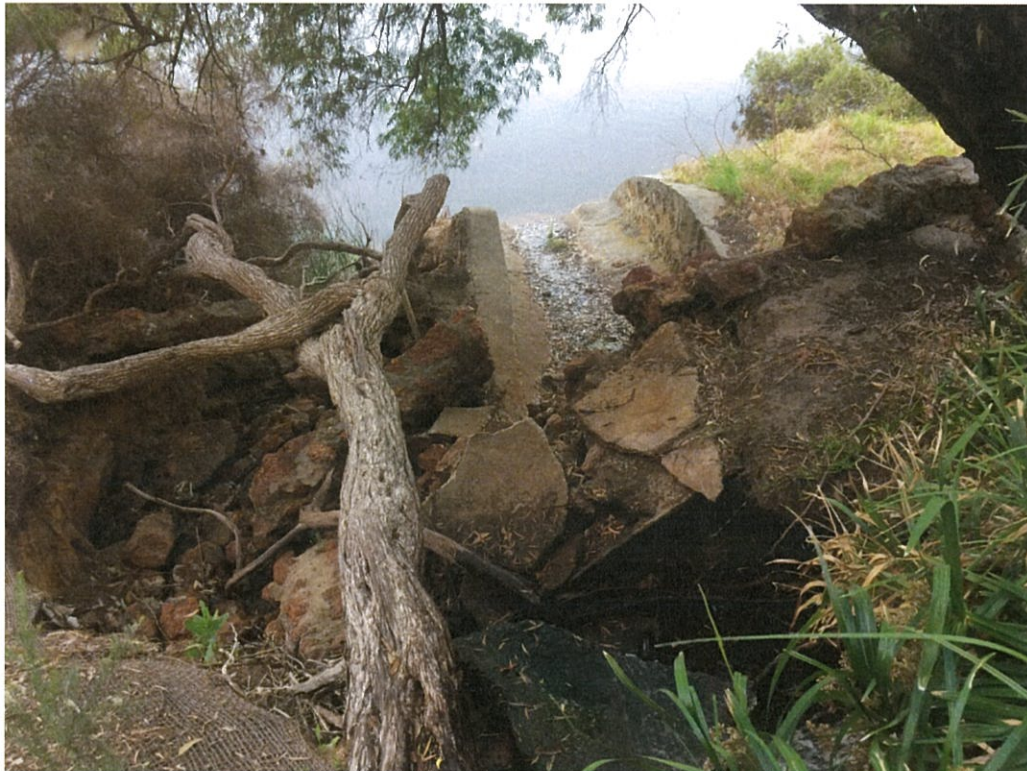
Photograph 1: Scour feature and collapsed 2nd tier concrete structure.

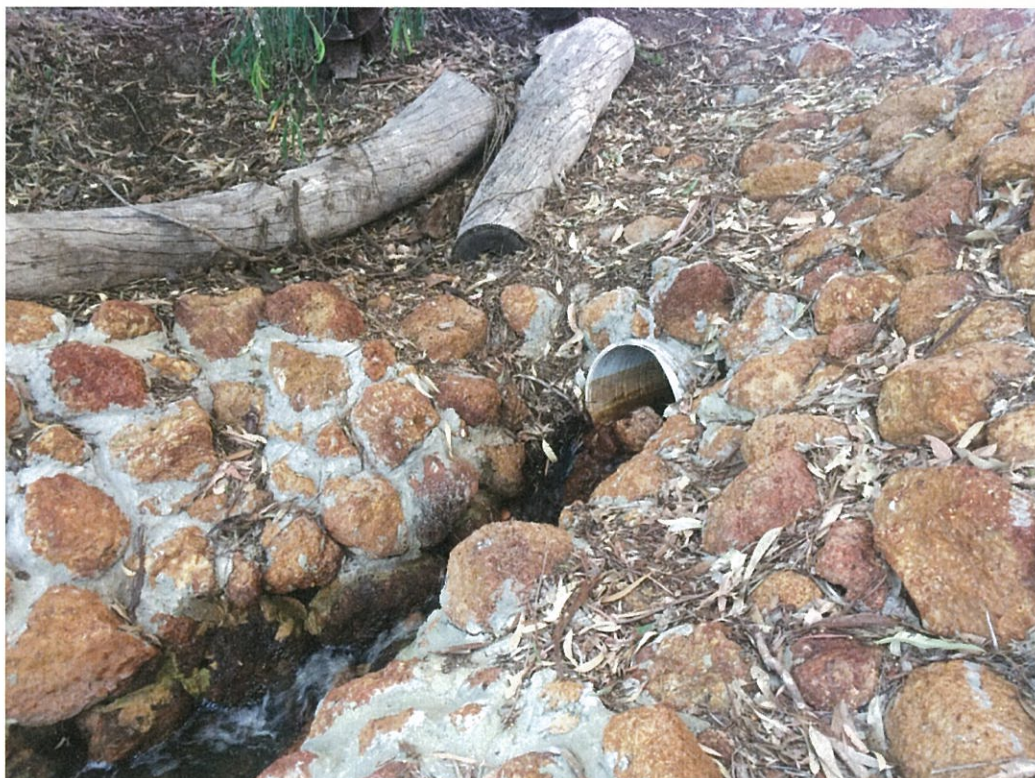
Photograph 2: Outflow pipe at the top of the embankment.

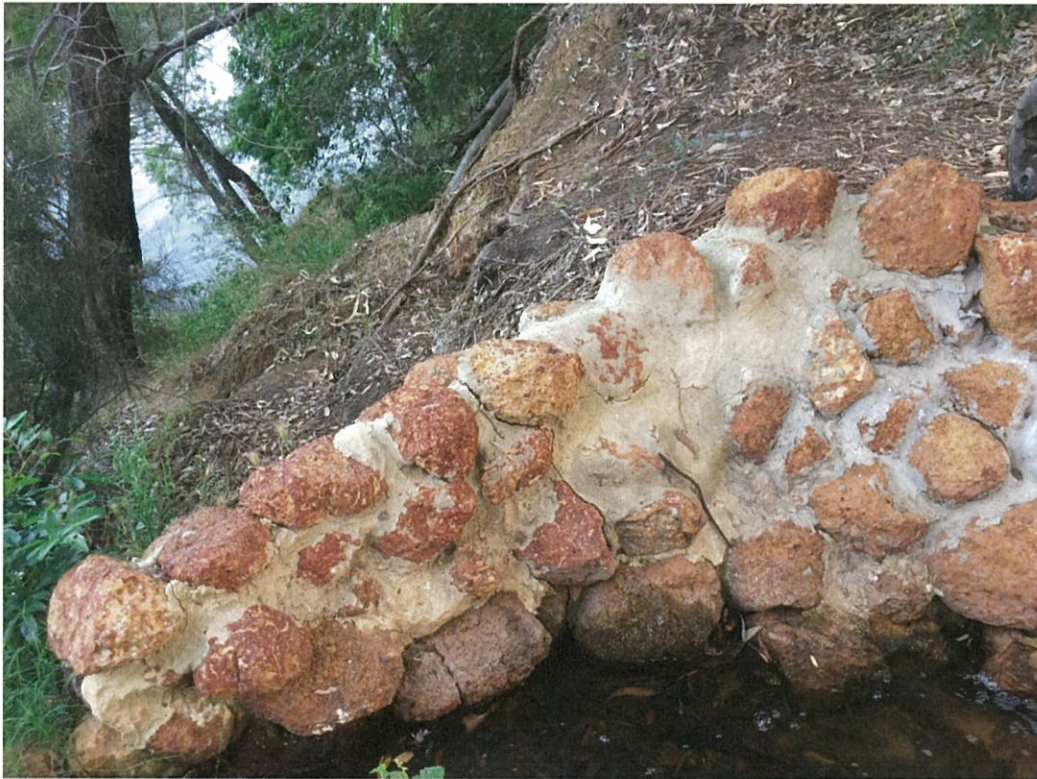
Photograph 3: Tension cracking within the existing structure.

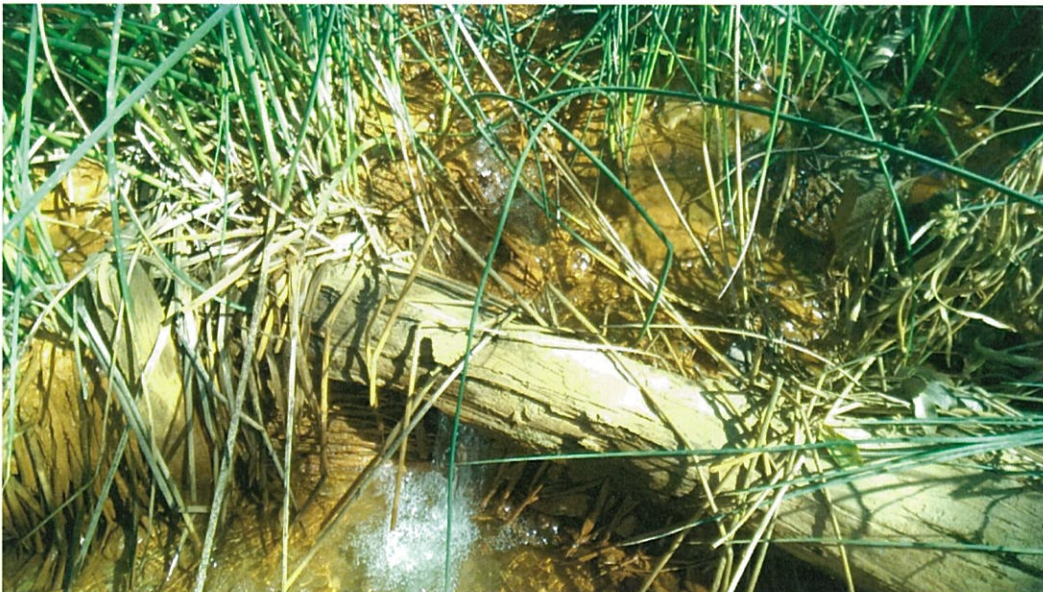
Photograph 4: Natural spring outflowing on the western river embankment upstream of the drainage outflow structure.

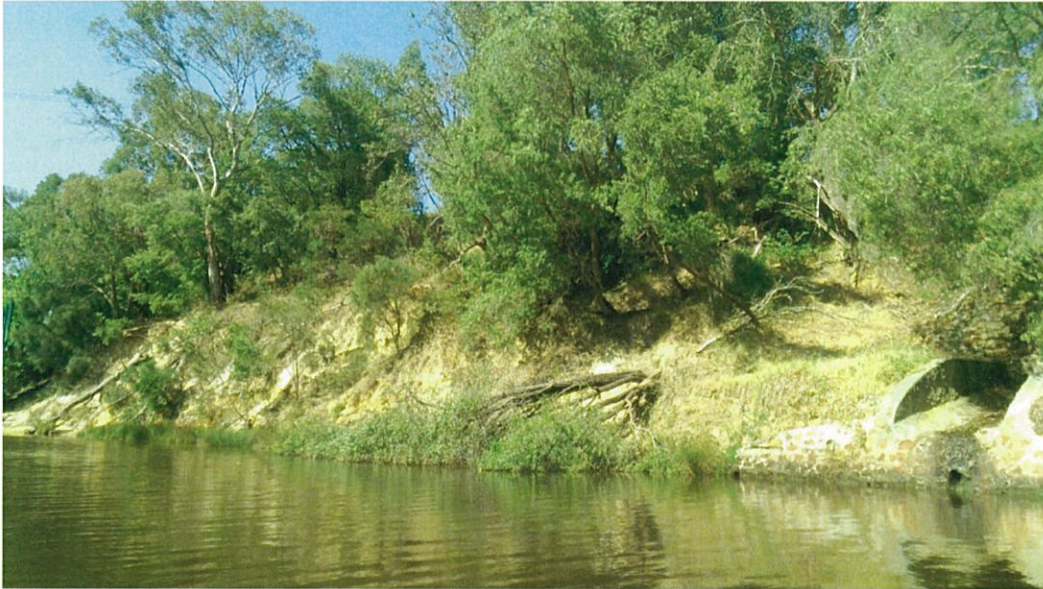
Photograph 5: (Right) Outflow structure. (Left) Recent collapse of several trees due to ongoing slope instability.
