TOWN OF BASSENDEAN

NOTICE OF A MEETING OF THE TOWN ASSETS COMMITTEE

Old Perth Road Street Tree Audit

Town of Bassendean

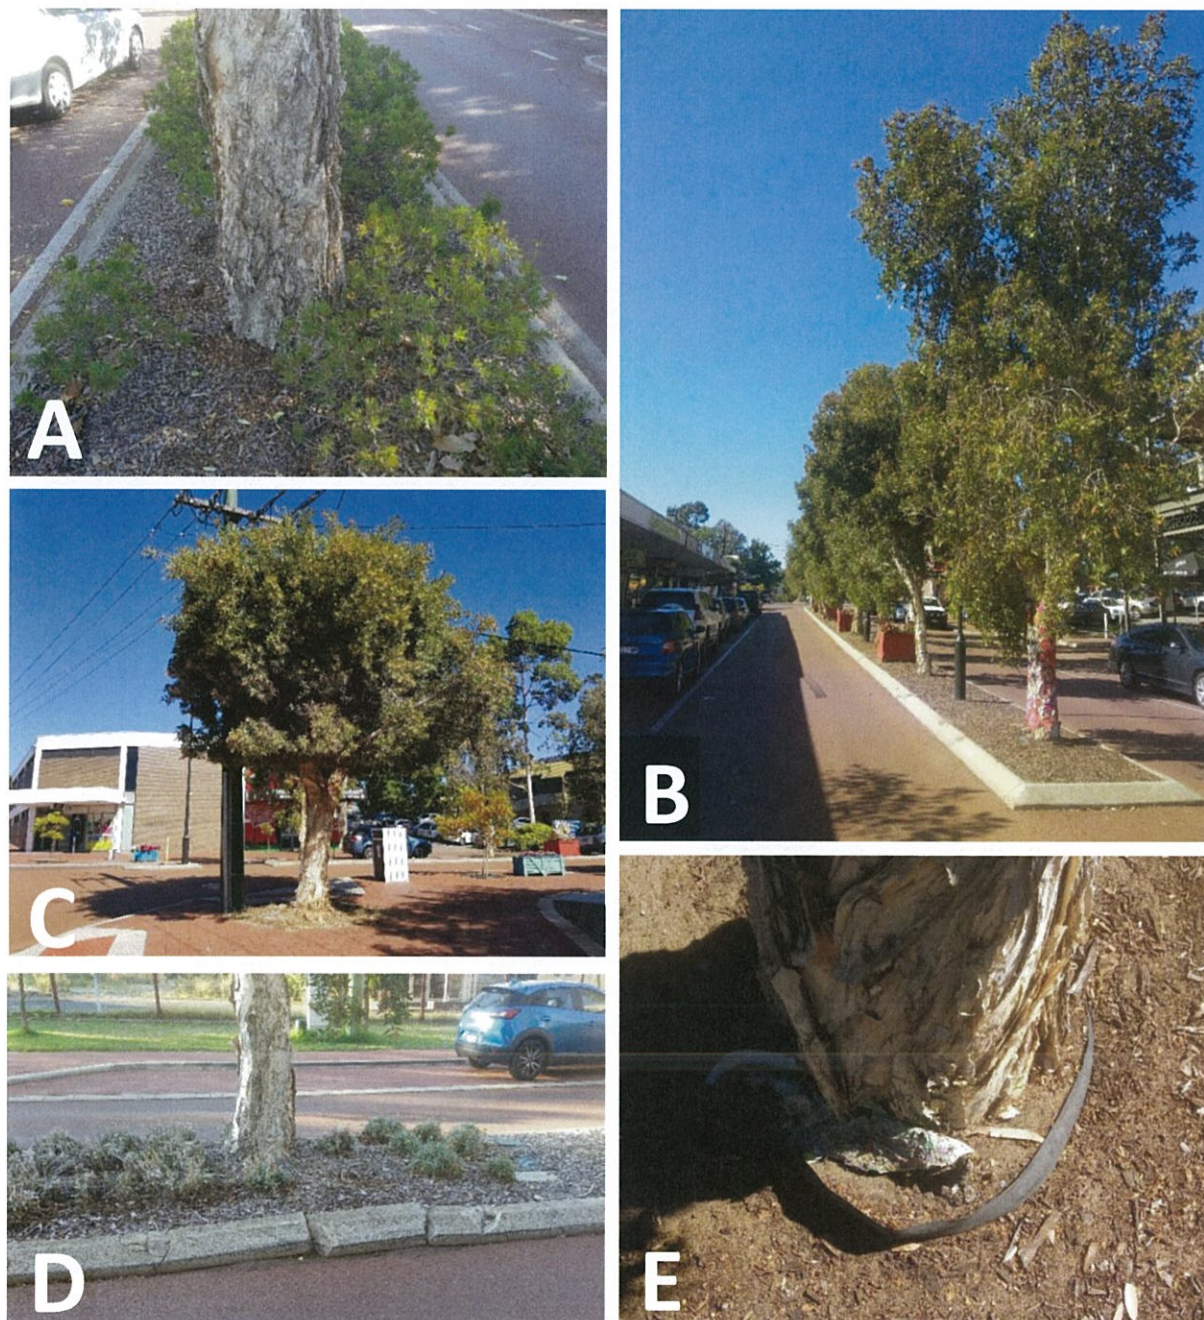
with dense canopy, which makes them well suited to their position in the median strip. However, they do not provide as much canopy as a tree with broader growth form. They can be structurally pruned to have a broader growth form (Figure 2C). *Melaleuca quinquenervia* roots are known to cause structural damage to their surrounds when planted in similar scenarios. There was minor cracking and uplifting of the median strip curb and surrounding road (Figure 2D). Root barriers were observed around the root systems of some of the *M. quinquenervia* (Figure 2E), which may have reduced or delayed such root damage.

Figure 2: *Melaleuca quinquenervia* along old Perth Road, showing (A) their position in the median strip, (B) their narrow growth form, (C) their broad growth form, (D) damage to curbs from their invasive roots, and (E) root barriers.

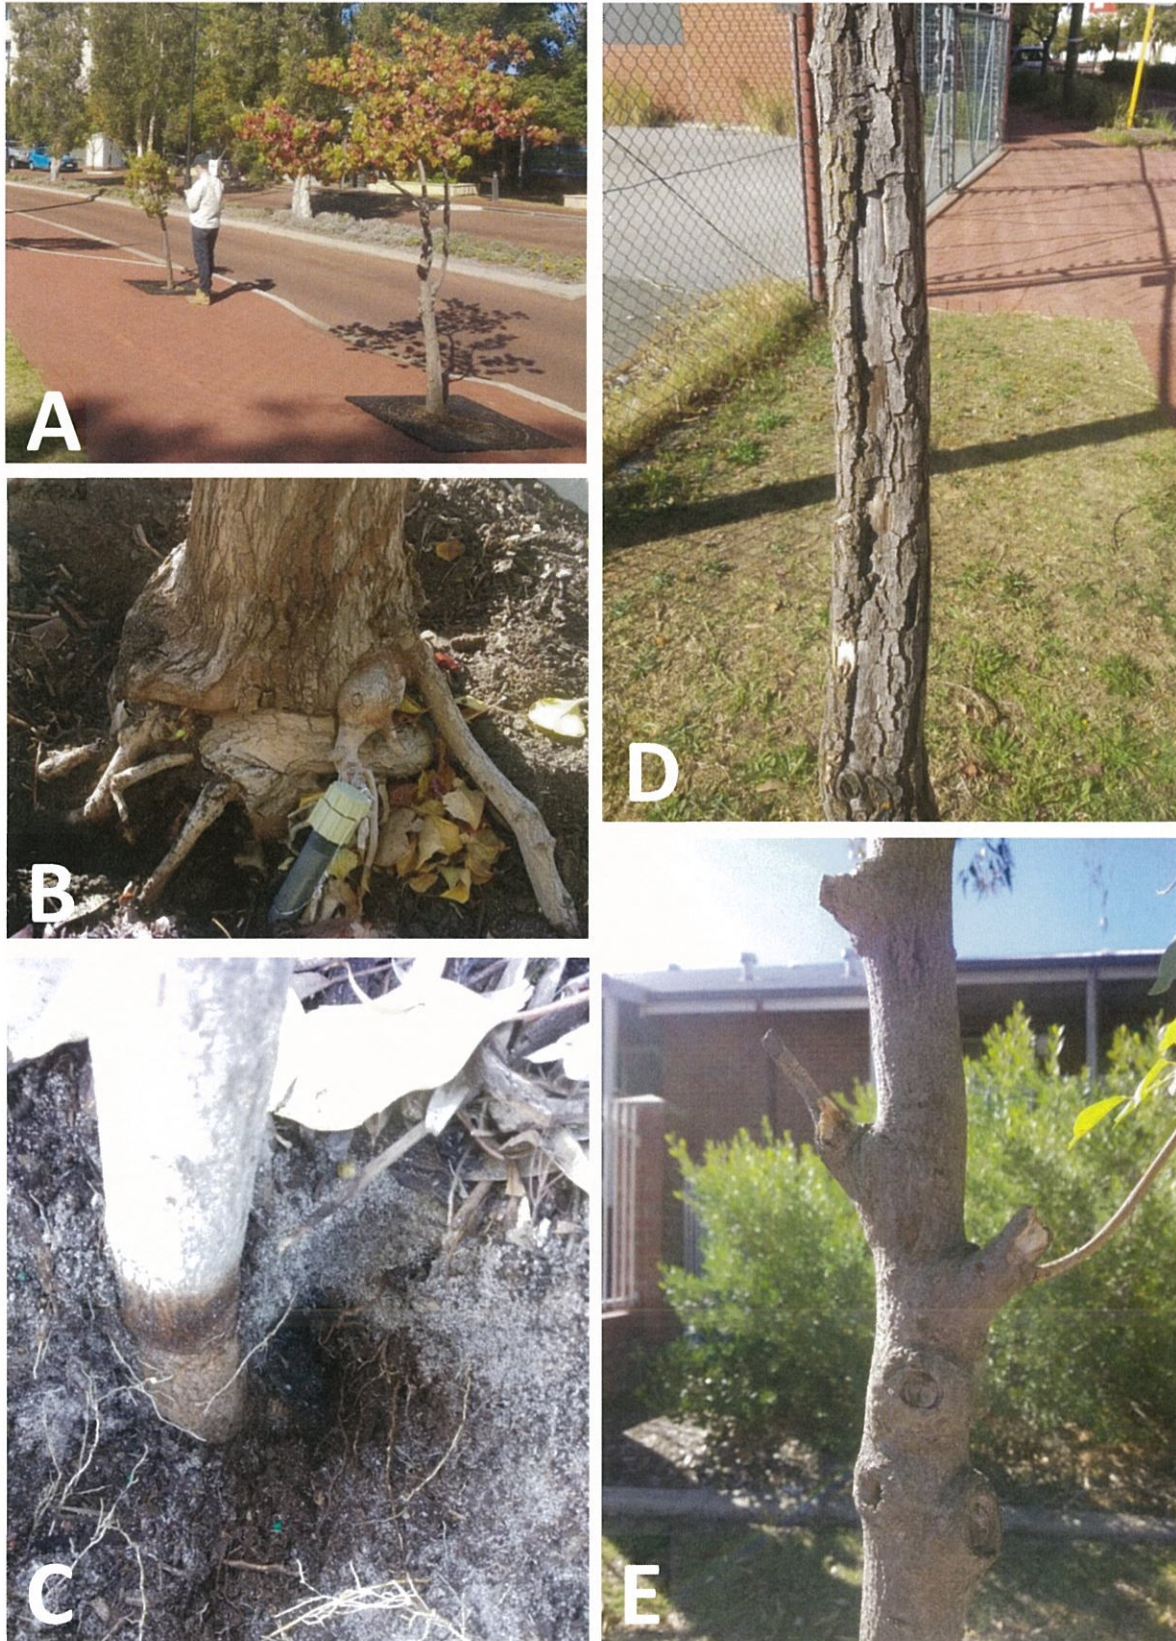
majority of these appeared to be planted between 2013 and 2014. The health of these recently established trees was generally poor. Several individuals displayed a stunted growth form (Figure 3A). Symptoms included frequent branch dieback, foliar chlorosis, sunscald (Figure 3D) and vandalism (Figure 3E). Many trees displayed an unstable root plate indicating poor root system development, and below-ground investigation revealed evidence of girdling roots (Figure 3B). These symptoms are often found in poor quality planting stock reflective of their sub-optimal growth and management in the nursery. In many cases, trees lacked a visible basal stem taper and appeared to be planted too deep or had received fill over their basal stem subsequent to planting (Figure 3C).

Figure 3: Examples of *T. sebifera* in poor condition: (A) stunted growth form, (B) girdling roots, (C) fill over basal stem, (D) sun-scald damage to the trunk, and (E) broken branches due to vandalism.

Many *T. sebifera* on the eastern end of Old Perth Road had severe sun-scald and mechanical damage to their trunks and branches, presumably from vehicles. This was particularly evident in specimens growing in roadside diamonds. The trees growing in roadside diamonds were relatively healthy when compared to many of the trees established in footpath planting pits. However, the extent of sunscald, and vehicle damage will likely reduce the lifespan of these tree in the future. Evidence of girdling roots was also observed in several specimens, which is likely to further reduce the life expectancy of these trees.

The simplest and cheapest option to improve canopy coverage within the street would be to remove and replace all poor performing *T. sebifera* (Chinese tallow) (Figure 7). Many of these trees have been planted for 4-5 years and are in a declining state of health. Our investigation suggests that the principle reason for the poor performance is the quality of the initial planting stock, for which there is no remediation possible. These trees could be replaced with a tree species with a greater potential crown size at maturity. However, the lack of sufficient soil volume of suitable quality will likely restrict the crown volume possible in many of the planting spaces.

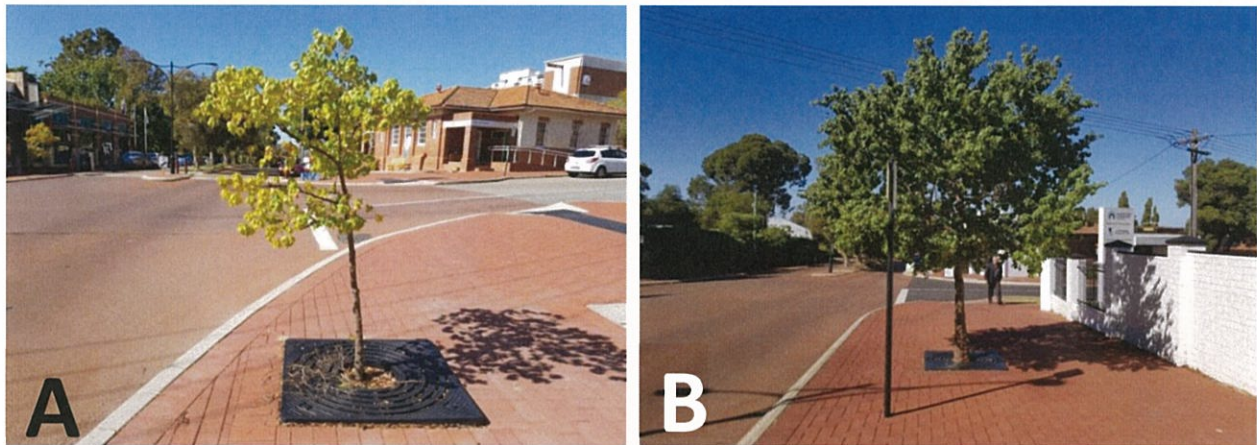
Relatively healthy *T. sebifera* were observed on Old Perth Road between Wilson Street and James Street. Examination of historical aerial photography showed these trees were planted in the same period as many of the other *T. sebifera* in 2014. Comparison of healthy and unhealthy *T. sebifera* established in the same year are presented in Figure 4.

Figure 4: Examples of unhealthy (A) and healthy (B) *Triadica sebifera* on Old Perth Road, both planted at the same time (2014).

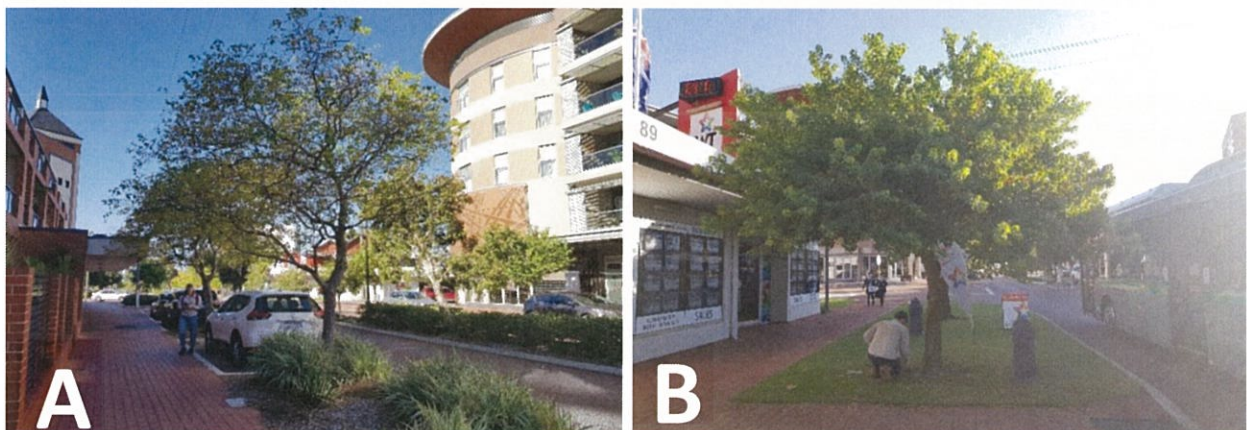
A stand of mature *T. sebifera* were present on the south eastern end of Old Perth Road. These trees were greater than 10 years of age and appeared to be relatively healthy, with some evidence of minor branch dieback observed. Tree condition was, however, difficult to ascertain as the foliage was becoming senescent as the trees entered their dormant stage. These trees had a much larger soil area in which to grow which likely contributed to the success of these plantings (Figure 5).

Figure 5: Example of mature *Triadica sebifera* in good condition on south eastern end of Old Perth Road, planted in (A) larger carpark bay and (B) turfed area.

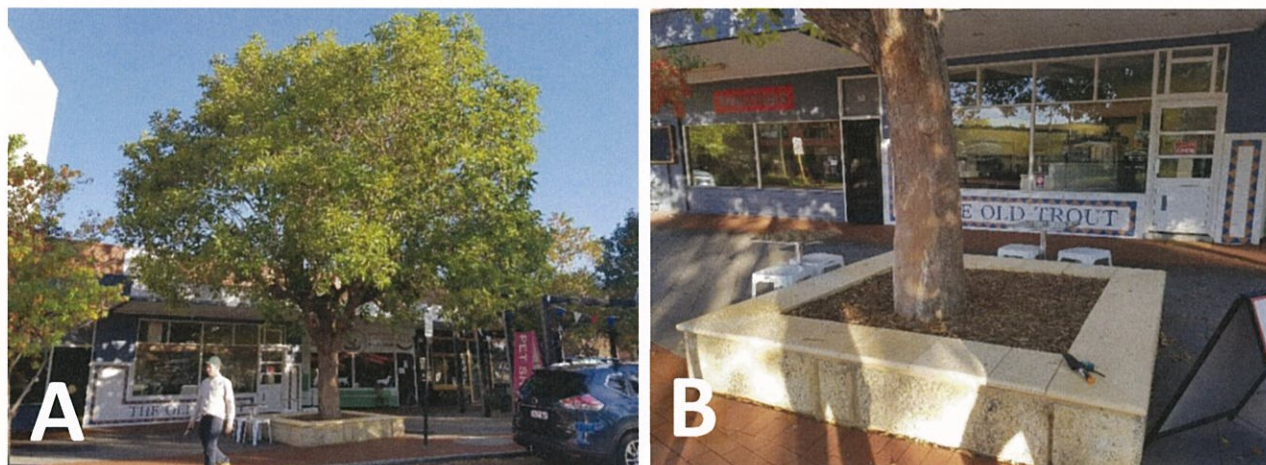
There were five mature, healthy *Lophostemon confertus* located on the eastern half of Old Perth Road. The trees had large, broad crowns (Figure 6A), and while they only made up 4.3% of the total number of trees, they contributed to 12.6% of the total canopy cover of Old Perth Road. Some individuals had raised garden beds built around them, bringing the soil level up around the base of the tree (Figure 6B), however, this has not appeared to have had a negative impact on the condition of the trees.

Figure 6: Healthy, mature *Lophostemon confertus* with (A) large, dense crown and (B) raised garden bed around base.

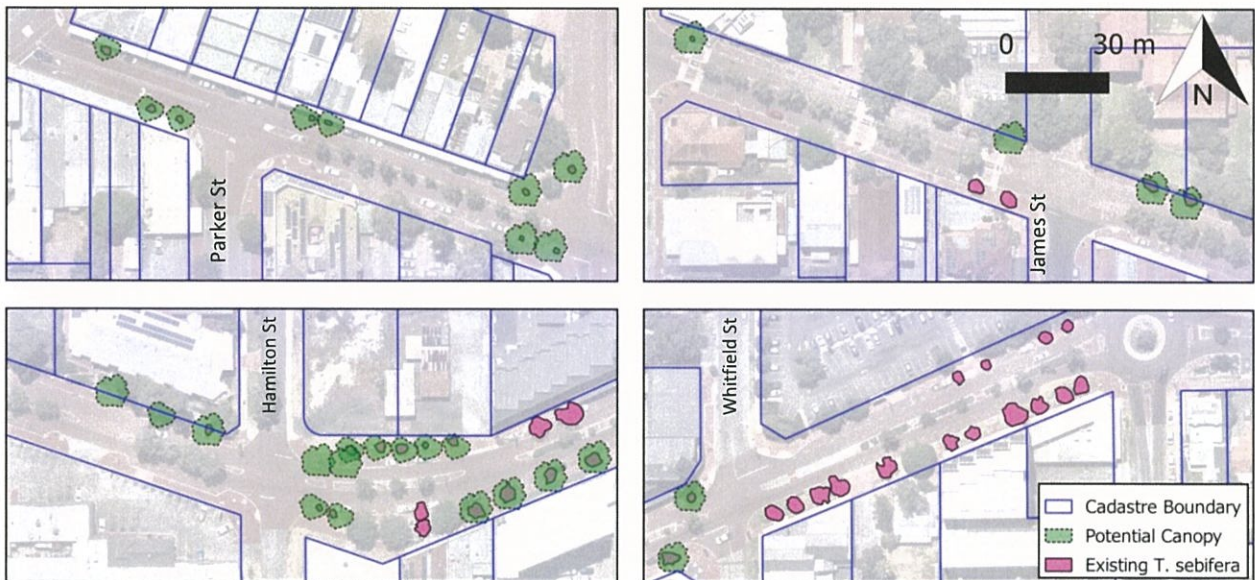
Figure 7: Replacement of poor performing *Triadica sebifera* with a species that has bigger potential crown size. The purple polygons are existing *T. sebifera* crowns, and the semi-transparent green polygons indicate potential canopy of poor performing *T. sebifera* are replaced with broader crowned trees. Note that some *T. sebifera* are could remain.
