**Ark Hospitality Group  
Bassendean Hotel Development  
Old Perth Road, Bassendean WA  
Arboricultural Impact Assessment**

3 December 2020

**Arboricultural Impact Assessment Report regarding nine (9) trees located within the vicinity of the proposed development at the Bassendean Hotel, Old Perth Road, Bassendean**

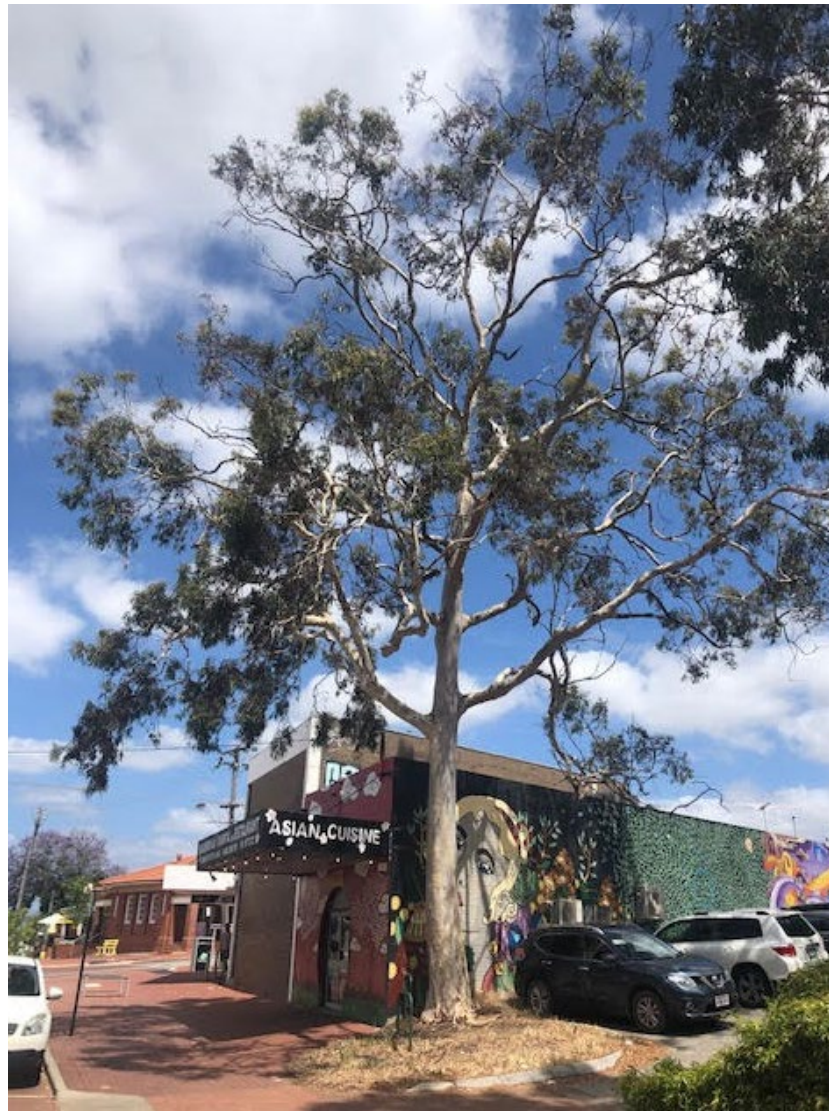
## 6.4 Tree 1

- 6.4.1 Tree 1 was a semi-mature Lemon-scented Gum (*Corymbia citriodora*). Although frequently used as an urban planting within Metropolitan Perth, the species (indigenous to Queensland and Northern NSW) is now considered undesirable and has proved to be invasive in banksia/tuart woodland to the south-west of WA. Tree 1 showed signs of reduced health and vigour with evidence of previous significant limb failures.

Figure 4. View of Tree 1 in its growing environment. (Author, November 2020).

- 7.2.3 Based on the supplied plans (Figure 1 and Section 6), a significant encroachment into the SRZ of Trees 1, 2, 3 and 4 would be required to accommodate the proposed design. It is recommended that each of these trees is replaced (Section 7.14) with a tree of medium dimensions (at maturation). It is further recommended that replacement tree(s) with a proposed planting location to the north of the alfresco seating area (adjacent to Old Perth Road) be deciduous in nature and of a species approved by the Town of Bassendean.

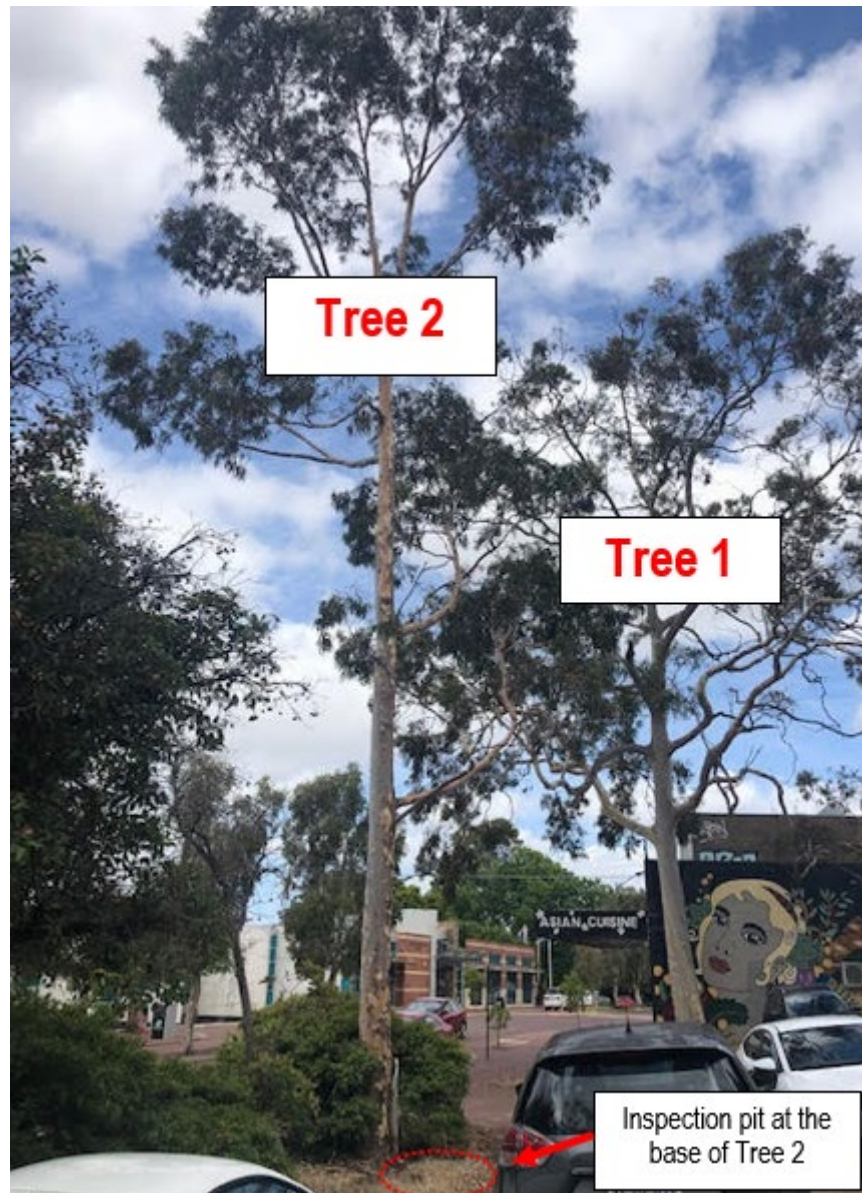
## 6.5 Tree 2

- 6.5.1 Tree 2 was a semi-mature Lemon-scented Gum (*Corymbia citriodora*). Although frequently used as an urban planting within Metropolitan Perth, the species (indigenous to Queensland and Northern NSW) is now considered undesirable and has proved to be invasive in banksia/uart woodland to the south-west of WA. Tree 2 was located in close proximity to an inspection pit.

Figure 5. View of Tree 2 in its growing environment. (Author, November 2020).

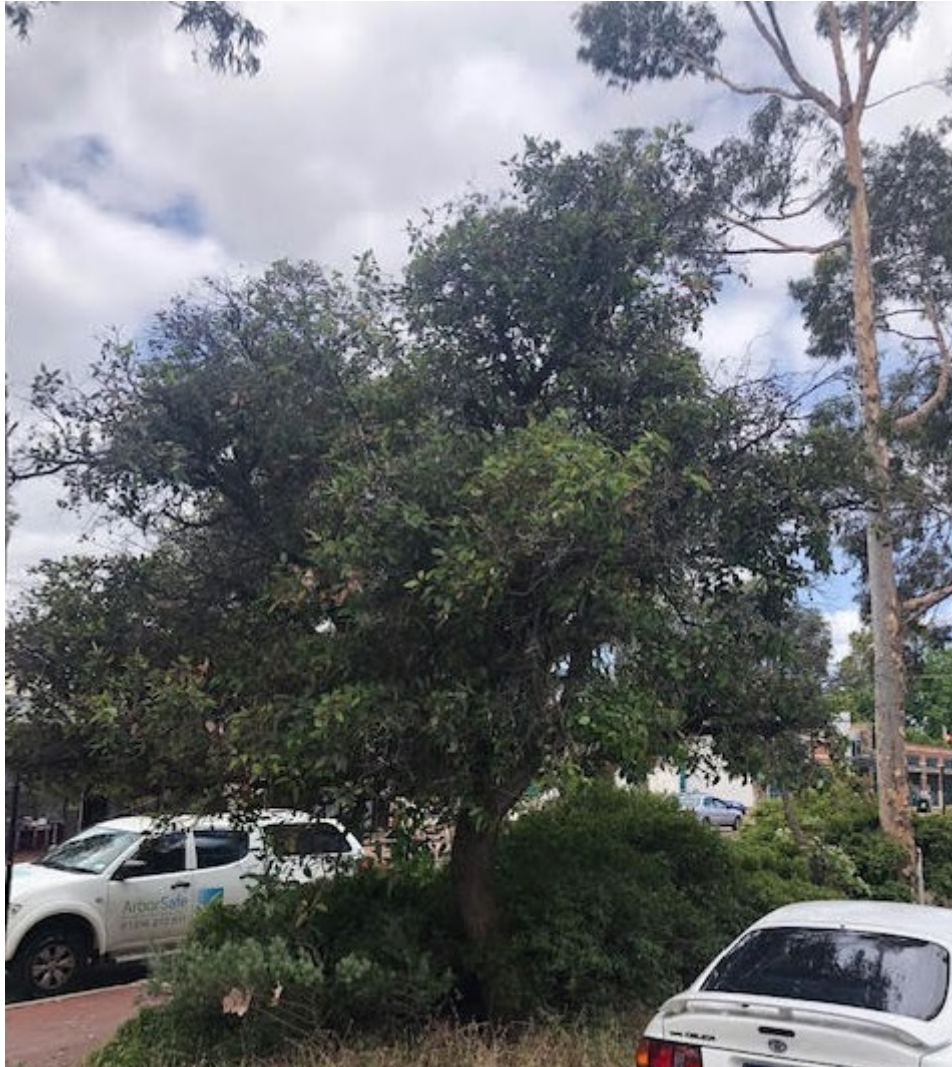
## 6.6 Tree 3

- 6.6.1 Tree 3 was a semi-mature WA Red Flowering Gum (*Corymbia ficifolia* – hybrid). Tree 3 showed signs of reduced health and vigour including tip dieback and minor deadwood accumulation.

Figure 6. View of Tree 3 in its growing environment. (Author, November 2020).

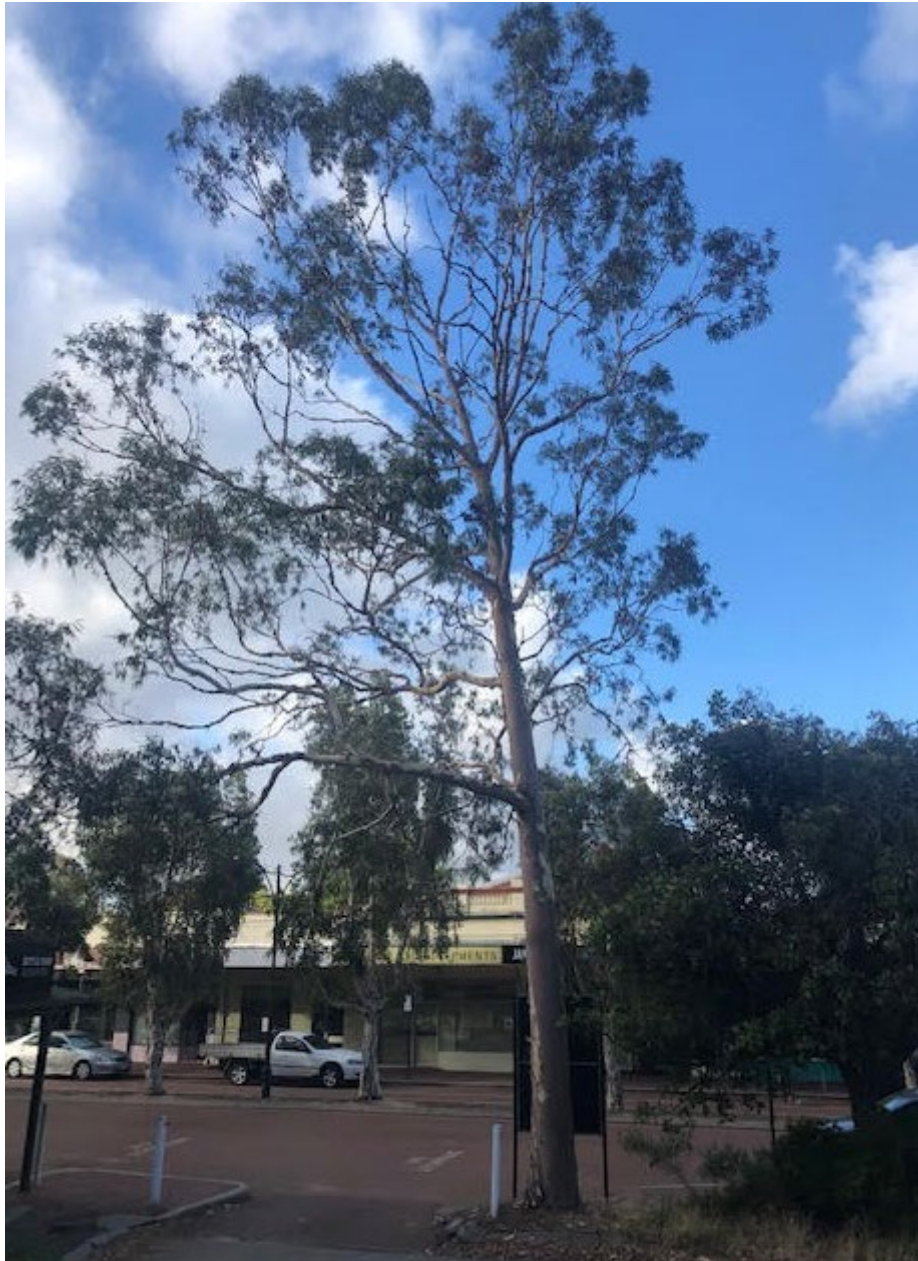
## 6.7 Tree 4

- 6.7.1 Tree 4 was a semi-mature Lemon-scented Gum (*Corymbia citriodora*). Although frequently used as an urban planting within Metropolitan Perth, the species (indigenous to Queensland and Northern NSW) is now considered undesirable and has proved to be invasive in banksia/tuart woodland to the south-west of WA. Tree 4 showed signs of reduced health and vigour with evidence of previous root damage.

Figure 7. View of Tree 4 in its growing environment. (Author, November 2020).

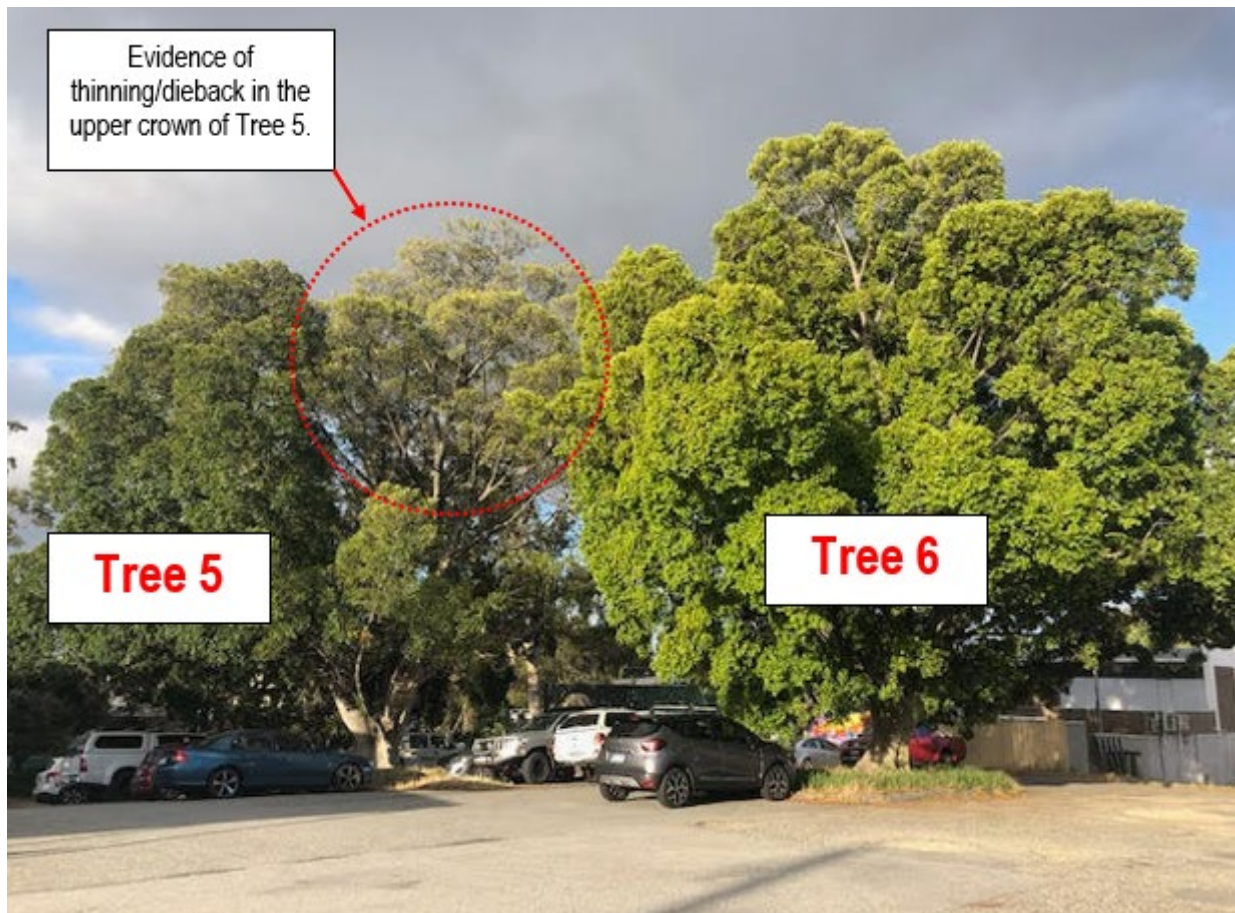
6.8.1 Tree 5 was a mature Hill's Weeping Fig (*Ficus microcarpa var. hillii*). The tree was located within a car park setting, surrounded by hard surfaces, and is a native fig species that commonly possesses expansive root systems. Historic root exposure, damage and compaction were evident and had likely contributed to an apparent reduction in tree health manifested by dieback/thinning in the tree's upper eastern crown (see Figure 8). Cracking observed beyond the extent of the tree's dripline would suggest that significant roots extend out into the existing car park area.

6.9.1 Tree 6 was a mature Hill's Weeping Fig (*Ficus microcarpa var. hillii*). The tree was located within a car park setting, surrounding by hard surfaces, and is a native fig species that commonly possesses expansive root systems. Although likely suffering from the effects of compaction and impermeable surfacing, Tree 6 presented as in better health when compared to Tree 5 (see Figure 8). This difference could potentially be attributed (in part) to lower levels of observed root severance and damage when compared to Tree 5. Lower trunk wounding, possibly a result of historic limb failure, poor pruning or vehicle strike was observed on Tree 6.

Figure 8. View of Trees 5 and 6 in their growing environment. (Author, November 2020).

- 7.2.4 Tree 5 presented as an established Hill's Weeping Fig also showing signs of reduced health and vigour. There was evidence of extensive historical root damage, severance and compaction which is likely to have contributed to a drop in vitality. This type of root damage and corresponding reduction in health could be expected to reduce the useful life of this tree and limit its resilience to further excavation works within the TPZ. Anecdotal evidence additionally indicated that significant roots emanating from Tree 5 extended past the drip line (as would be expected from this species). Consequently, a degree of further root severance would likely be required to accommodate the proposed design.

- 7.2.5 Due to these factors it is recommended that Tree 5 be removed and replaced with a single large tree or a minimum of two medium trees (at maturation).

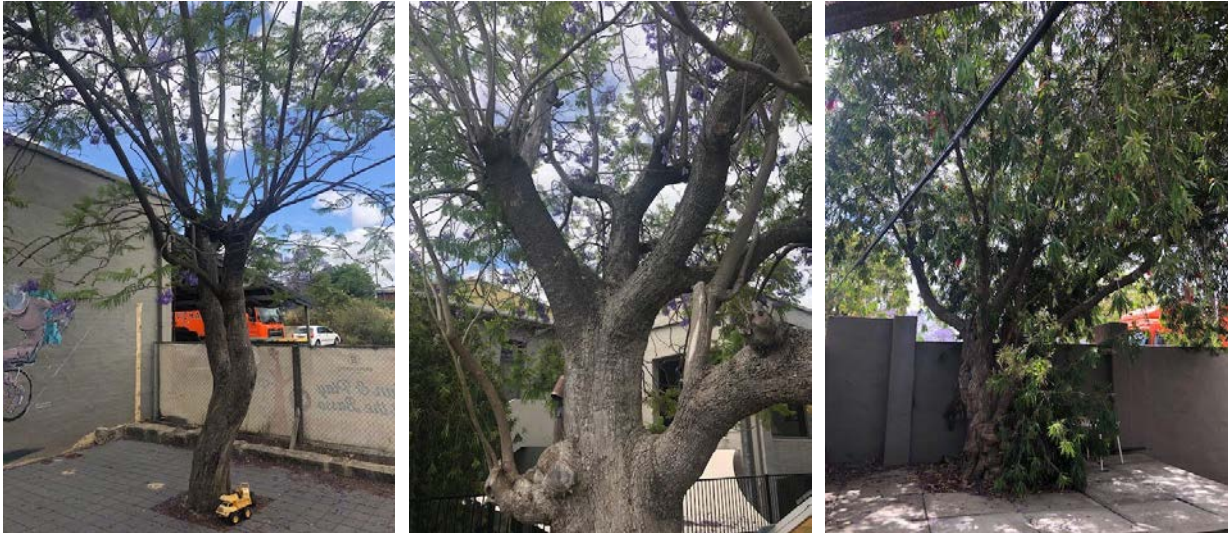
## 6.10 Trees 7, 8 and 9

- 6.10.1 Trees 7 and 8 were semi-mature Jacarandas (*Jacaranda mimosifolia*). Both trees displayed diminished form (e.g. degrading pruning wounds, poor regrowth attachments) and reduced ULEs as a result of historic lopping practices. A lack of observable basal flare at the base of Tree 8 also indicated historical soil grade changes.
- 6.10.2 Tree 9 was a Bottlebrush (*Callistemon* sp.) and although the tree provided some shade/screening value, its form and ULE were deemed to have been diminished by historic poor pruning practices.

Figure 9. View of Tree 7 (left), Tree 8 (centre) and Tree 9 in their respective growing environments. (Author, November 2020).

- 7.3.9 Trees 7, 8 and 9 where deemed to hold diminished retention values as a result of defects linked to historic pruning practices. Consequently, removal and replacement with small to medium tree species on a one-to-one basis (minimum) within the site footprint is recommended.

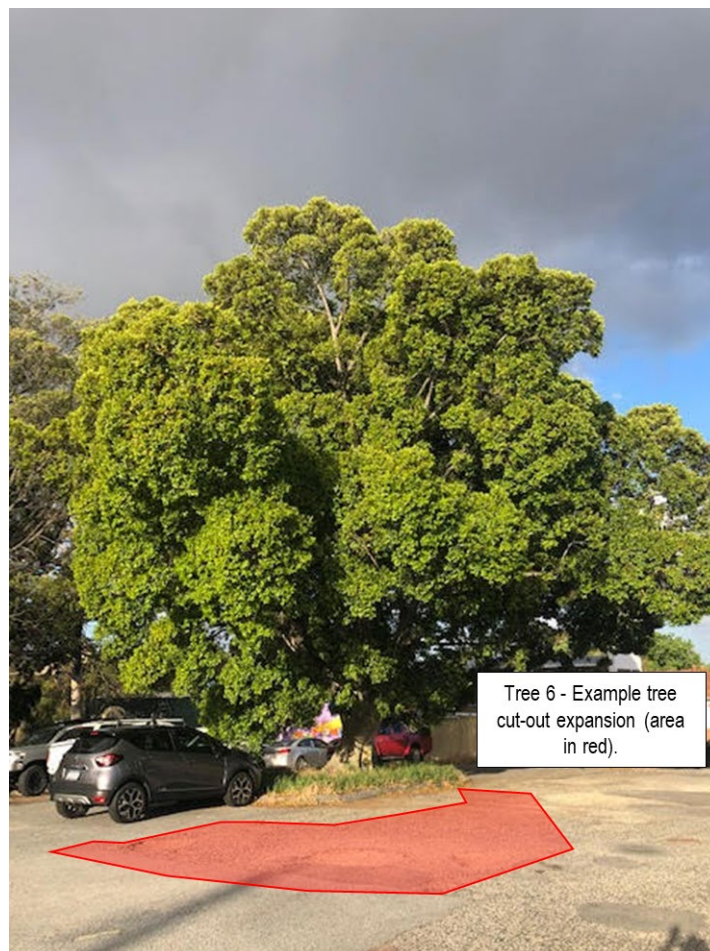
- 7.5.1 Tree 6 would be impacted by excavation works (resurfacing) within a portion of its TPZ as part of the proposed works.
- 7.5.2 Excavation within the TPZ is to be carried out under arborist supervision. No unsupervised excavation should occur within the SRZ of this tree. It is recommended that the proposed excavation commence at the outer extent of the TPZ and move inwards to minimise root damage to the trees.

Figure 10. View of Tree 6 in its growing environment. (Author, November 2020).

- 7.5.7 It is further recommended that the existing tree cut-out be expanded to the full extent permitted by the design but at a minimum should extend past the SRZ/basal flare of this tree to improve the tree's growing environment and future reduce root vs infrastructure conflicts (see Figure 10).
