Pollution Response Unit
Action Report

Cleanaway Materials Recovery Facility Fire
Hyne Road, South Guildford 25/11/19

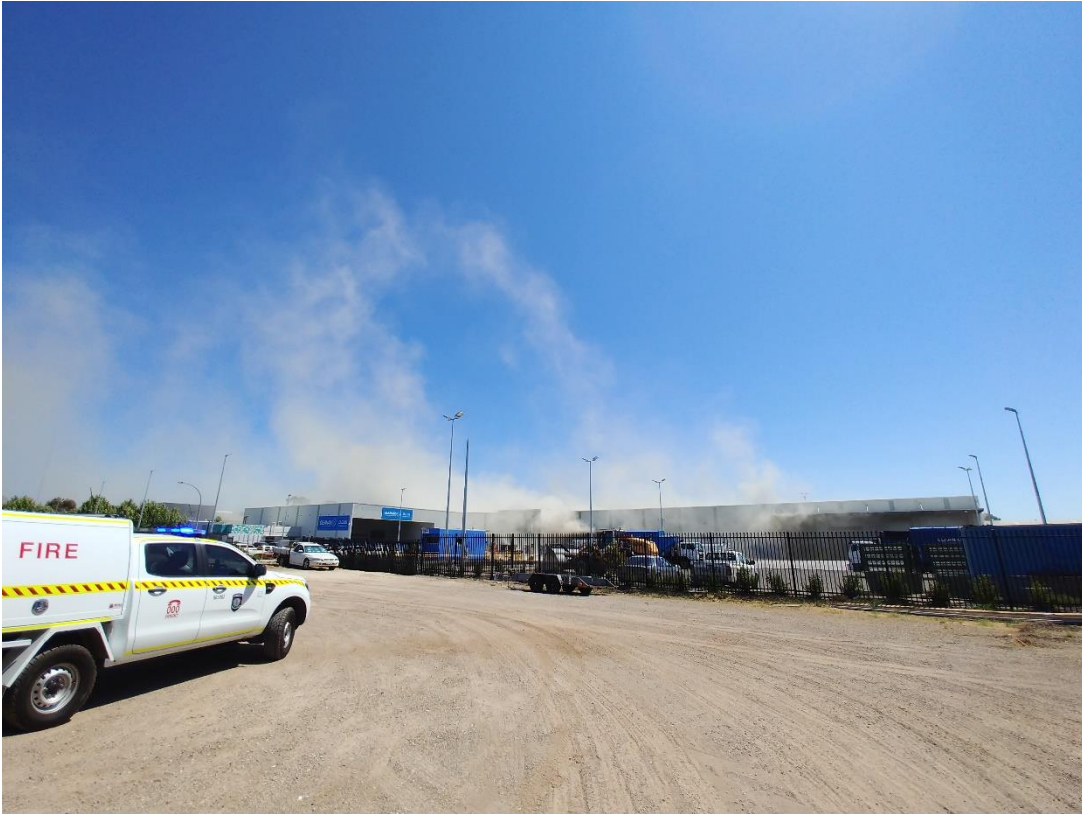
At 09:26 hrs, Monday 25 November 2019, DFES requested DWER's PRU to respond to a 'Fifth Alarm' structure fire at the Cleanaway MRF in South Guildford. Three Pollution Response vehicles and five officers were immediately deployed as a 'Code 3' (highest level of response for DWER PRU) emergency response. Officers arrived on scene approximately 30 minutes after the DFES notification and immediately deployed downwind to conduct air monitoring. A dense grey smoke plume was being emitted when officers arrived (Appendix 1 Photo 1).

Photo 1 – Cleanaway fire during paper/cardboard impacts.

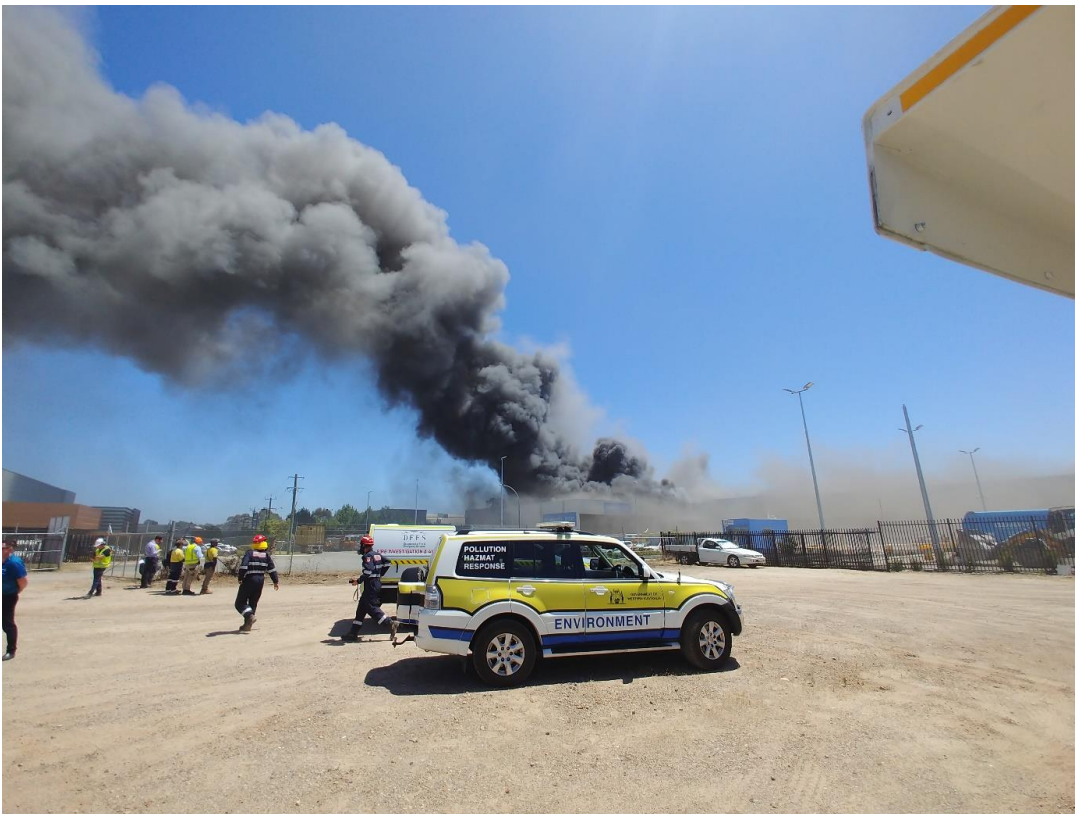
At approximately 11:00 hrs, it is understood that the fire spread to the plastic material causing a significant increase in the heat of the fire and the emission of a dense black smoke plume which was later visible from Rottnest Island (Photos 2 and 3).

Photo 2 - Cleanaway Fire when impact to plastics commenced.

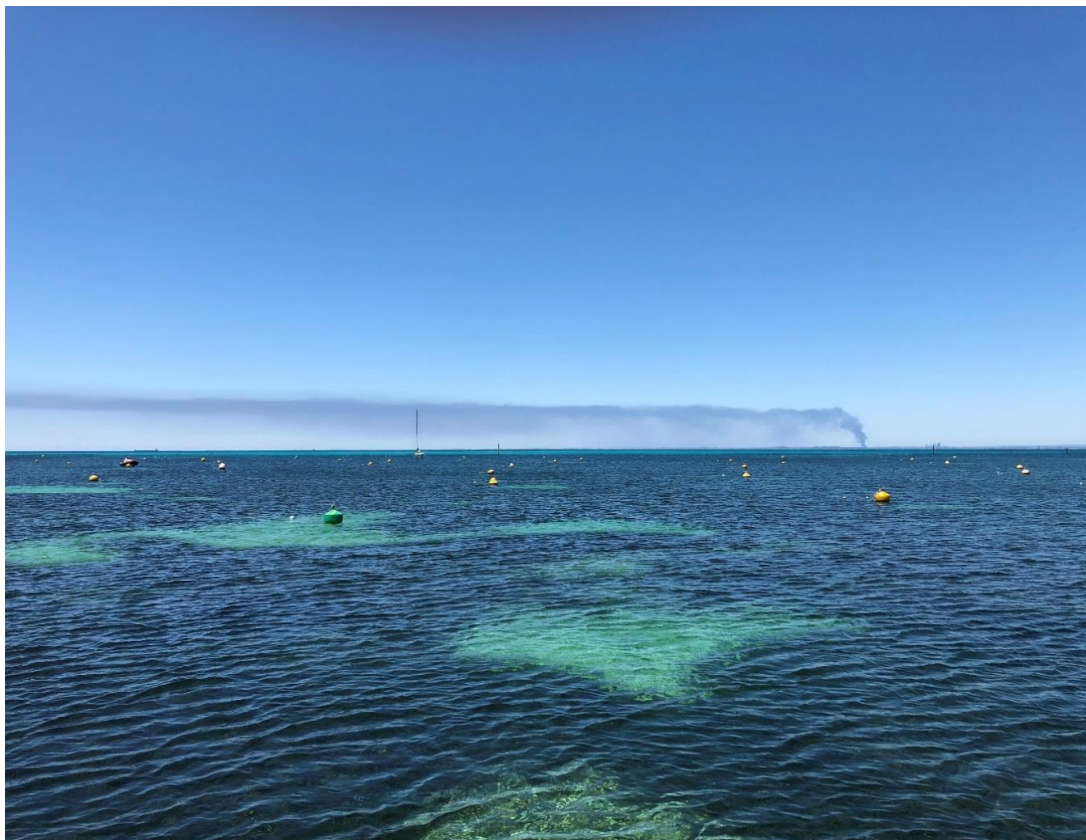
Photo 3 – Smoke plume from Rottnest Island, WA.

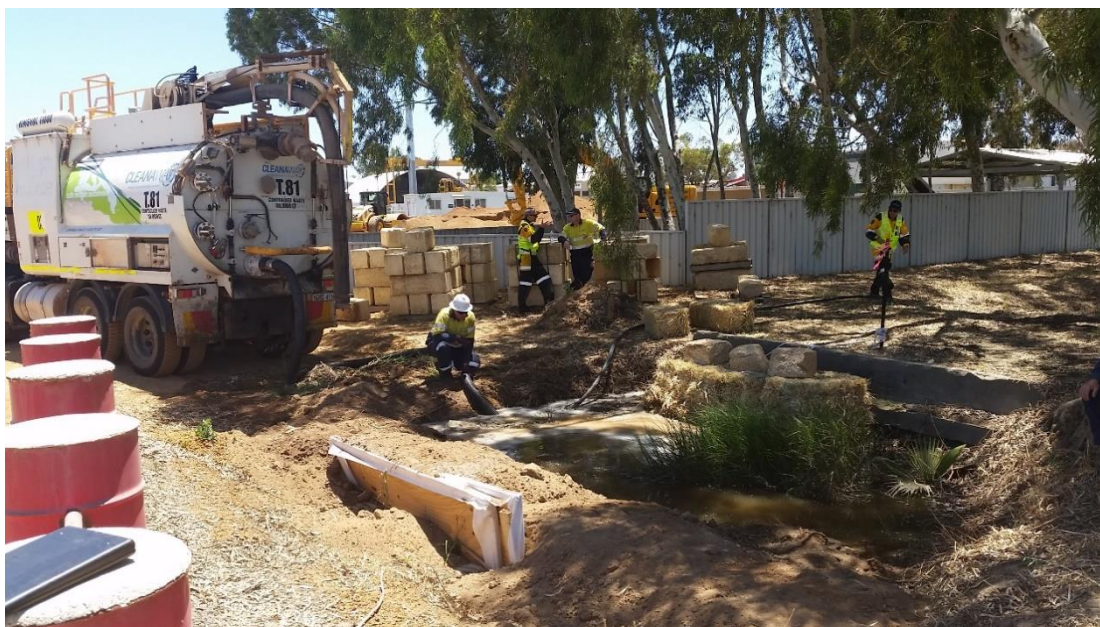
Firefighting run-off water was leaving the site through the Hyne Rd stormwater drainage network (Appendix 5). As a result DWER PRU and the City of Swan commenced an assessment to determine the connectivity and direction of flow path to inform decision making around containment and recovery of impacted firefighting run-off. It was identified that the stormwater drains from the fire entered an open drainage system that eventually led to the Swan River approximately 1 km away. This prompted immediate mitigating action involving a temporary dam (earth bund) being installed by the City of Swan within the open drain (Photo 6).

Photo 6 – Drainage culvert blocked by City of Swan.

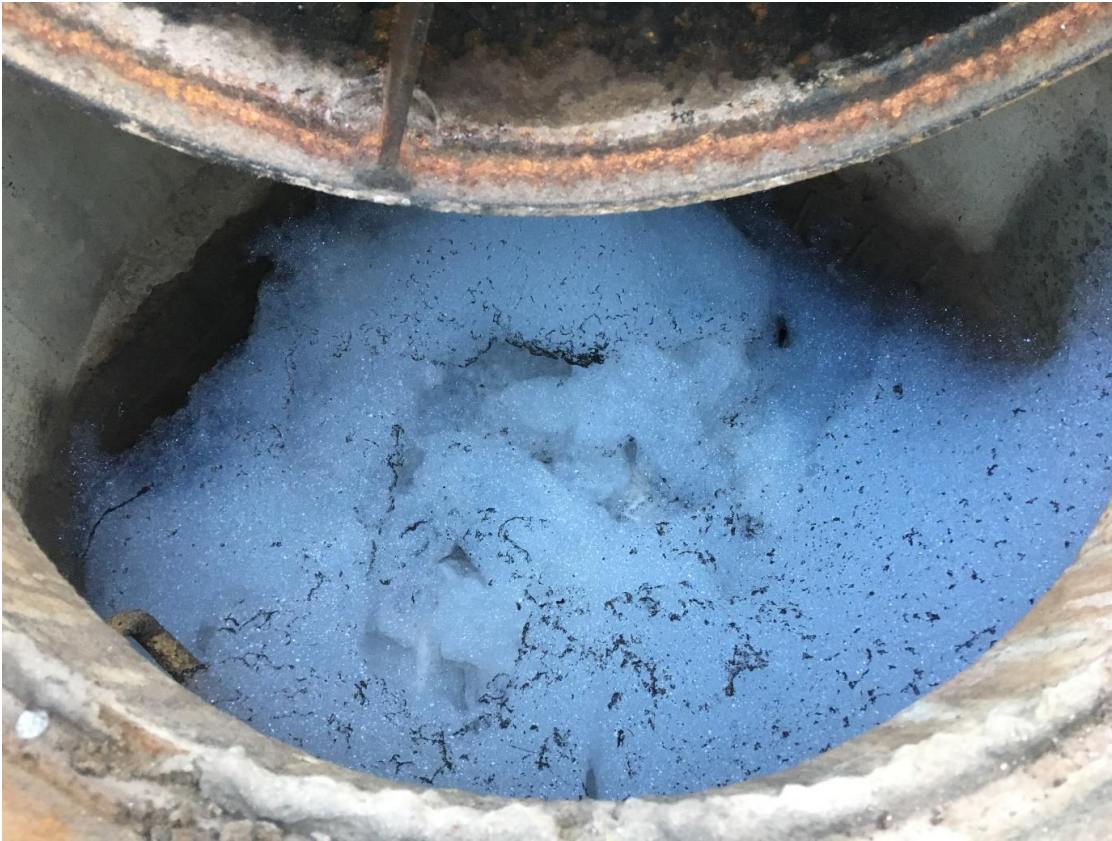
Photo 7 - Foam observed inside City of Swan stormwater system.

DWER PRU requested Cleanaway to commence the recovery of firefighting runoff from the stormwater drainage network (Photo 7).

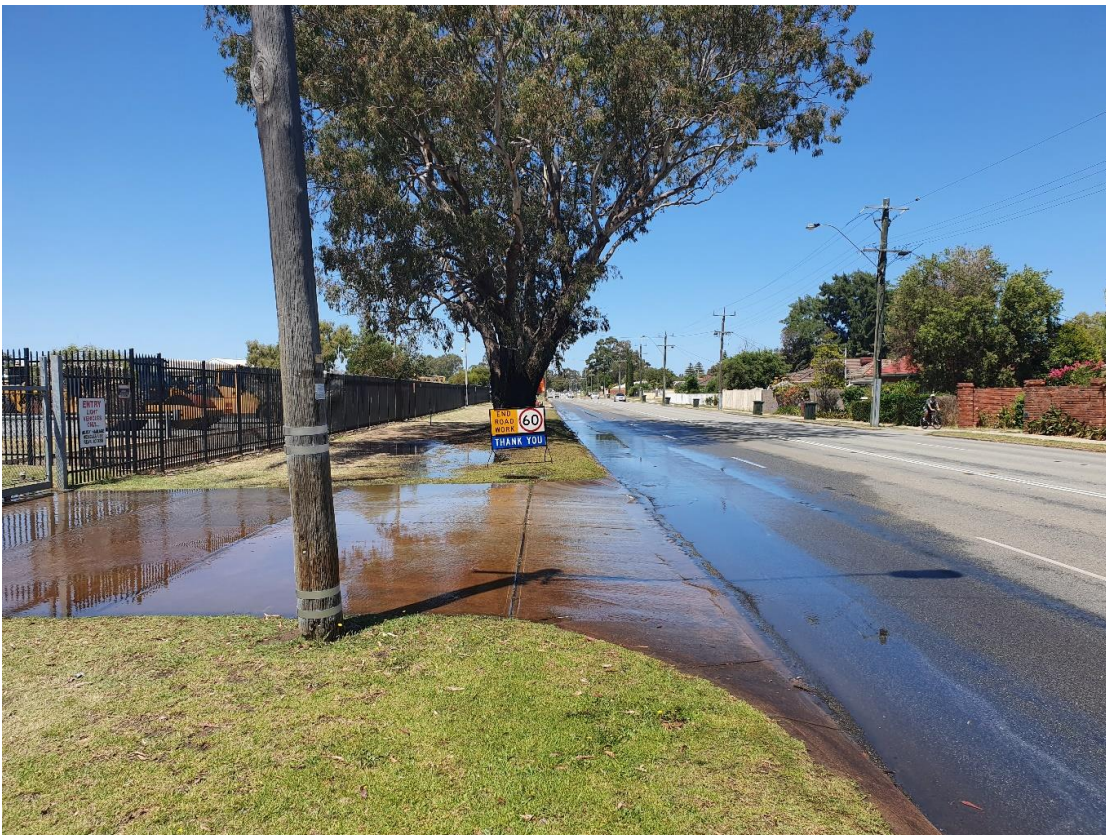
Despite recovery actions and a change to disposal locations arrangements, at around 9:20pm, PRU officers observed firefighting run off water overflowing from a spoon drain onto Great Eastern Hwy at the rear of 8 Anvil Close, and running down the road into a stormwater drain (Photo 8). A small amount of foam was visible and the odour was consistent with fire water runoff.

Photo 8 – Wastewater flooding on Great Eastern Highway, South Guildford.

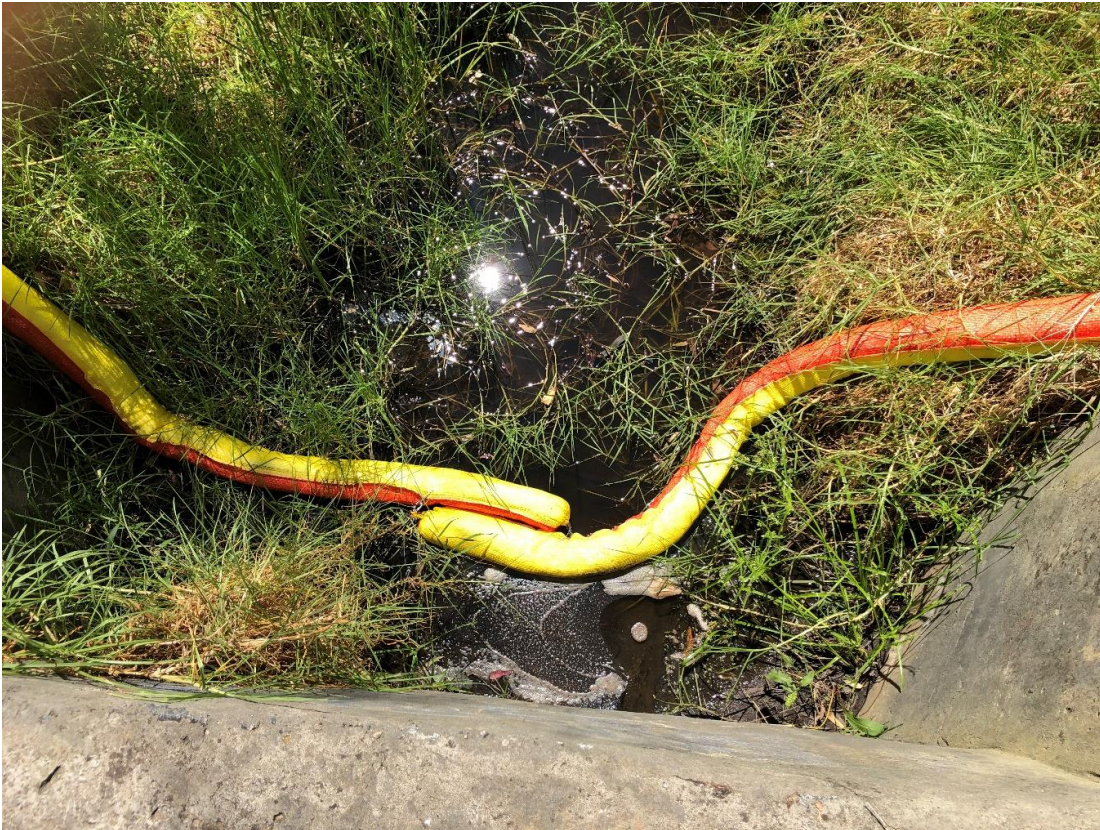
Photo 9 – Booms installed at the Swan River drainage outlet.

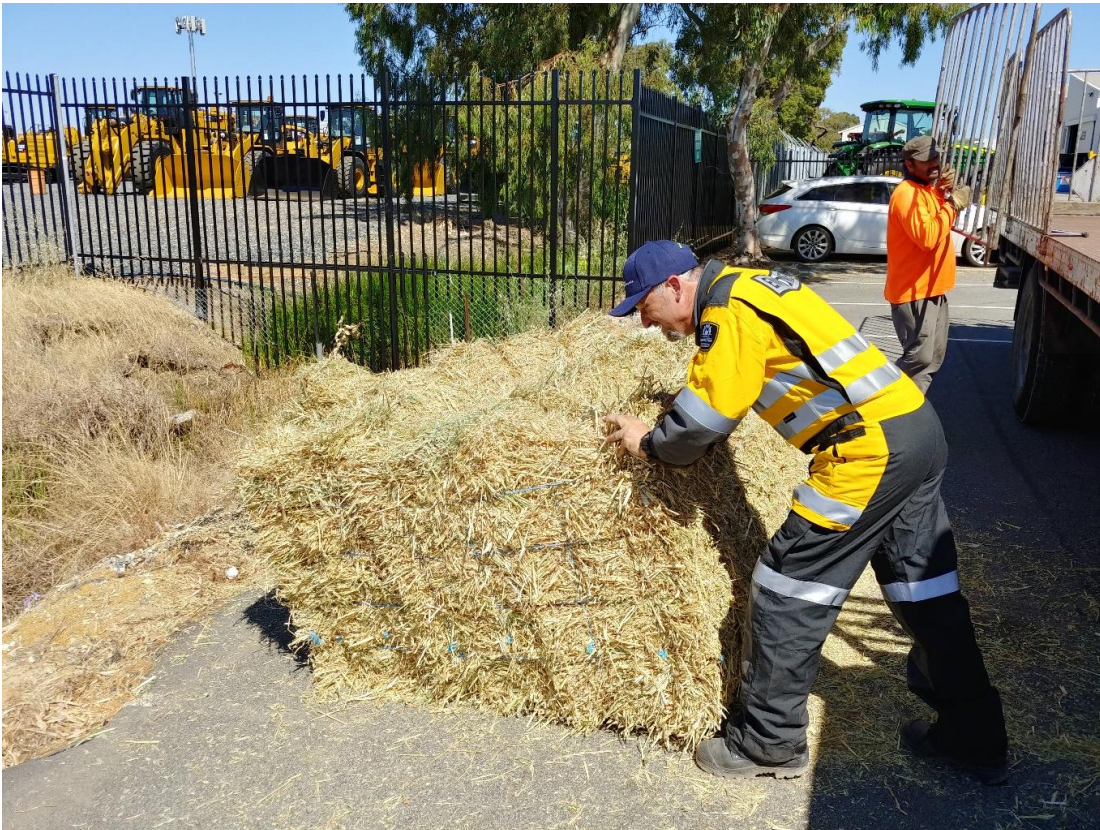
Photo 10 – DWER officer installing hay bales in the open drainage.

On Tuesday 26 November 2019, further preventative measures were undertaken with Department of Biodiversity, Conservation and Attractions (DBCA), River and Estuaries officers installing booms at the stormwater discharge point near the Swan Estuary as well as the entry point into the river (Photo 9). Hay bales were also sourced and positioned within the open stormwater drain as a contingency for the filtration of particulates should the dam be compromised (Photos 10 & 11).

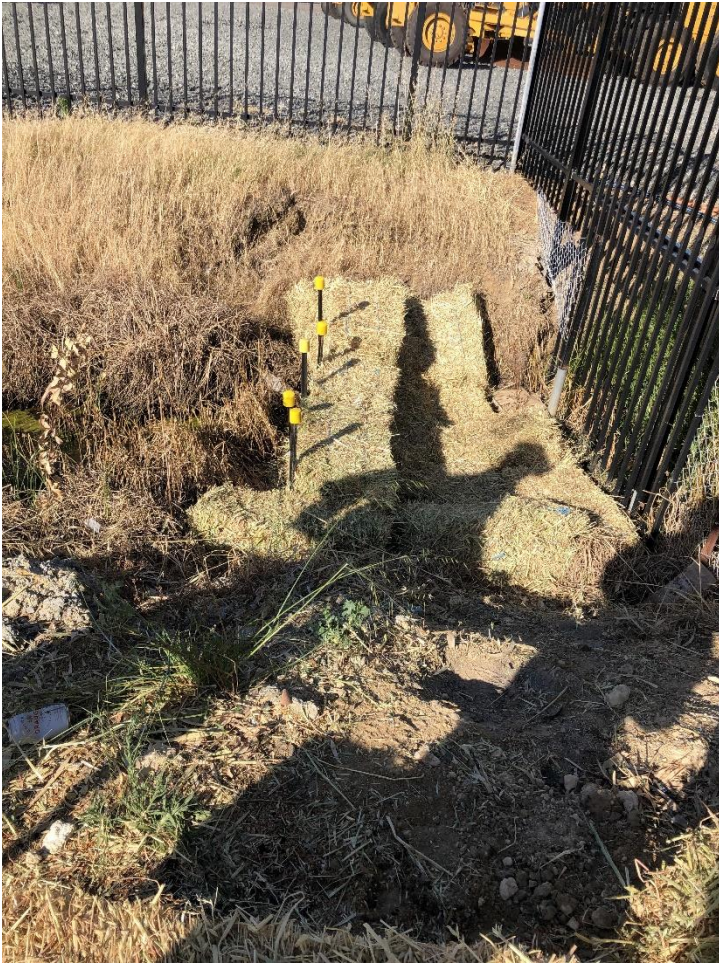
Photo 11 – Installed hay bales near to Great Eastern Highway, South Guildford.

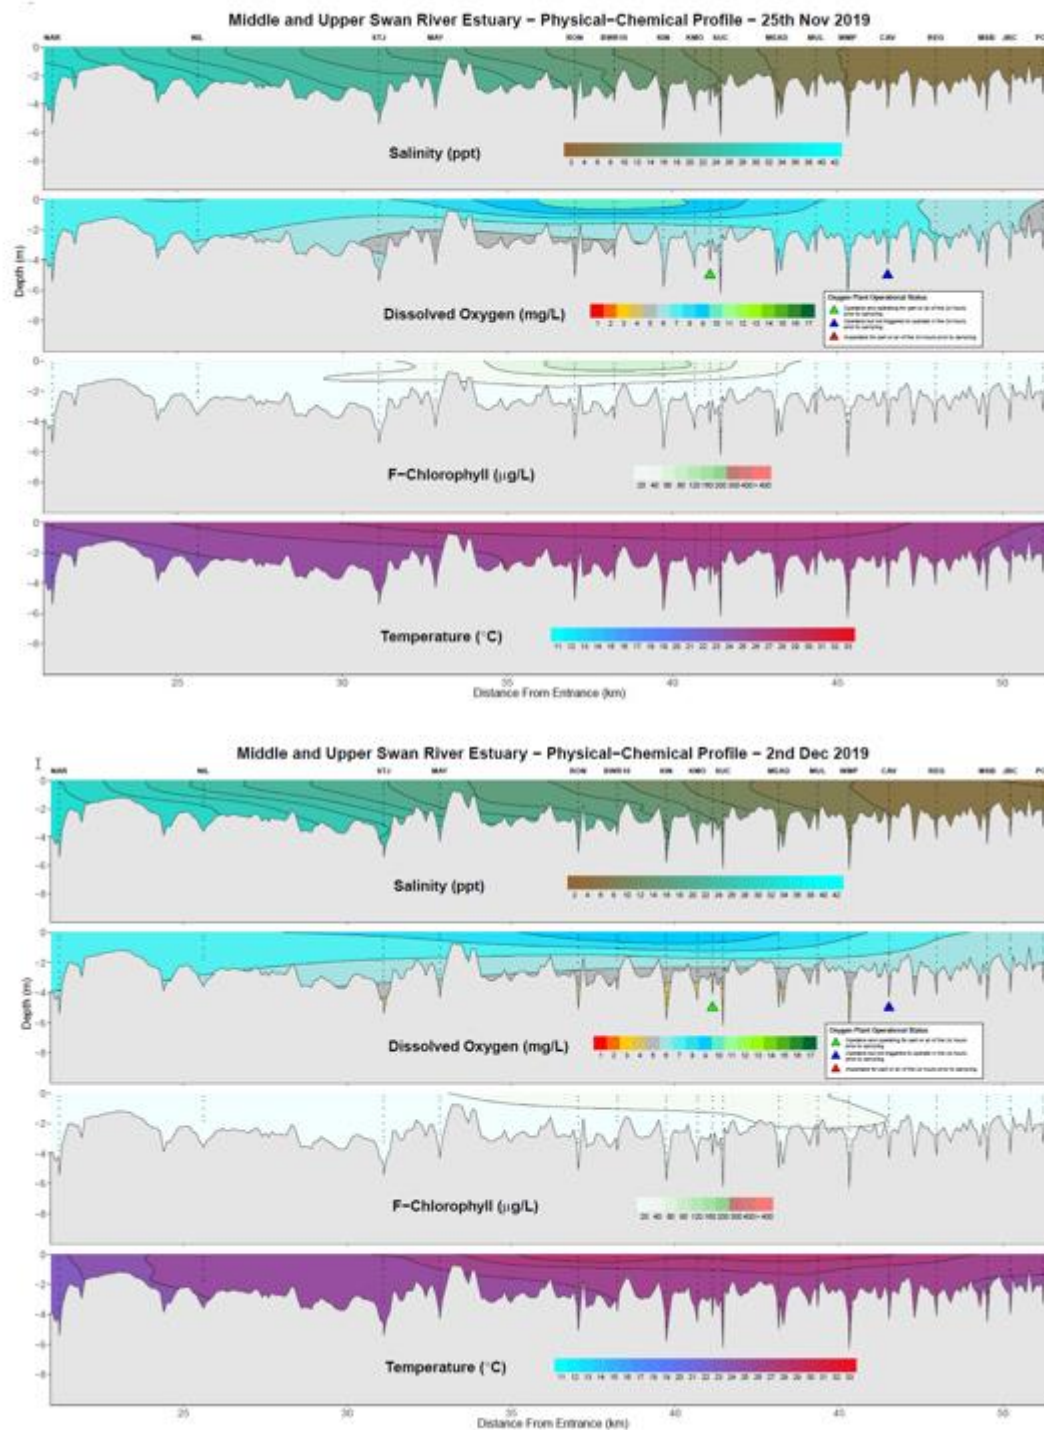
nutrient run off may have contributed to this bloom. No anoxia was observed close to the site on the day of the fire and or a week later (Figure 1).

In the routine weekly estuary sampling conducted by DBCA, no anoxic event was observed on the 2nd December (Figure 1).

Figure 1. Estuary water quality profiles before (25 November 2019) and after (2 December 2019) the fire event.
