***ARBORICULTURAL REPORT FOR SHACKLETON STREET BASSENDEAN***

Please find enclosed the results of the arboricultural assessment undertaken recently for the proposed upgrade at Shackleton Street, Bassendean.

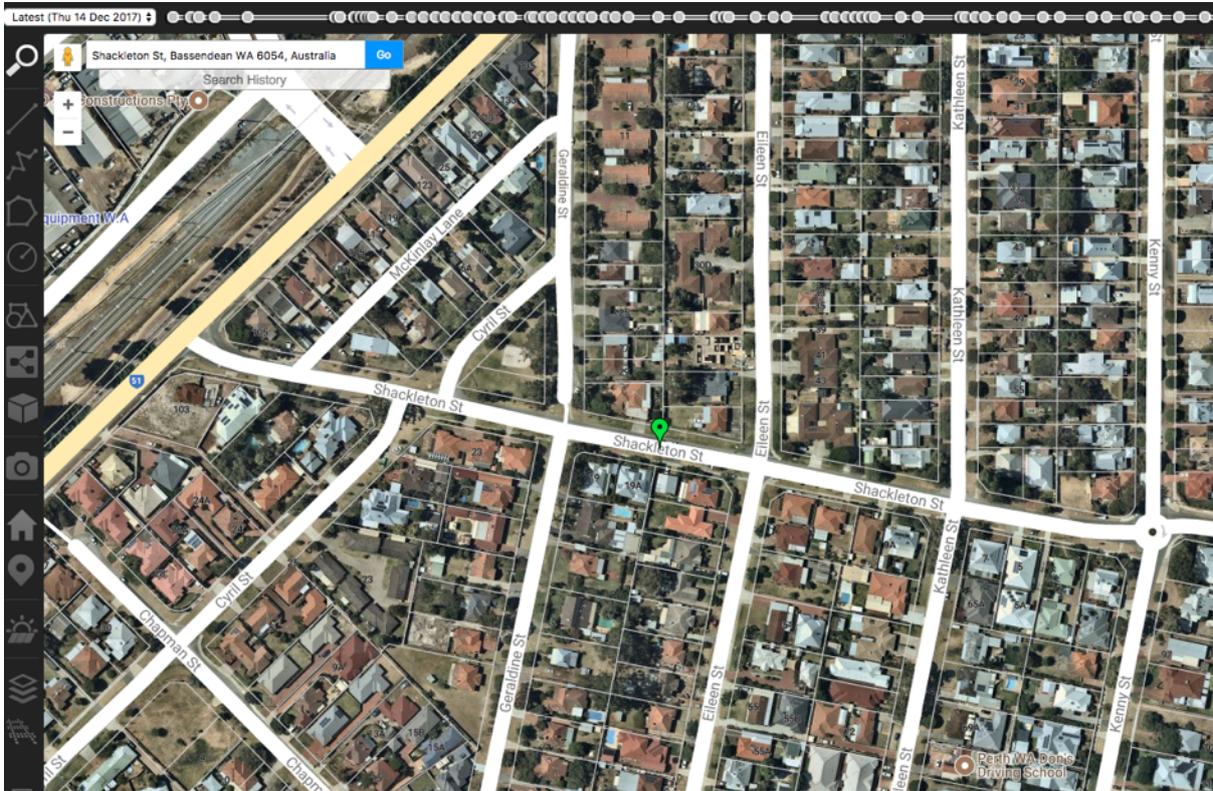
**Figure 1.** Aerial photo of site, with the planned upgrade for Shackleton Street to occur between Guildford Road and Kenny Street and include tree planting within the proposed central median islands.

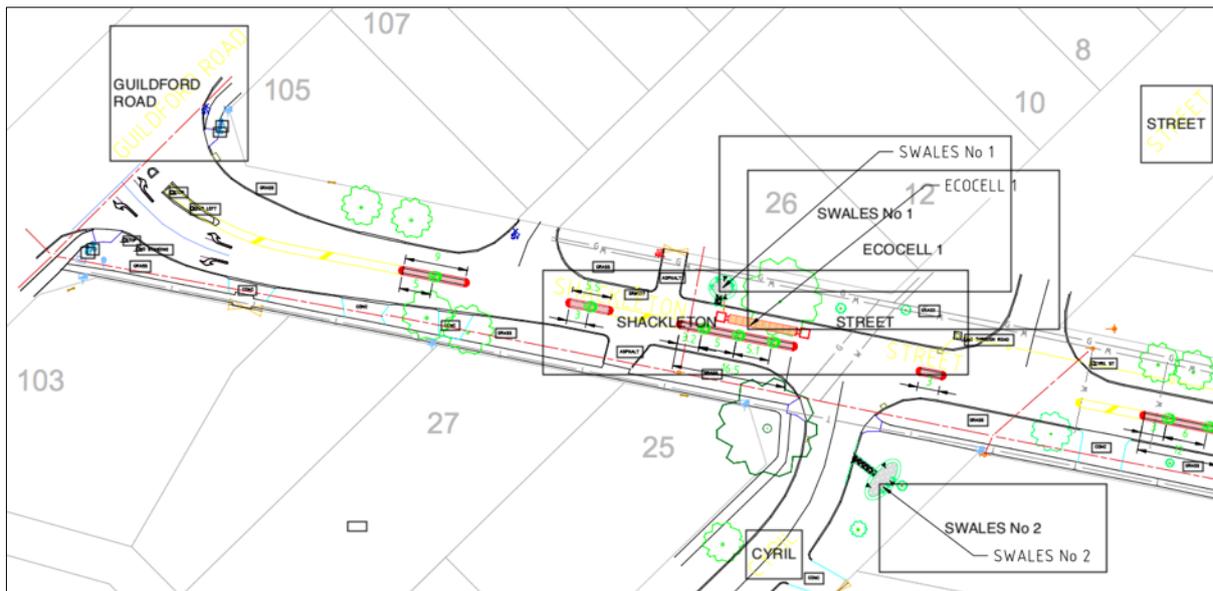
**Figure 2.** Approximately 26 trees are proposed for installation within the central median traffic islands, and include individual trees as well as groups of two, three and four trees.

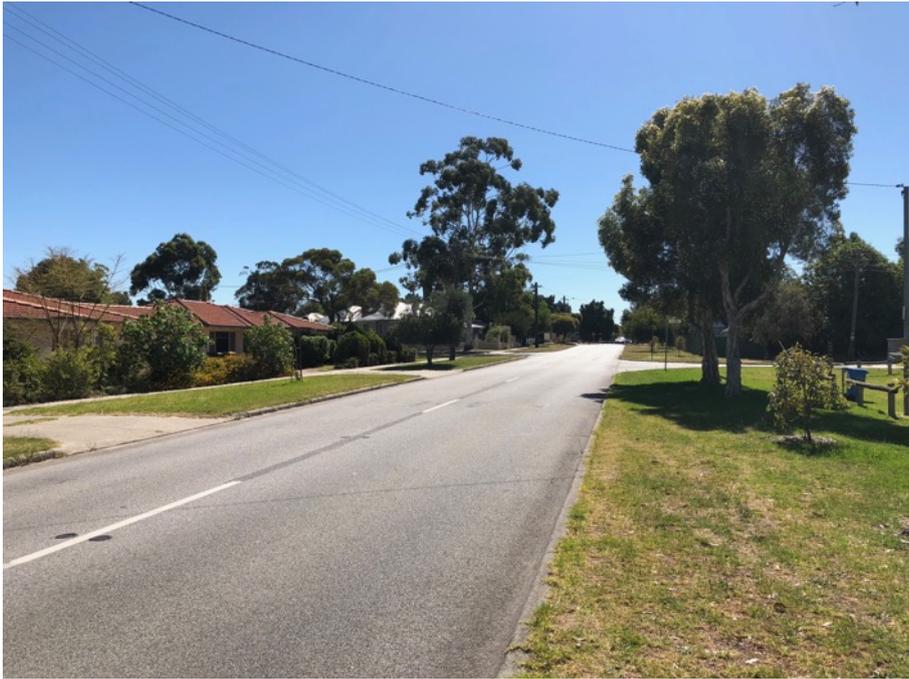
**Figure 3. Shackleton Street, Bassendean streetscape; looking towards the west.**

- 3.8 Road width was measured at 7m whilst width from the northern property boundary to the low-voltage powerlines on the south side was measured at 16m. With tree selection often being a subjective decision following site-specific criteria being satisfied, it is recommended that a medium-sized tree species be selected that fully utilises the available space for crown growth, as larger trees provide more benefits to the surrounding urban environment.

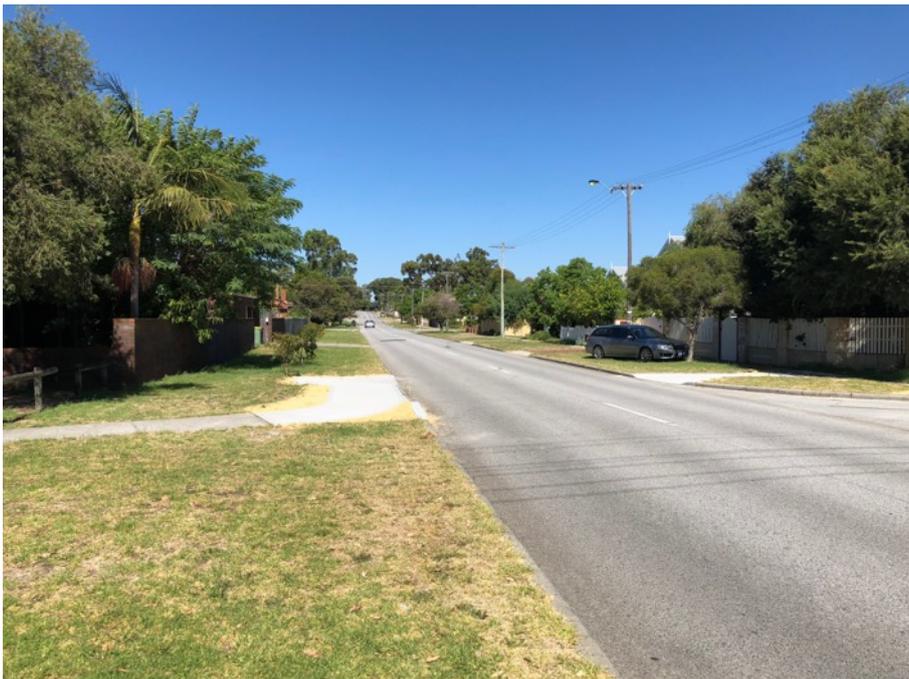
**Figure 4. Shackleton Street, Bassendean streetscape; looking towards the east.**

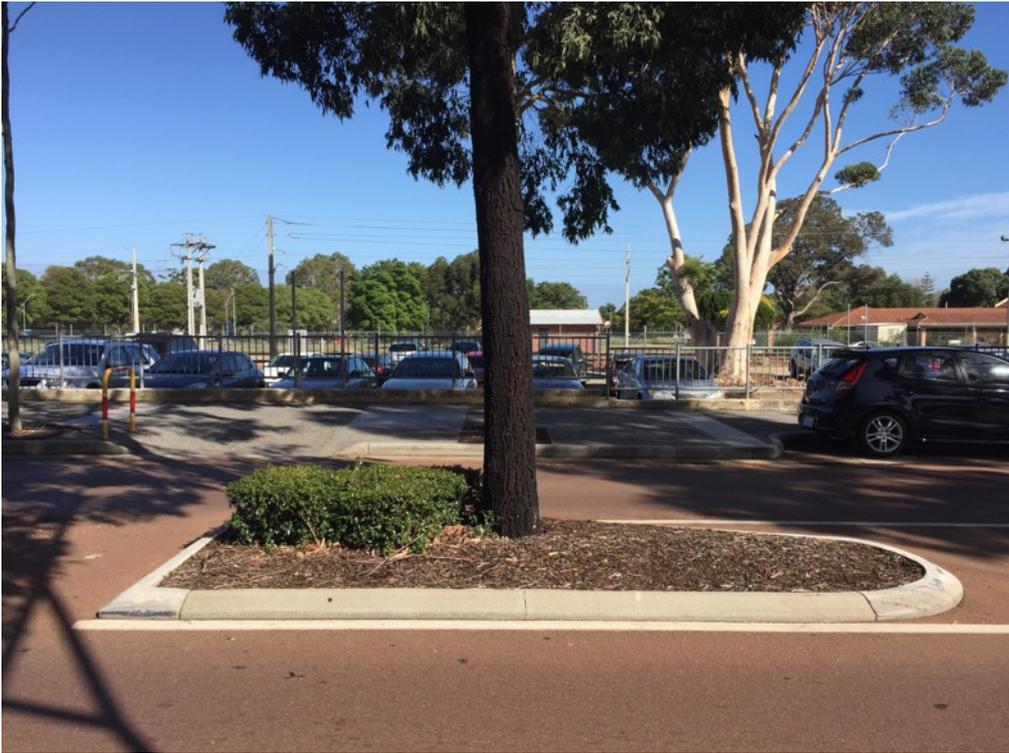
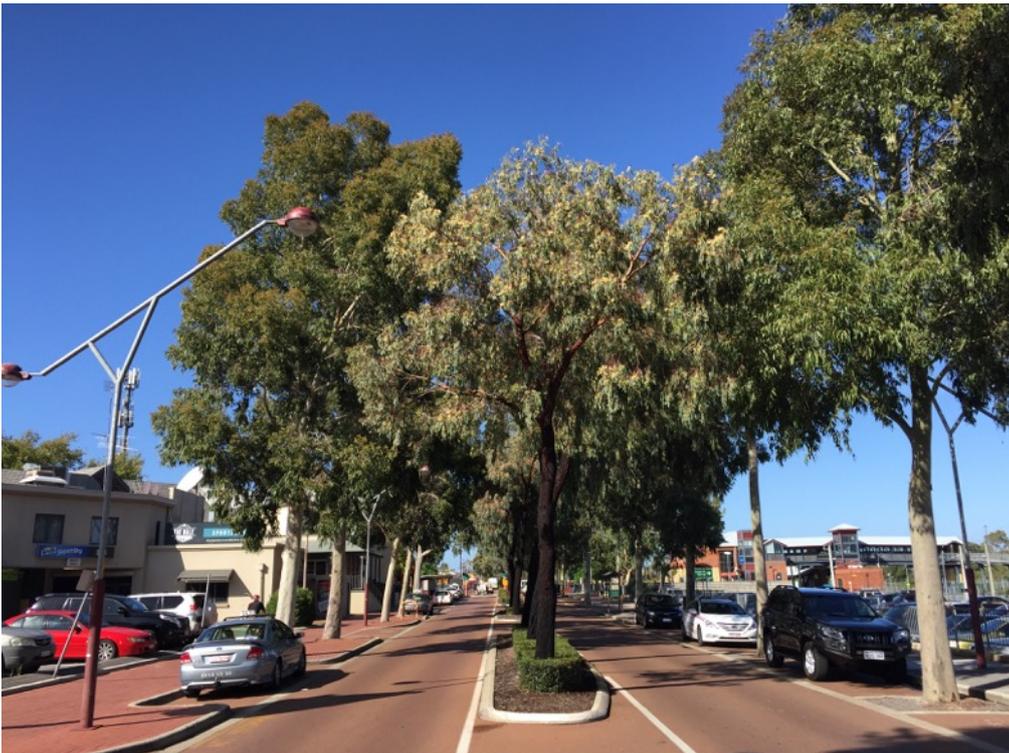
1. **Soil conditions:** Soil type for the location is Bassendean sands, a free-draining yet infertile soil (nutrients generally leached from the upper soil profile adjacent to the ground surface down to the deeper levels beyond the rootplate). The streetscape/ road location is a highly modified environment in which the capacity for water infiltration, nutrient integration and oxygen diffusion (aeration) have been significantly altered, and in many instances, result in conditions unfavourable for new tree establishment and subsequent growth. The specification of woodchip mulch as the final surface treatment will provide the optimal growing conditions at the tree installation stage and into the long term.

**Figures 5 & 6. Wherever possible, specification of woodchip mulch as the surface treatment will provide the optimal growing conditions at the tree installation stage and into the long term, for a single tree (top image) as well as for multiple trees (bottom image) within a central median island.**

2. Excavation of the existing soil within the proposed central medians of 0.5-1m and replacement with an enriched landscaping soil mix provides the most preferable option for improving the soil nutrient status, improving the likelihood for successful tree establishment, and boosting tree performance. Alternatively, enhancement of the existing soil profile utilising soil improvers and composts incorporated into the upper level of the soil profile provides another less intensive option. Improvement of the soil into which the new trees will be installed will improve the water holding capacity, availability of nutrients, and better the existing soil aeration; subsequently improving the likelihood of successful tree establishment and mitigating the requirement for replacement trees (and additional costs), thereby providing a greater return on investment.

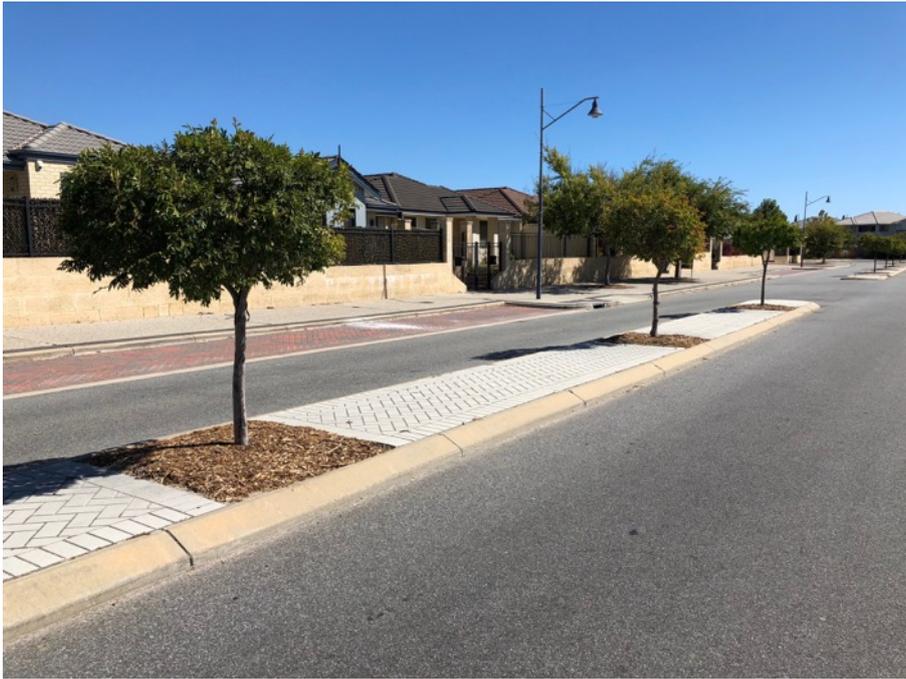
**Figure 7.** For the majority of tree species, the likelihood of successful establishment following installation into a site that consists almost entirely of hard impermeable surfacing is low (and should be avoided); additionally, such conditions increase stress and predispose trees to pest and disease outbreaks and reduced growth rates.

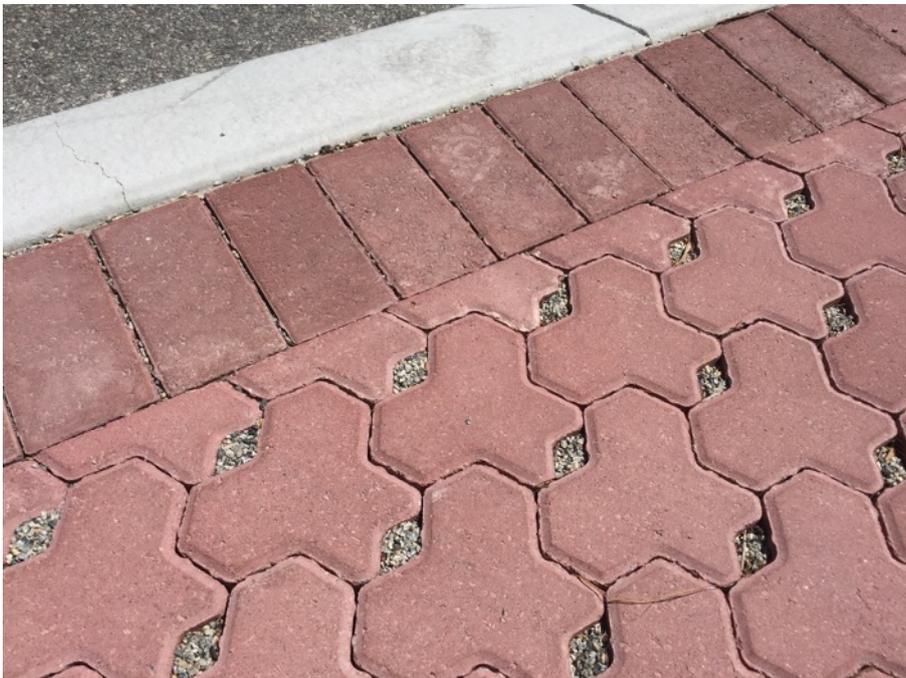
**Figure 8.** Permeable paving provides an option for hard surfacing that improves water infiltration and aeration to the soil profile (and tree roots) below, subsequently increasing tree growth rates and boosting performance.

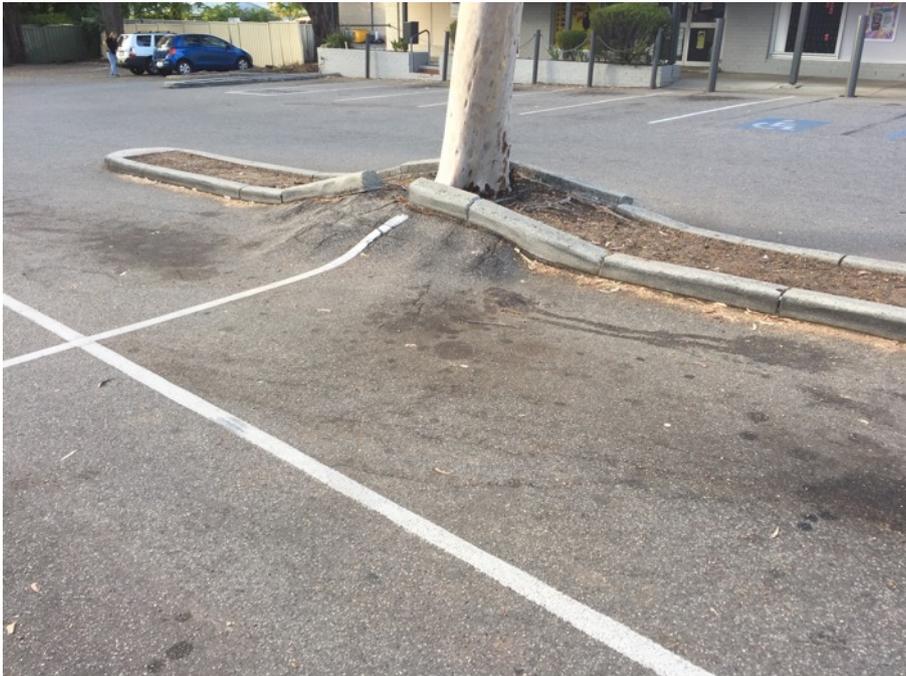
5. **Species selection:** The selection of an appropriate species for the location provides the best approach to mitigate tree/ infrastructure conflicts into the future. With 1.2m identified as the central median width, tree selection should seek to specify a species that attains a trunk diameter at maturity of approximately 50cm. Where a larger species is desired for shade and other tree-related benefits, an allowance (expectation) must be made for future median repair/ modification/ increase in width as the tree matures. The tree selection process should also avoid species known to possess a vigorous rootplate such as *Casuarina* spp., *Ficus* spp., *Tipuana tipu* etc.

**Figure 10.** Selecting the correct tree species for the site is imperative to alleviate the potential for root/ surface conflicts in the long term; above – the large maturing lemon-scented gum (*Corymbia citriodora*) incorrectly selected for a very narrow car park median island, whilst insufficient planting hole preparation is also highly probable.

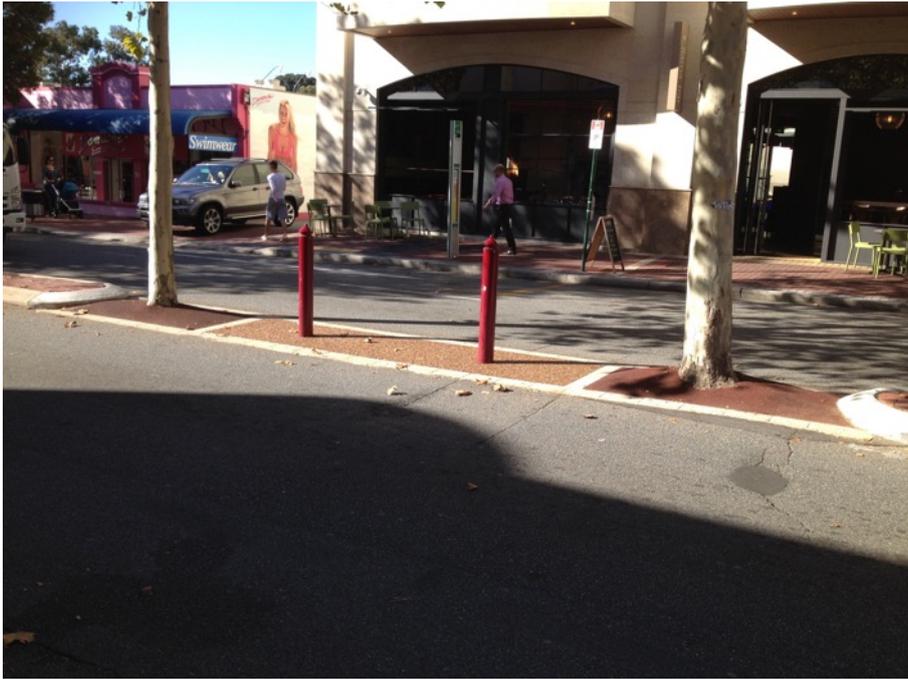
4. **Tree protection:** Central island protection measures are required to alleviate the potential for collision injury and/ or stem breakage following vehicle impact. The use of bollards (wood or steel) at the median island ends and preferably several metres from each tree is expected to be sufficient to mitigate the potential for vehicle follow-through damage in the event of collision, and together with concrete kerbing, generally provides sufficient protection for advanced trees in residential streets with low speeds i.e. <50 km/h.

**Figure 11.** A combination of bollards (wood or steel) together with concrete kerbing generally provides sufficient protection for new trees in residential/ commercial streets with low traffic speeds i.e. <math>< 50\text{ km/h}</math>.

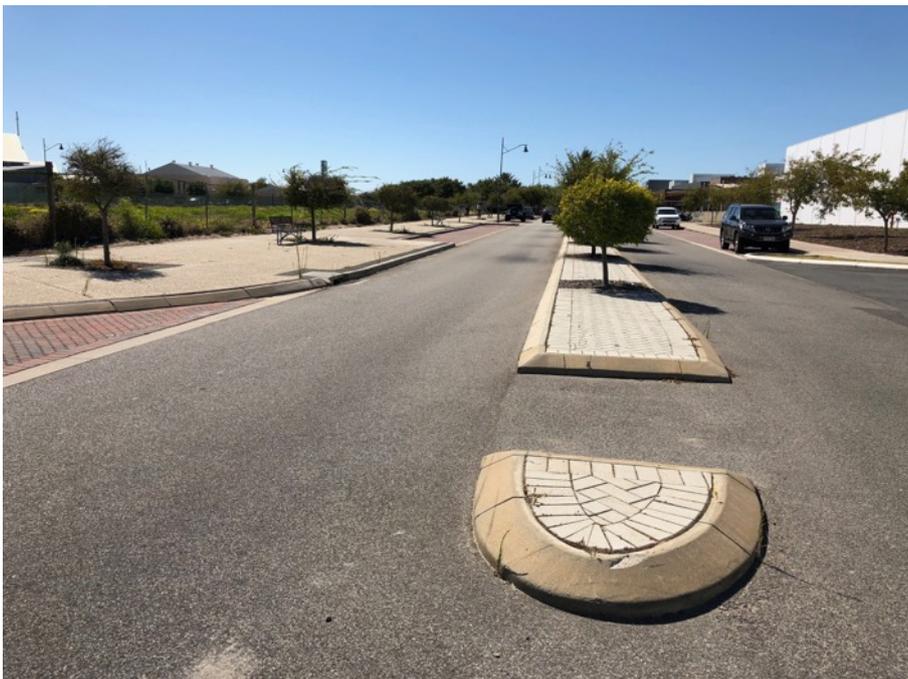
**Figure 12.** Placement of trees several metres away from the ends of the central median islands provides another technique to mitigate the potential for tree damage/ loss resulting from vehicle impact, and in doing so may reduce the total number of trees identified in the original design.

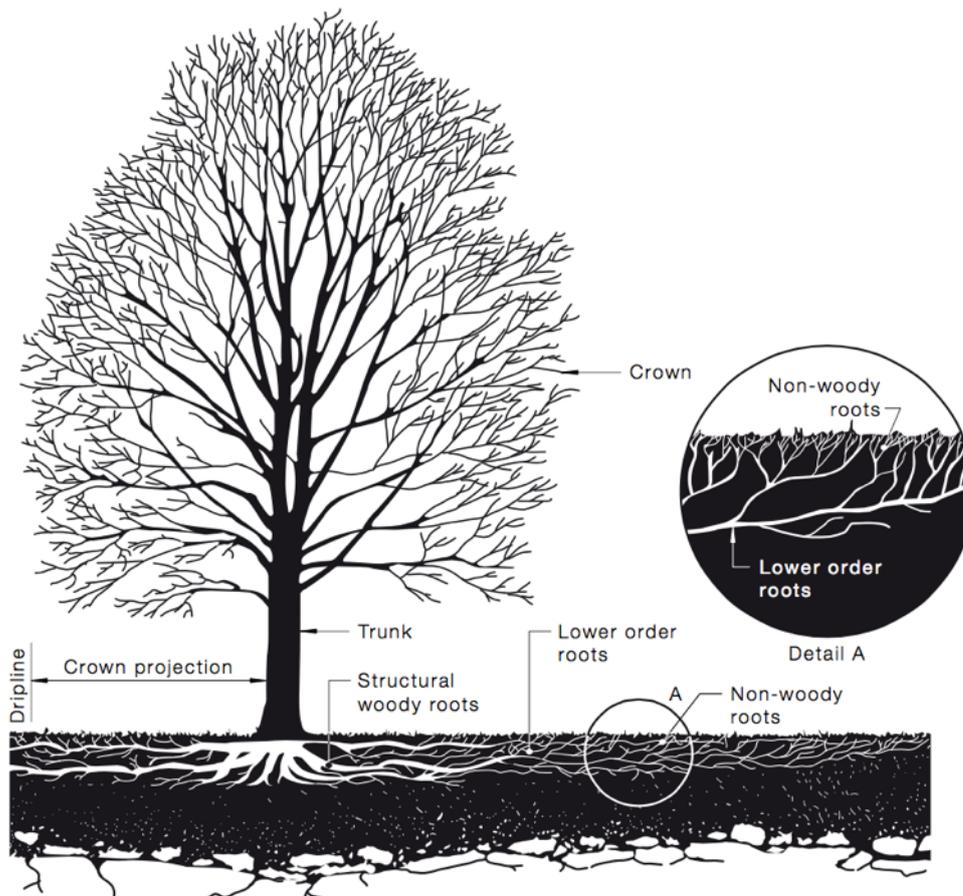
- 3.2 Tree root plate:** Root plate composition for most tree species consists of a structural root zone and an absorbing root zone, responsible respectively for the stability/ anchorage of the tree and the uptake of water/ mineral solutes from the soil. Severance of the large diameter woody roots within the structural root zone (the root plate area immediately adjacent to the tree and generally determined as trunk diameter x 5) can compromise tree stability and must be avoided. It can also result in the loss of a significant proportion of the fine, water-absorbing roots, subsequently placing considerable stress on the tree in the short term and may initiate a decline in health condition and/ or tree mortality. The severance of large diameter roots also provides an entry opportunity for infection by wood decay fungi and infestation by wood-destroying insects, increasing the potential for the degradation of wood tissue at the root collar and trunk basal area and compromising tree stability in the long term.

**Figure 13.** Typical tree structure above and below ground for cultivated urban trees. Source: AS4970-2009: Protection of Trees on Development Sites.
