A report on an archaeological excavation of the

FORMER ENROLLED PENSIONER GUARD COTTAGE 1 Surrey Street, Bassendean

September 2007

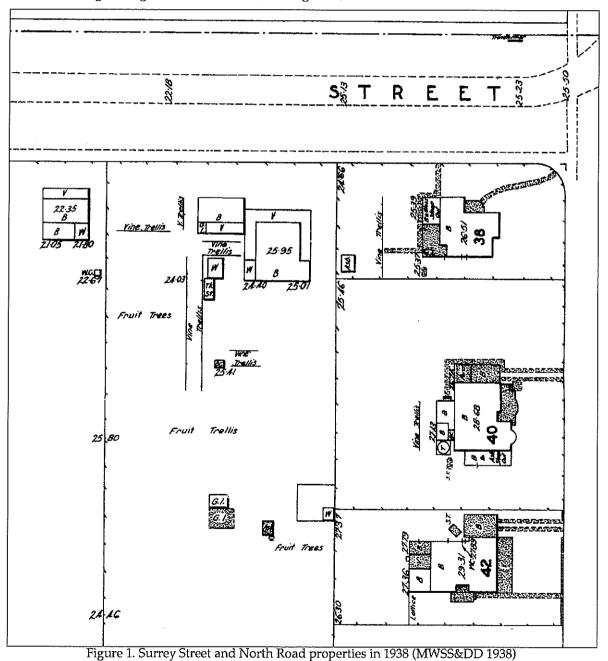
In 1938, Lot 114 comprised the c.1857 cottage, the 1893 residence and five outhouses or sheds to the cottage and residence's south. In addition, much of the block's use was for vines and fruit tree growing (MWSS&DD 1938; see Figure 1).

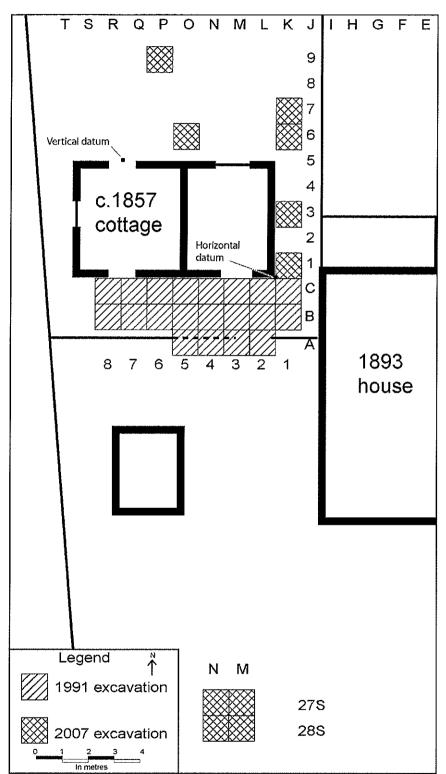
Figure 2. Locations of the 1991 and 2007 excavations

To address the aims outlined in section 1.1, one fixed point on the south east corner of the *former Pensioner Guard Cottage* was selected to serve as a horizontal datum point. From this point, compass bearing and taped measurements were taken to the six, 1 by 1 metre squares and the one 2 by 2 metre excavation (Figure 2).

Excavation was by trowel, with soil deposits removed in blocks of similar consistency (units), or when thick, in arbitrary 'spits' of 5 cm unless a notable change in the deposit occurred, in which case the unit ended at the level of the natural stratigraphy. Figure 2 gives square locations.

An automatic level plotted depths, with all squares using the top of the *former Pensioner Guard Cottage's* north step as the height datum (see Figure 2). Deposits from all squares were

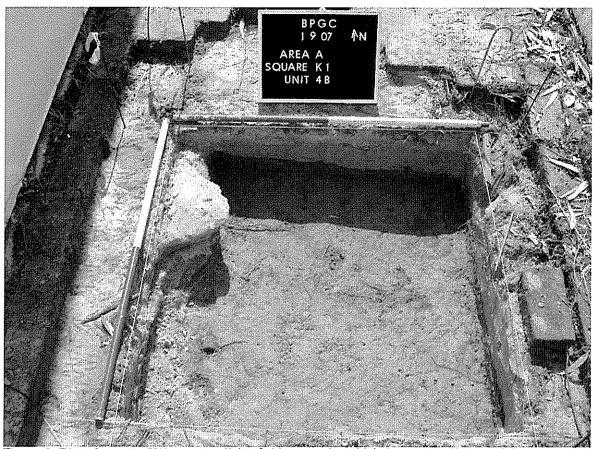
Figure 3. Disturbance in K1's west wall (with blue metal visible) due to installation of drainage pipe. Scales are in 500 mm increments

Initial squares K1, K6 and O6 all encountered a layer of yellow builder's sand under the brick pavers. This layer varied between 5 and 14 cm thick across the six squares at the side and front of the cottage. Its obvious association with the recently (1990s) laid brick pavers meant low archaeological potential, resulting in its rapid removal by shovel. In addition, the sand was not sieved. A layer of clay was exposed in K1 and a sandy clay and lumpy clay matrix in K6 and O6. In addition, K1 exposed blue metal, filter material and remains of mortar. These items were associated with the 1990s cottage refurbishment, with the blue metal, filter material - and subsequent exposure of a PVC pipe - associated with the laying of a drainage pipe to stop rising damp in the cottage's walls. However, the stratigraphy's disturbance occurred only along the squares' west margin (Figure 3).

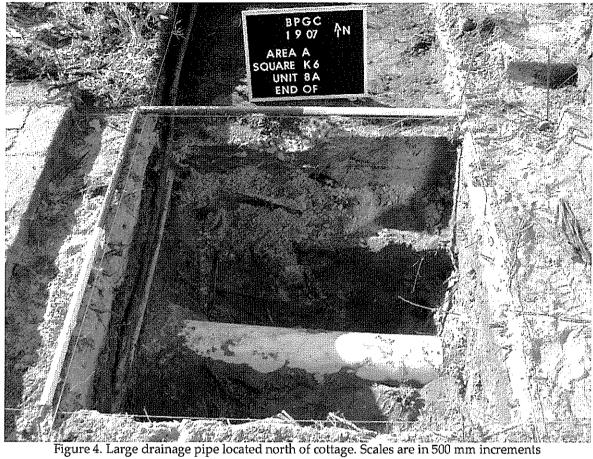
Removal of the sandy clay and lumpy clay layer in K6 and O6 exposed a large PVC pipe associated with water drainage way from the cottage. This feature was most likely installed during the 1990s cottage refurbishment. Physical proof was not found, but the small PVC pipe found in squares K1 and K3 most likely connected with this larger 30 cm diameter pipe that ran along the cottage's north face. The pipe and the trench dug for its installation took up much of squares K6 and O6's surface area. Due to the disturbance to stratigraphy, squares K6 and O6 were finished. In addition, the 30 cm pipe's placement in front of the cottage meant disturbed stratigraphy on the six metre east-west line (Figure 4).

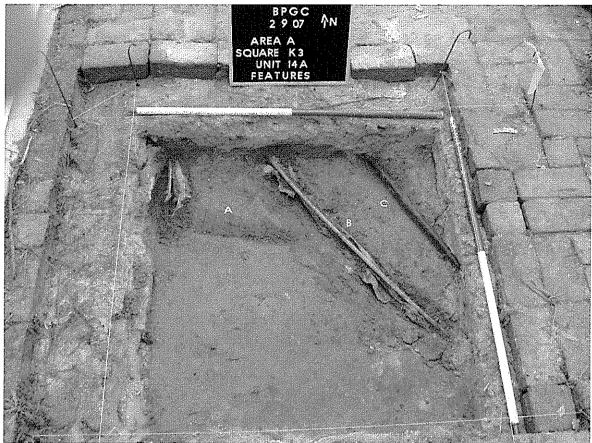
Figure 5. Ditch features in K3. 'A' associated with an old copper pipe; 'B' with a modern copper pipe; and 'C' with garden reticulation. Scales in 500 mm increments

Black glass and underglaze ceramic fragments from the small wedge of undisturbed sediment in K6's north margin saw the opening of the neighbouring K7, while K3 and P9 were opened away from areas known to be disturbed. All encountered the yellow builders sand and lower clay unit. K7 and P9 were undisturbed by modern utility installation, but K3 encountered features for conduit to the 1893 house (Figure 5). Two by two metre square MN 27-28's placement at the rear of Lot 114 tested this area's richness. Couch grass removal exposed a true loan matrix.

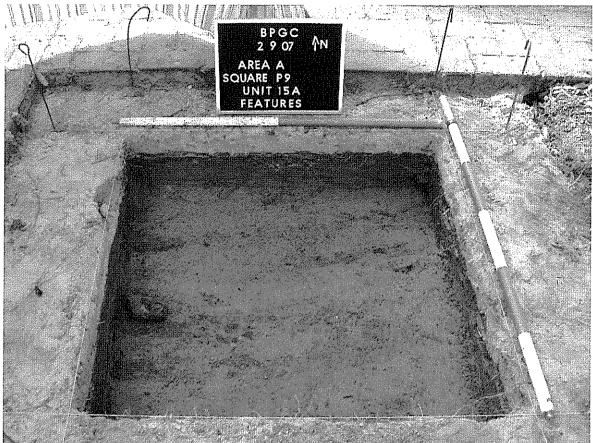
Figure 7. Parallel lined garden feature from square P9, and possible trellis stake near the square's west margin. Scales in 200 mm (right) and 500 mm (top) increments

Square P9 north of the cottage produced a feature associated with the place's Foodways artefacts. The strong clay soils preserved what appears to be small furrows commonly seen in vegetable gardens. The feature - comprising parallel lines of different coloured soil types (Figure 7), exists 25 cm below the place's present ground surface.

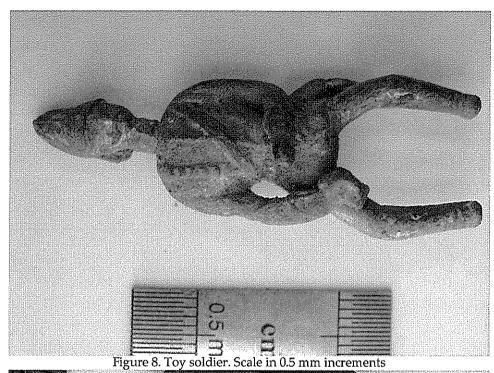
Figure 8. Toy Solider. Scale in 0.5 mm increments

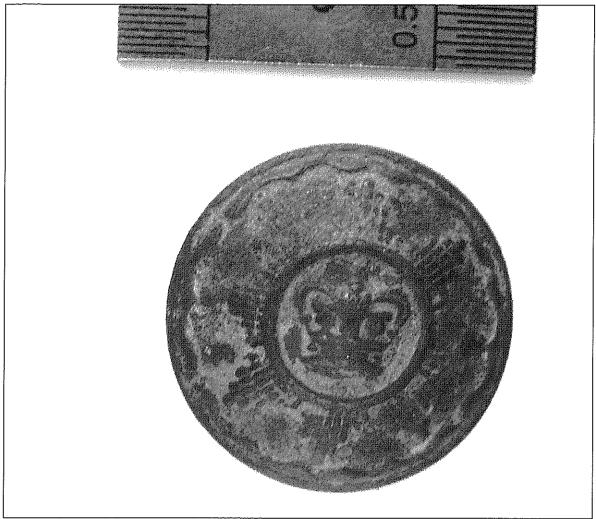
Figure 10. Button possibly from a pensioner guard's tunic. Scale in 0.5 mm increments

The excavated archaeological material has some monetary value. The pensioner guard button is very rare, and if displayed, should be in a secure receptacle.

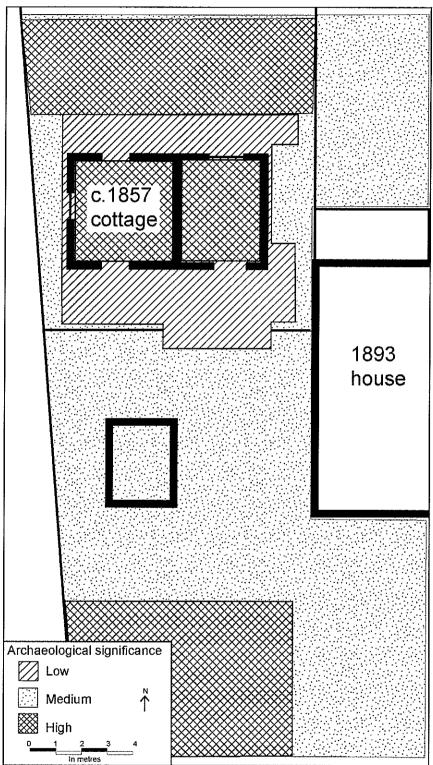
Figure 12. Areas of high, medium and low archaeological significance

The grounds containing the *former Pensioner Guard Cottage* archaeological record are in good condition. The site has been, in places, heavily disturbed by the mechanical introduction of electrical conduit and drainage pipes, but areas south and north of the cottage and 1893 residence retain well-preserved stratified archaeological deposits.
