TOWN OF BASSENDEAN

NOTICE OF A MEETING OF THE TOWN ASSETS COMMITTEE

Old Perth Road Street Tree Audit

Town of Bassendean

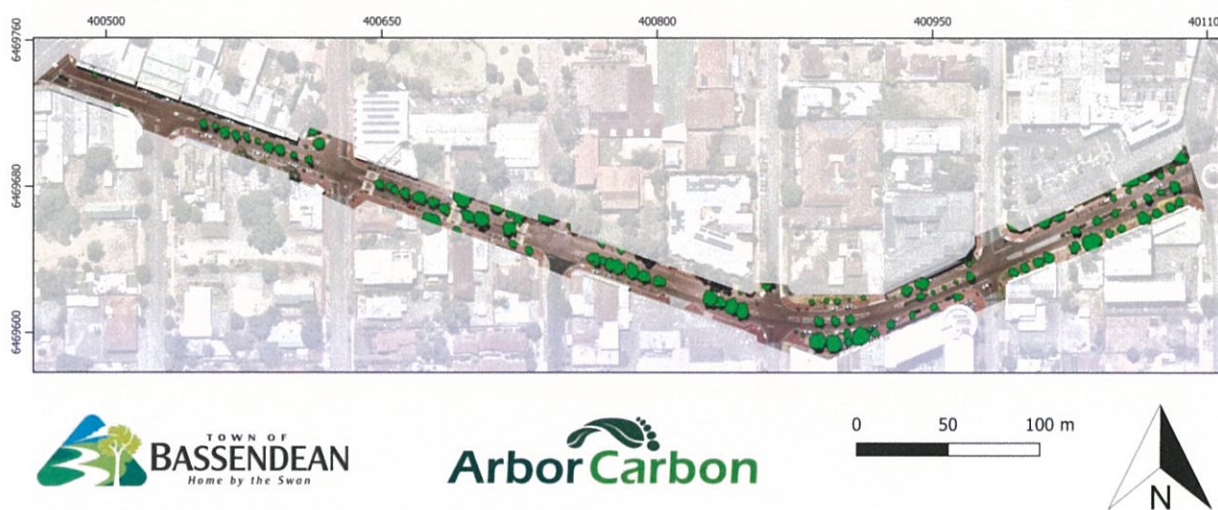
An estimate of canopy (vegetation more than 3 m in height) was calculated by delineating the crowns of trees using aerial imagery sourced from Nearmap (Figure 1). The analysis includes trees on Town of Bassendean owned land, as well as crowns of trees planted on private land that contribute to the streetscape. The current canopy area within the street area assessed was 2140.9 m² (Table 1). This equates to a 13.4 % canopy cover if the total area of interest is 15,994.2 m². The Town of Bassendean have suggested a target of 70% canopy cover is desired to enhance the aesthetics and amenity of the street.

Figure 1: Current canopy cover of Old Perth Road.

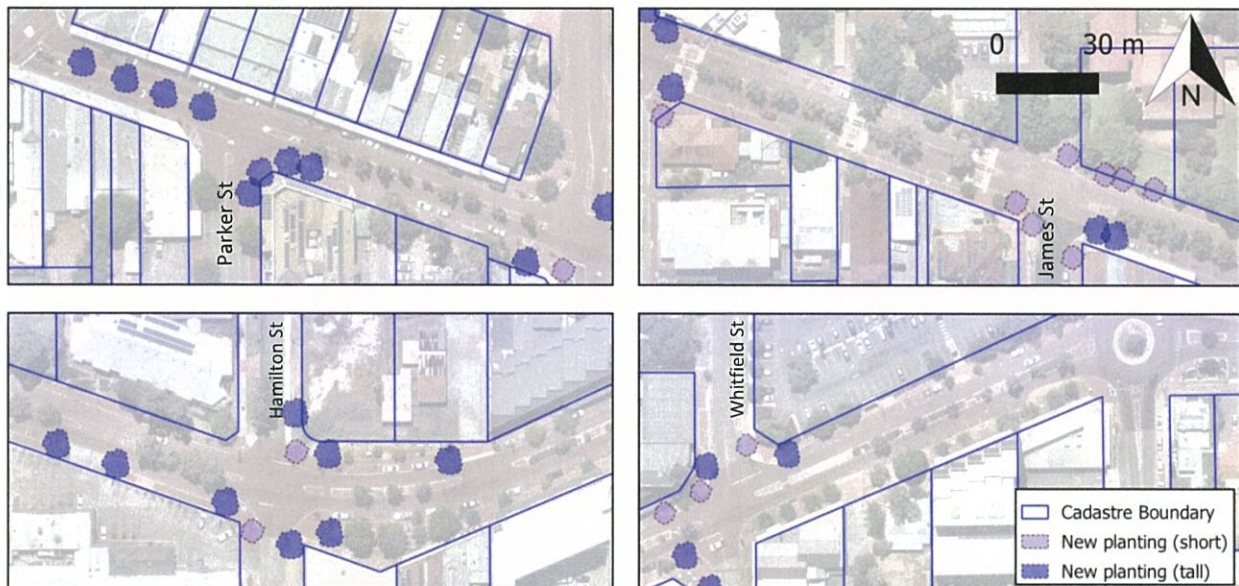
Similarly, there are still remaining spaces within the footpath area in which additional planting pits could be installed. The initial Old Perth Road drawings from 2013 (TOB 11-2013/1) (Appendix 1) identify several potential locations for additional planting pits which have not been utilised. It is possible that reasons exist for not adopting these planting locations which may be known within the Town. We have identified 40 potential new planting locations which could be developed (Figure 8).

Figure 8: Increased tree planting in available spaces. The semitransparent purple polygons indicate potential canopy of additional planting of short trees, which are located under powerlines or other overhead obstructions. The semitransparent blue polygons are potential canopy of additional planting of larger, tall trees.

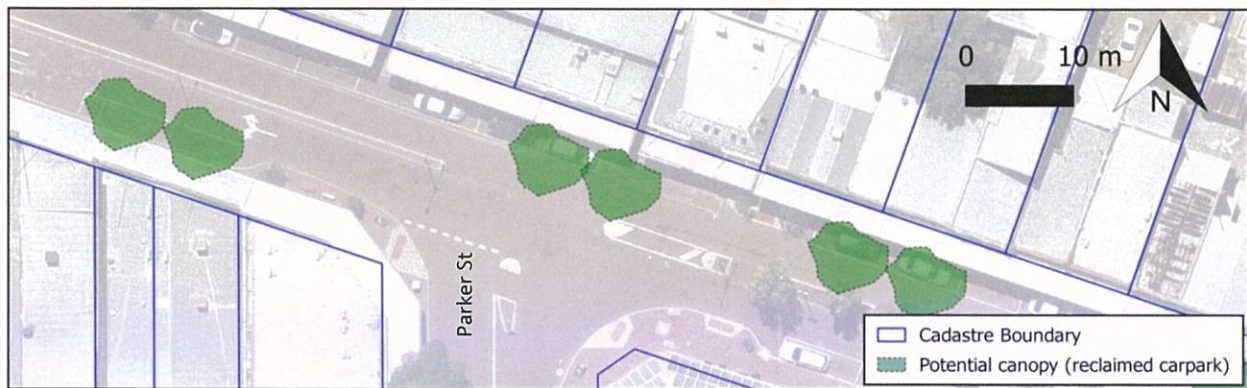
Figure 9: An example of a section of Old Perth Road where car parking bays could be reclaimed and new plantings spaces for trees created, (indicated by the semitransparent green canopies).

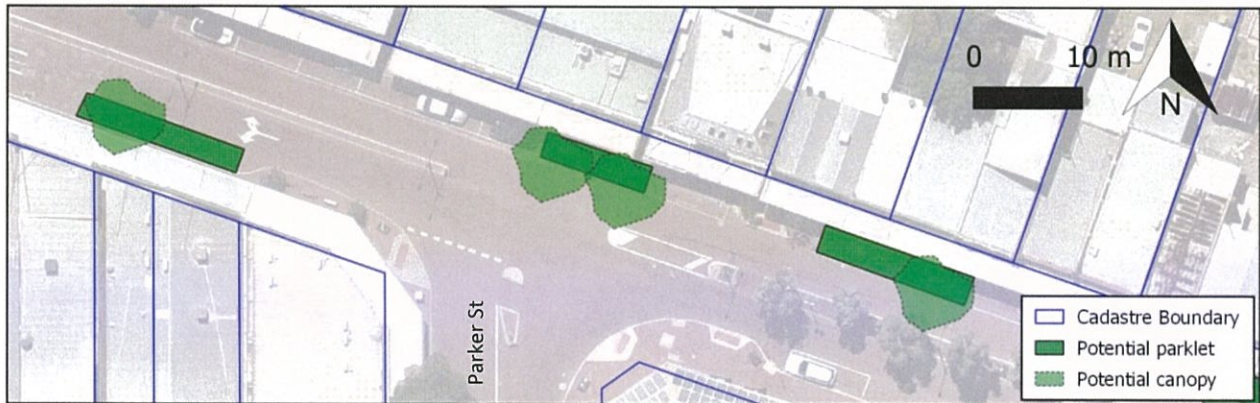
Figure 10: Example of the creation of parklets in reclaimed car parking bays. The shaded green polygons indicate the boundary of the potential parklet, and the semitransparent green polygons are potential canopy if broad crowned trees are planted within the parklet.

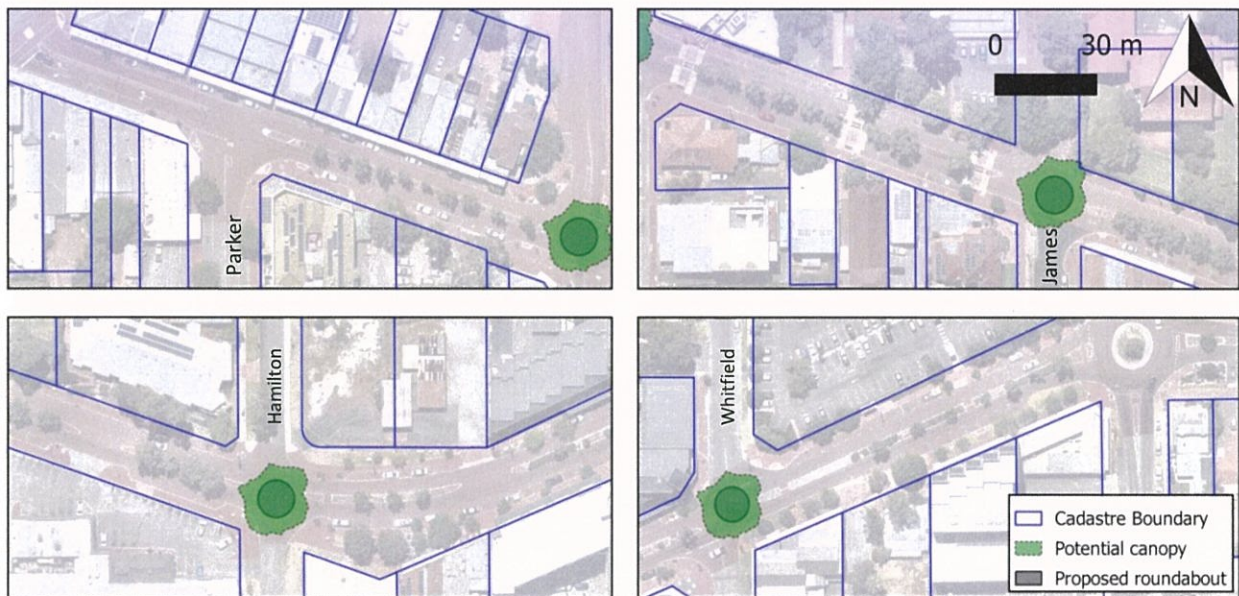
Some of the largest areas of exposed land within Old Perth Road are found at road intersections. There may be a possibility to install a small roundabout at the centre of each junction. This would allow a relatively large tree species to be planted without interference from overhead wires, or underground services, which is a limiting factor of tree establishment in footpath areas. Roundabouts may also have a traffic calming effect, making the street more attractive to pedestrians while improving traffics flows.

Figure 12: Potential canopy if new roundabouts are installed and large trees are planted in them. The dark circles are the proposed roundabouts, and the semitransparent green polygons are the potential canopy.

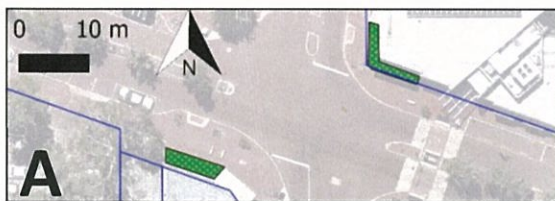
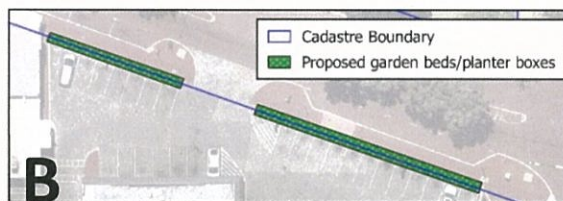
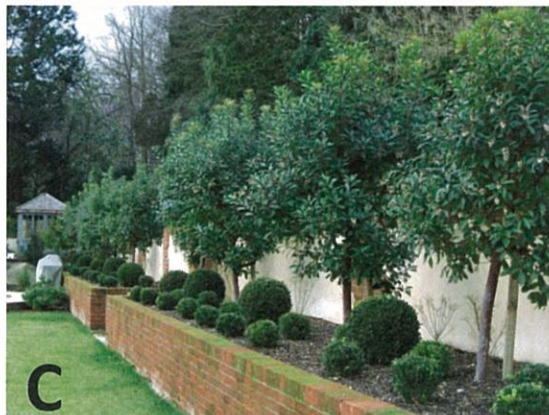
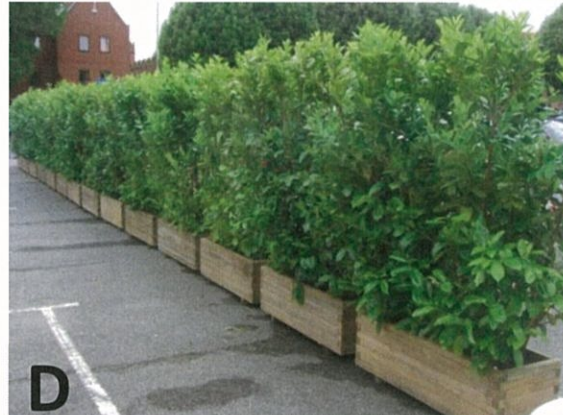
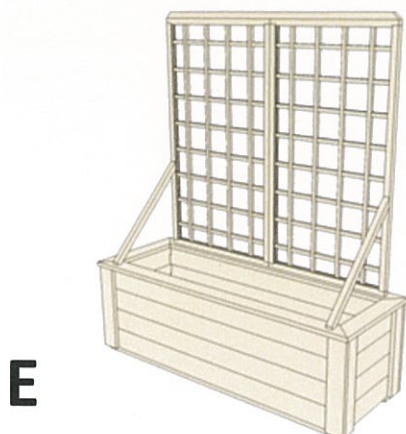
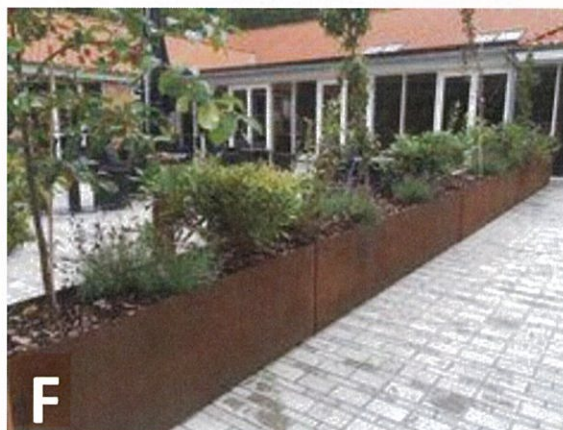
The installation of additional gardens beds and planter boxes has the potential to make a significant contribution the streetscape aesthetic (Figure 13). Planter boxes are generally not appropriate for planting large trees with the aim of increasing canopy. However, planter boxes can contribute to vegetation at or

Figure 13: (A) and (B) Examples of locations for potential planter boxes and garden beds on Old Perth Road. (C to F) Examples of planter boxes and garden beds that could be used.

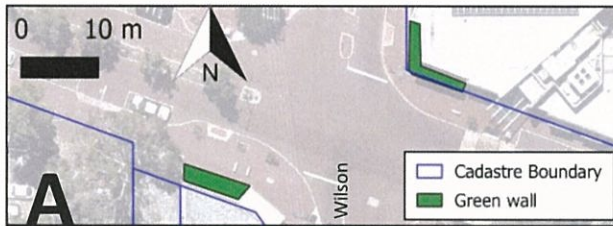
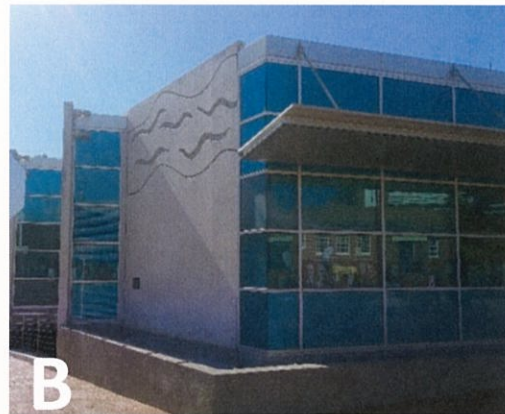
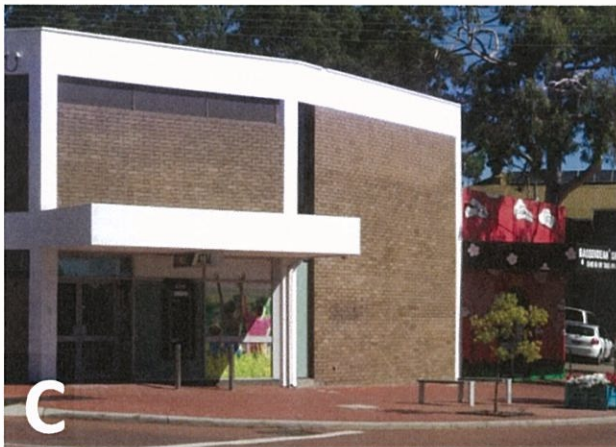
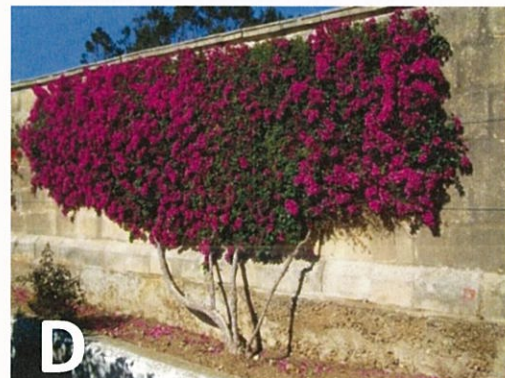
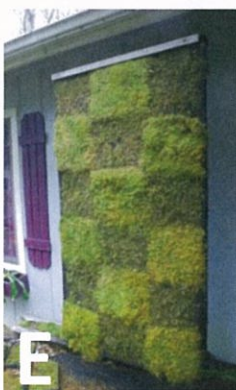
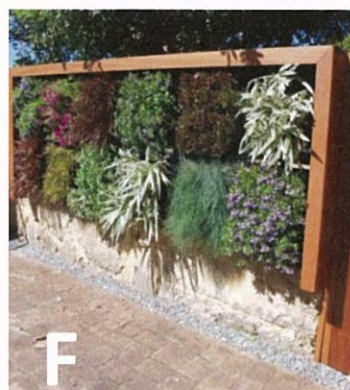
Figure 14: (A) Potential locations for the addition of a green wall (green polygons). (B) and (C) show currently bare walls that could be made into green walls such as shown in D to F.

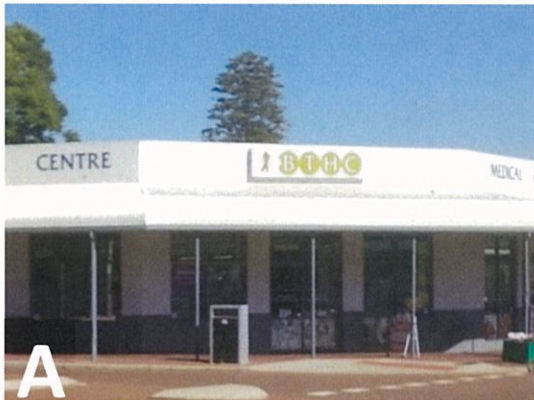
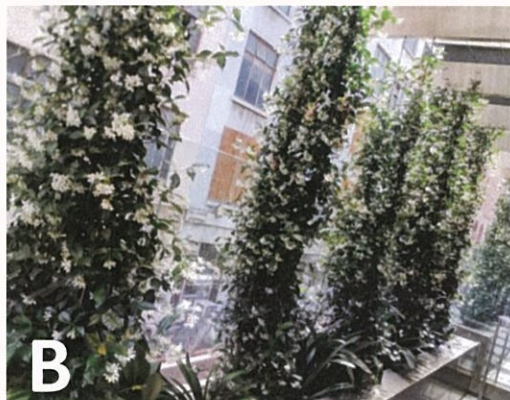
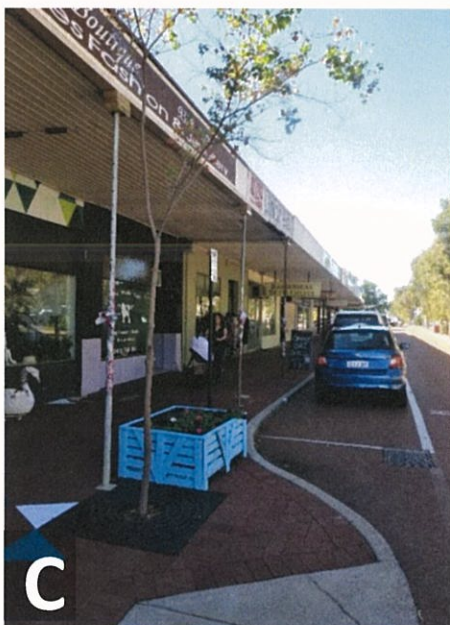
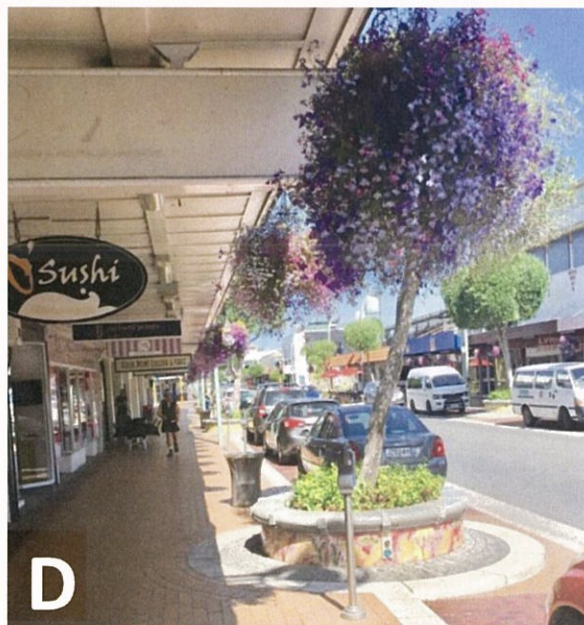
To achieve a similar effect, trellising could be established on these walls with climbing plants or vines established from garden beds below. These are likely to be easier to establish and maintain, however, it would take several years to fill a target wall. On a smaller scale, climbing plants could also be established on supporting structures associated with shop awnings, light poles and other opportunistic locations (Figure 15).

Hanging baskets are another option to increase vegetation under the shop awnings and add to the aesthetic of the streetscape (Figure 15). However, given the age and condition of the current awnings this option may require additional engineering to support the weight of soil and water required. These also require irrigation and regular maintenance and can be difficult to implement successfully.

Figure 15: (A) Example of supporting poles on Old Perth Road that could be enhanced with climbing plants such as in (B). Hanging plants could be established along awnings (C) such as that shown in (D).

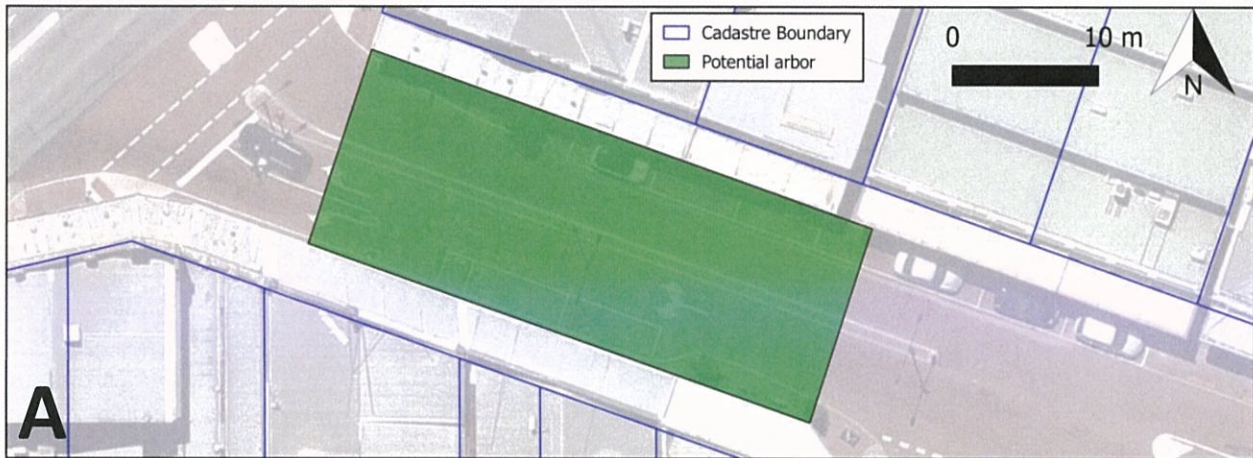
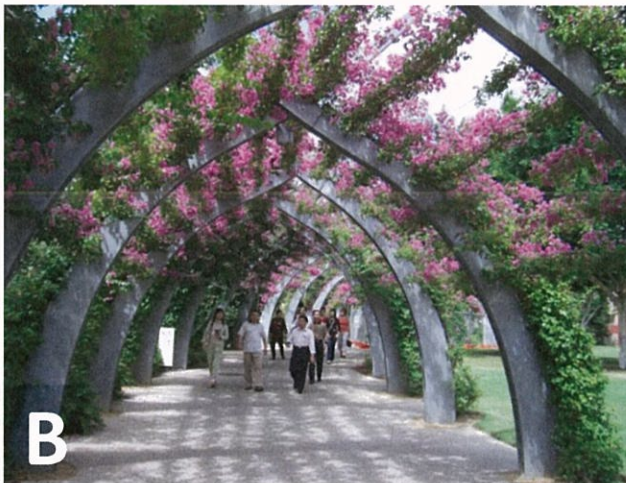
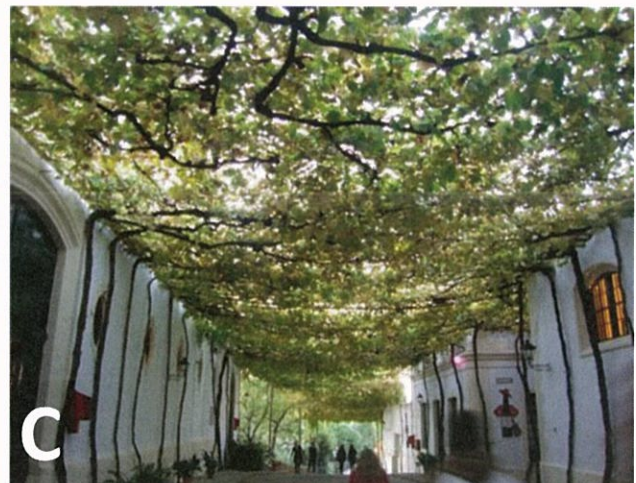
In order to achieve a major transformation to the level of shade and vegetation within the street, an arbor could be erected (Figure 16). This could be used to achieve close to 100% shade cover in at least part of Old Perth Road, with comparatively little footprint at ground level. The use of vine and climbing plants for shade cover would reach maturity faster than tree canopy would. The drawback to this approach is the significant cost that would be involved in the design, engineering and installation of the support structures. However, such a structure would be unique in WA and would provide a feature to raise the profile of the street and draw in visitors from outside the local area.

Figure 16: (A) The addition of an arbor between Guildford Road and Parker Street could add a large amount of canopy. B and C are examples (Source: Pinterest).

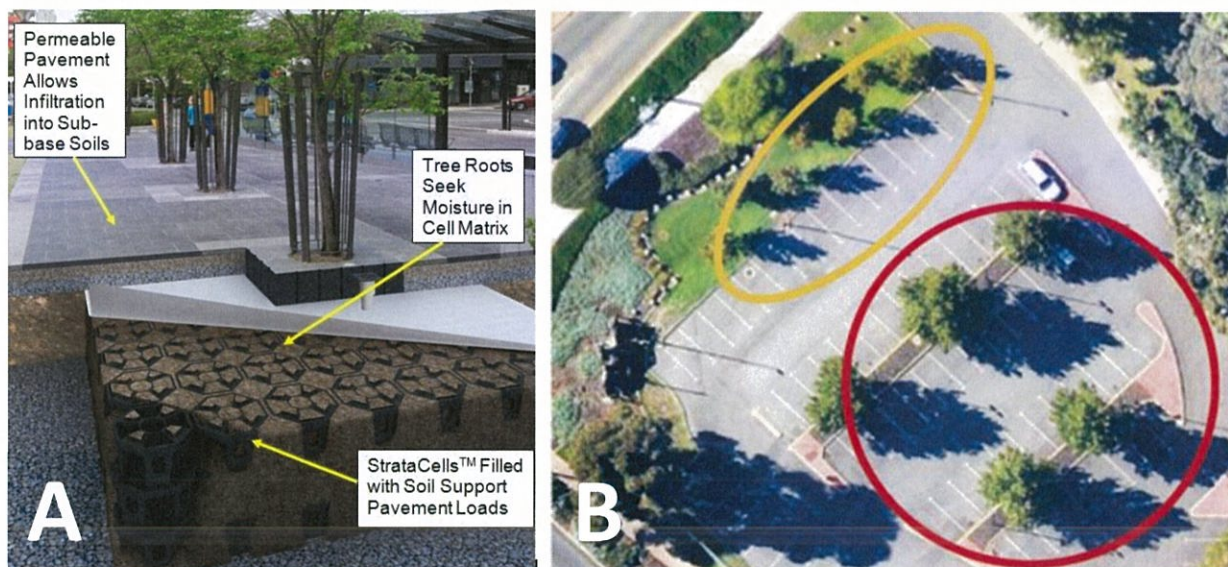
The use of structural cell systems such as Stratacells™ is becoming increasingly popular. These systems involve a modular suspended pavement system that can support pedestrian and vehicle traffic above ground (load-bearing) while creating an air void between the soil and the paved surface. This gives the root system access to a large volume of high-quality uncompacted soil, while minimizing the possibility of root damage to hard surfaces above. These systems can be integrated with storm water management systems to provide water and stormwater mitigation functions. Stratacells™ also allow for the use of custom soil blends which can be tailored to the requirements of different tree species, allowing a greater range of potential species to be planted.

The cost of providing high quality growing environments in the urban setting is not small. A base cost of \$700 per m³ of soil should be allowed for supply and installation of structural cells. A tree crown of 5 m² diameter ideally would require at least 12 m³ of soil therefore \$8,400 per tree should be allowed. Costs could be reduced by connecting the soil pits, thus allowing tree roots to share adjacent pits. Initial costs, however, can be offset through decreased costs for establishment, maintenance and reduced rates of failure and replacement. Using structural cell systems is likely to improve establishment success, growth rates and final crown volume of any of the options listed therein, resulting in improved amenity and benefits to residents and businesses along Old Perth Road.

Figure 17: (A) Example of a Stratacell™ and a (B) carpark in Belmont demonstrating the size and health of trees planted using Stratacells™ (circled in red) compared to those planted conventionally (circled in yellow) (Source: City Green Pty Ltd.).

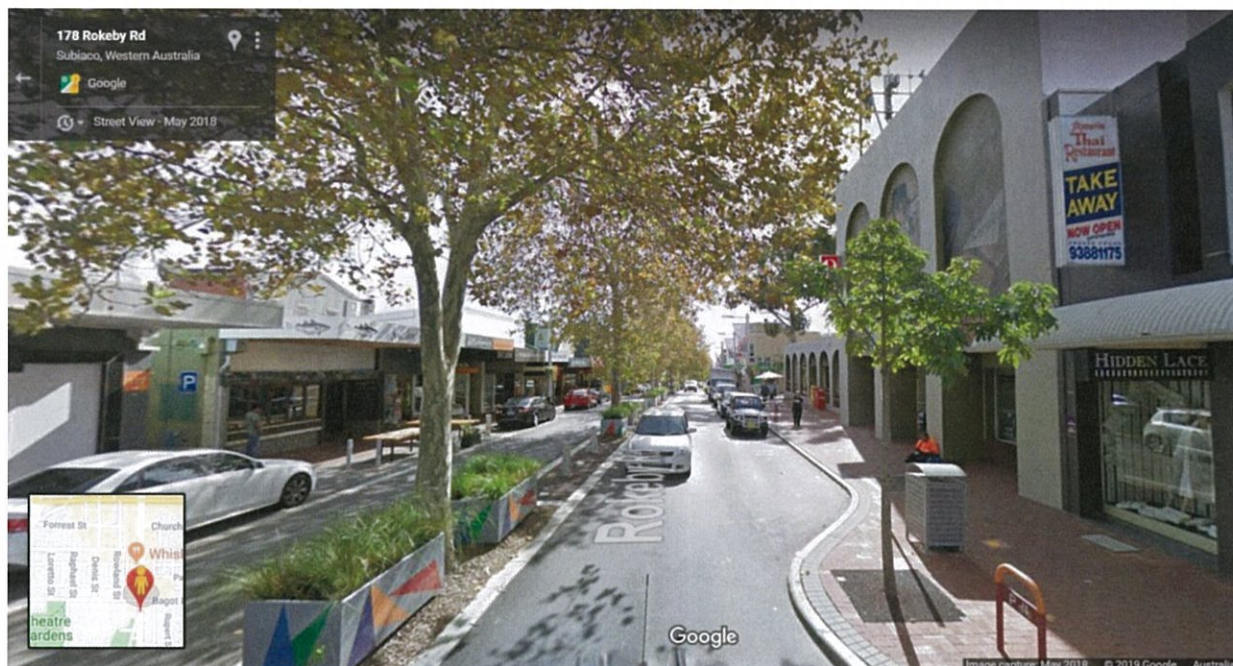
The best potential planting area within Old Perth Road is probably in the street median. These locations are less restricted by buildings and awnings, underground services, powerlines, and the long relatively thin strip of soil offers a greater volume of quality soil for root growth than individual tree pits. However, the median strips are currently fully occupied by the mature *Melaleuca quinquenervia*. These trees are generally performing well within Old Perth Road, however, this species tends to have an erect form which projects relatively little overhead shade. The use of different species within this area could almost reach the 70% canopy target without additional tree planting (Figure 18). However, removal of these trees is likely to be

Figure 18: Rokeby Road in the City of Subiaco, demonstrating high canopy cover by planting a broad canopied tree such as *Platanus x acerifolia* (London plane) along the median strip (Source: Google Maps).

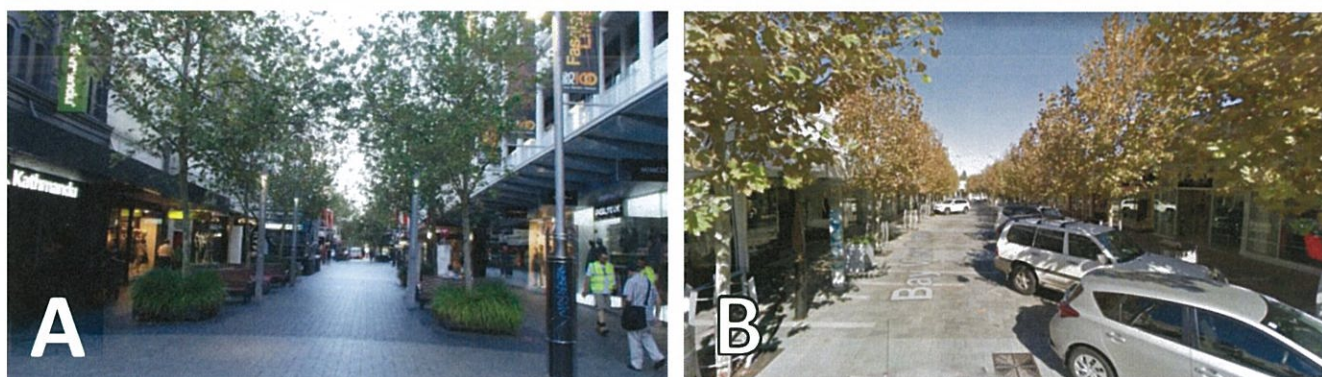
The greatest area of land within the streetscape is reserved for vehicle traffic. Conversion of the street or part thereof to a pedestrian mall would provide ample space for additional planting of broad canopied tree species (Figure 19A). This type of dramatic renovation of the street will have far reaching implications for the current commercial tenants of the street impacting traffic flow and availability of parking. This option would require extensive community engagement and be part of a larger plan which is beyond the scope of this document. Less severe alternatives to the pedestrian mall exist, such as reducing the traffic flow by converting the street to a one-way street. This could allow space for increased parking spaces at the same time as additional tree planting space (Figure 19B).

Figure 19: (A) Pedestrian-only mall in the City of Perth and (B) a one-way street in the City of Claremont.
