Old Perth Road Street Tree Audit

Town of Bassendean

Report No. J19384

29 May 2019

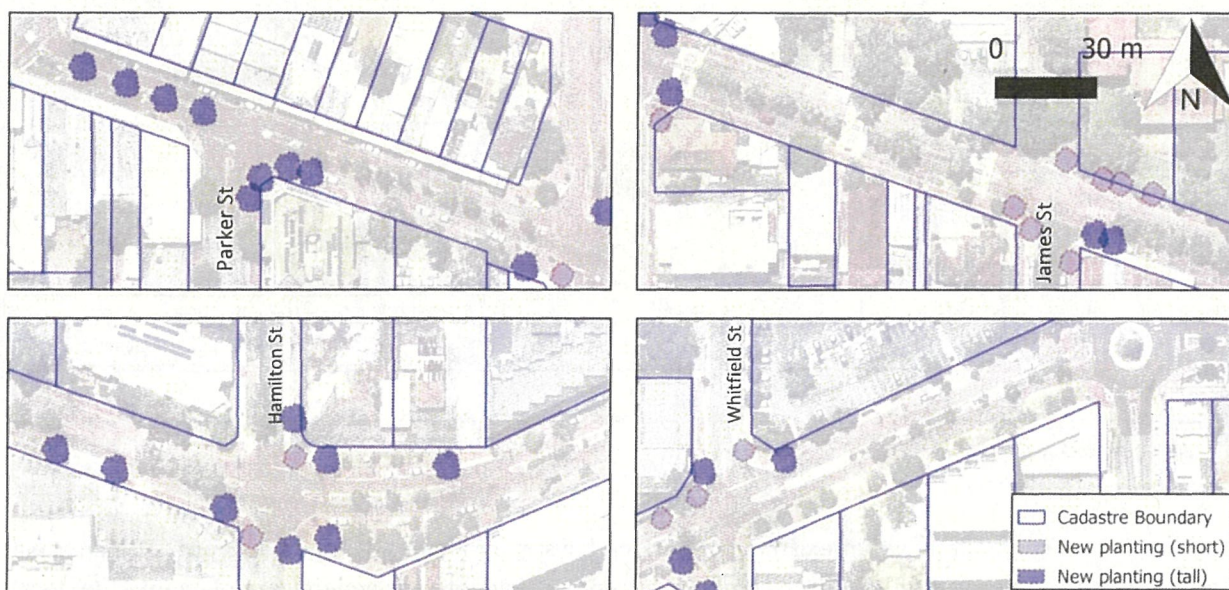
Figure 8: Increased tree planting in available spaces. The semitransparent purple polygons indicate potential canopy of additional planting of short trees, which are located under powerlines or other overhead obstructions. The semitransparent blue polygons are potential canopy of additional planting of larger, tall trees.

Similarly, there are still remaining spaces within the footpath area in which additional planting pits could be installed. The initial Old Perth Road drawings from 2013 (TOB 11-2013/1) (Appendix 1) identify several potential locations for additional planting pits which have not been utilised. It is possible that reasons exist for not adopting these planting locations which may be known within the Town. We have identified 40 potential new planting locations which could be developed (Figure 8).

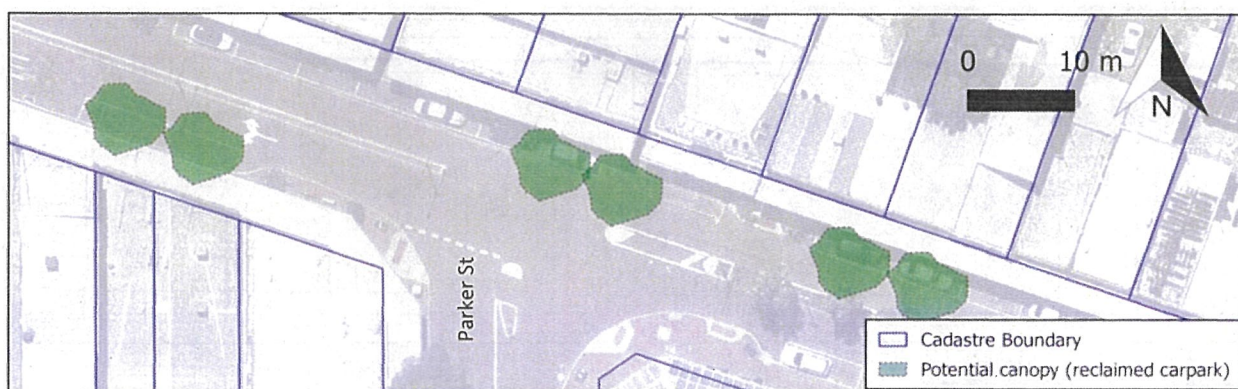
Figure 9: An example of a section of Old Perth Road where car parking bays could be reclaimed and new plantings spaces for trees created, (indicated by the semitransparent green canopies).

In addition to finding space for additional planting pits within footpath areas, an option exists to develop new planting pits in areas currently reserved for on-street parking. This option allows for greater flexibility in the location and number of spaces for tree planting. Existing attempts to plant trees within diamonds placed in between car parking bays have been relatively successful compared to footpath pits established at the same time. However, increasing the size of the pits would increase tree growth rates, and also reduce the incidence of vehicle impacts which are likely to suppress the vigour of these trees. This would necessitate sacrificing car parking space for each tree.

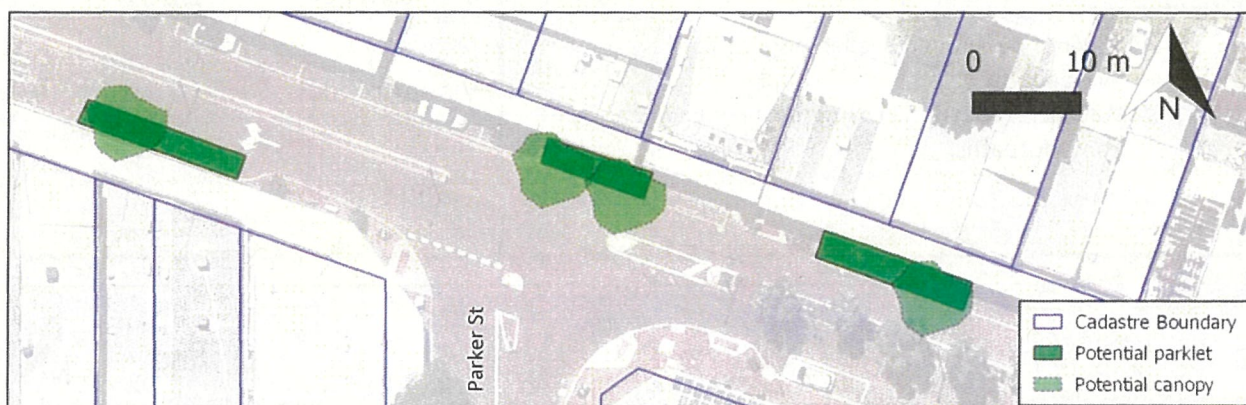
Figure 10: Example of the creation of parklets in reclaimed car parking bays. The shaded green polygons indicate the boundary of the potential parklet, and the semitransparent green polygons are potential canopy if broad crowned trees are planted within the parklet.

The installation of parklets within existing car-parking bays is an increasingly popular form of increasing street vibrancy and greenery in similar commercial centres. Parklets are generally implemented by local businesses in partnership with the council, which may involve a fee for rental of the street space. Parklets are generally non-permanent structures, however, if developed in partnership with the council, permanent tree planting pits could be established within the parking area prior to establishment of the semi-permanent parklet installed above. These options are advantageous because the establishment and maintenance cost is passed on to the business owner, who benefits in the form of increased seating capacity and alfresco dining options.

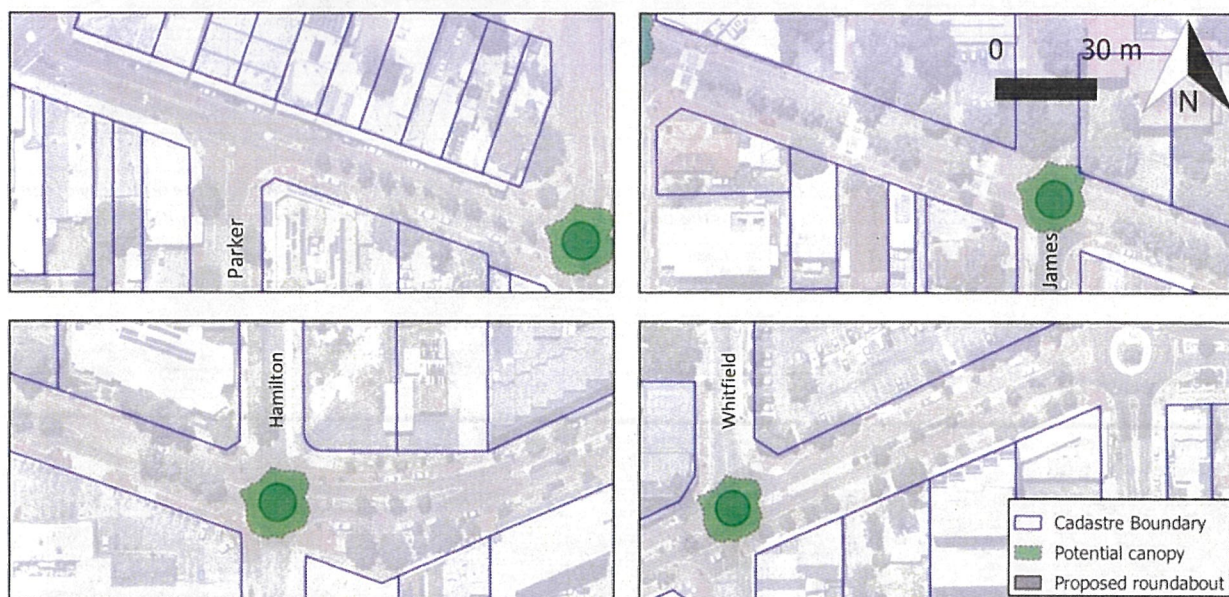
Figure 12: Potential canopy if new roundabouts are installed and large trees are planted in them. The dark circles are the proposed roundabouts, and the semitransparent green polygons are the potential canopy.

Some of the largest areas of exposed land within Old Perth Road are found at road intersections. There may be a possibility to install a small roundabout at the centre of each junction. This would allow a relatively large tree species to be planted without interference from overhead wires, or underground services, which is a limiting factor of tree establishment in footpath areas. Roundabouts may also have a traffic calming effect, making the street more attractive to pedestrians while improving traffic flows.

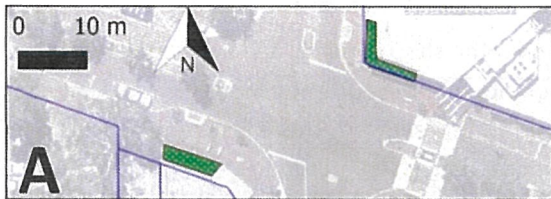
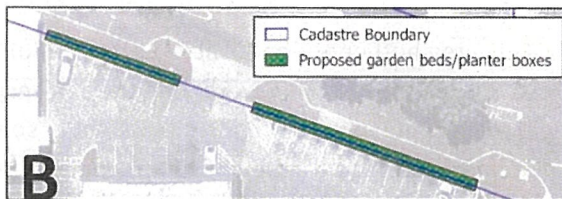
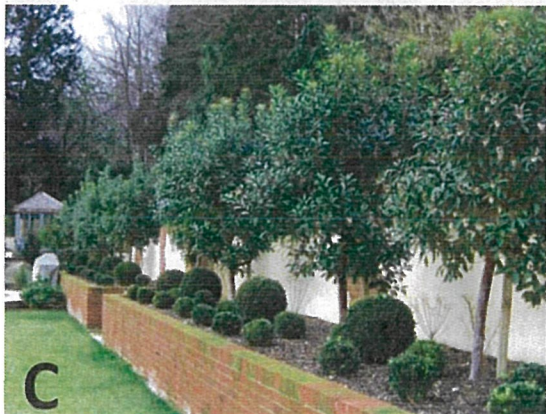
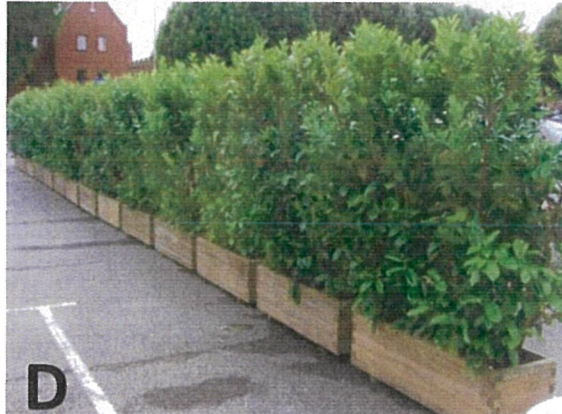
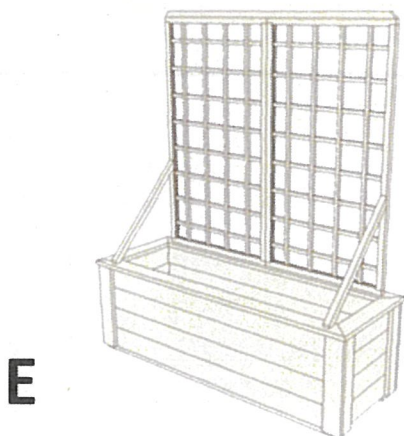
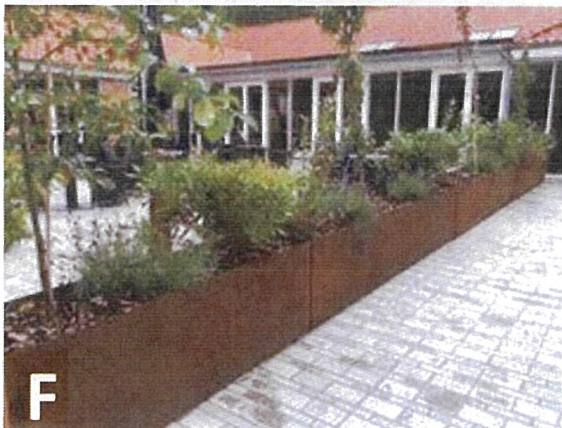
Figure 13: (A) and (B) Examples of locations for potential planter boxes and garden beds on Old Perth Road. (C to F) Examples of planter boxes and garden beds that could be used.

The installation of additional gardens beds and planter boxes has the potential to make a significant contribution the streetscape aesthetic (Figure 13). Planter boxes are generally not appropriate for planting large trees with the aim of increasing canopy. However, planter boxes can contribute to vegetation at or

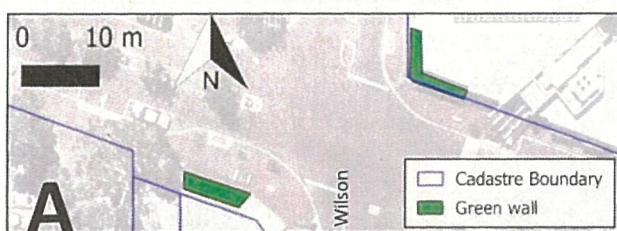
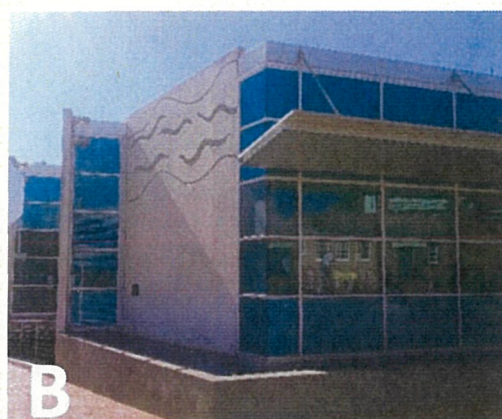
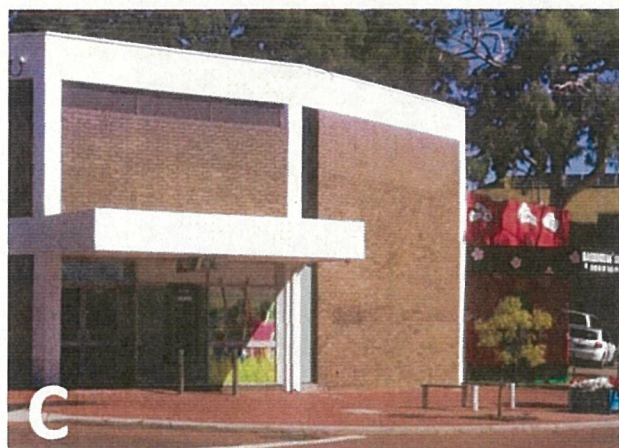
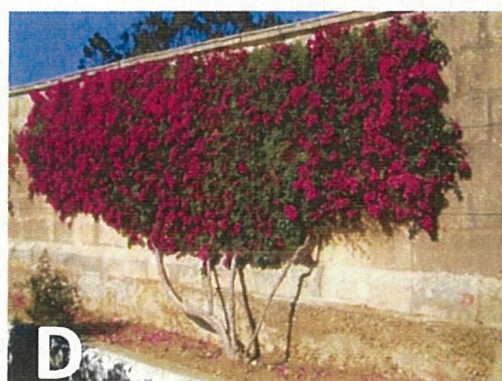
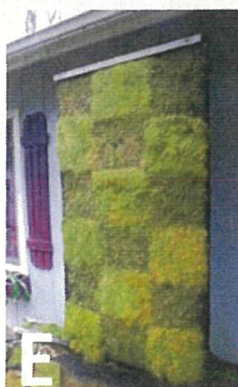
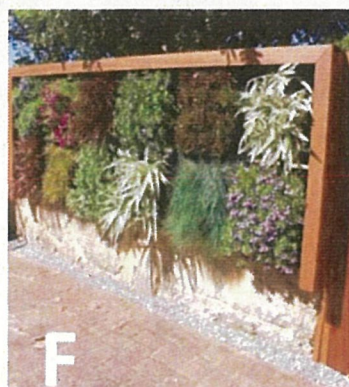
Figure 14: (A) Potential locations for the addition of a green wall (green polygons). (B) and (C) show currently bare walls that could be made into green walls such as shown in D to F.

Green walls are another popular method to screen bare walls and increase vegetation at eye level (Figure 14). These are a relatively modern and fashionable design statement. There are relatively few examples within the Perth region. This is possibly due to difficulties in establishing and maintaining these systems in the hot and dry Perth conditions. However, it is certainly possible with thoughtful design and selection of plant species, such as *Bougainvillea*, which are commonly used in Mediterranean countries. If this option is to be selected it would be advisable that a competent contractor be sought with a successful track record of green wall establishment in the Perth region.

To achieve a similar effect, trellising could be established on these walls with climbing plants or vines established from garden beds below. These are likely to be easier to establish and maintain, however, it would take several years to fill a target wall. On a smaller scale, climbing plants could also be established on supporting structures associated with shop awnings, light poles and other opportunistic locations (Figure 15).

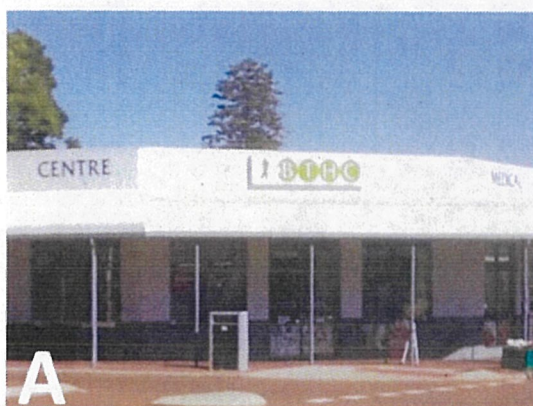
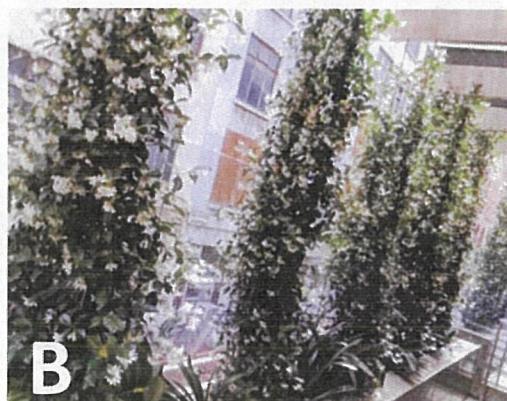
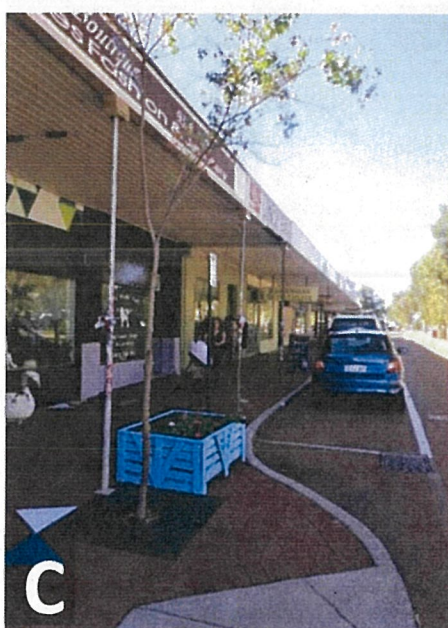
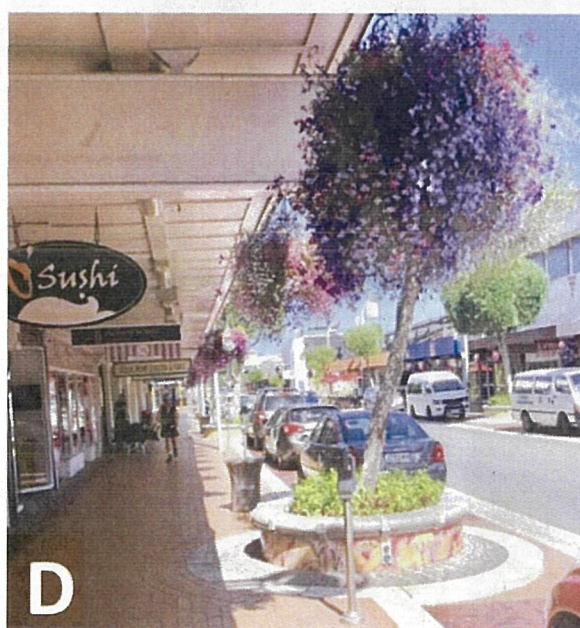
Figure 15: (A) Example of supporting poles on Old Perth Road that could be enhanced with climbing plants such as in (B). Hanging plants could be established along awnings (C) such as that shown in (D).

Hanging baskets are another option to increase vegetation under the shop awnings and add to the aesthetic of the streetscape (Figure 15). However, given the age and condition of the current awnings this option may require additional engineering to support the weight of soil and water required. These also require irrigation and regular maintenance and can be difficult to implement successfully.

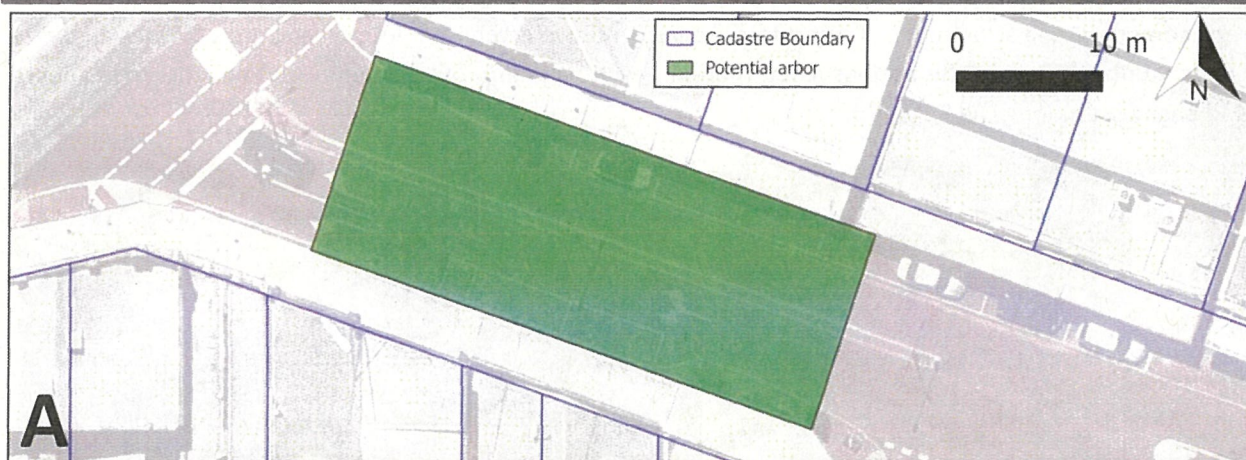
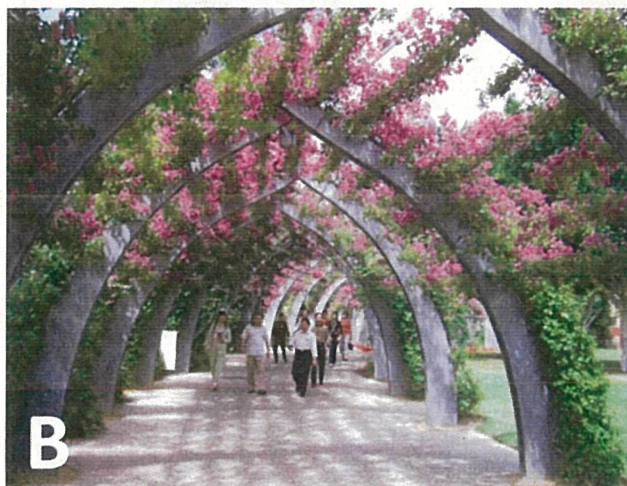
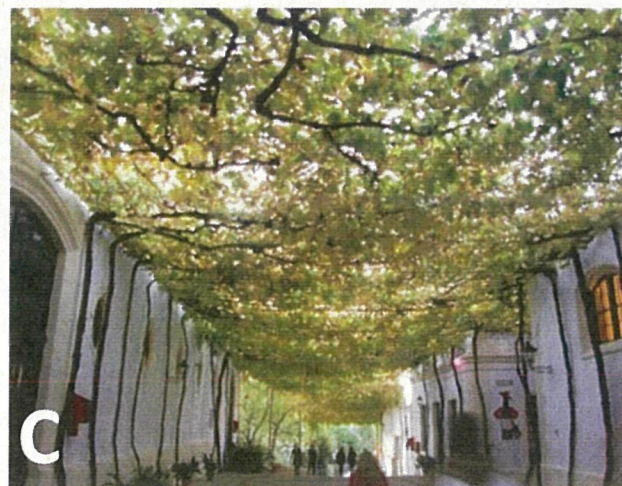
Figure 16: (A) The addition of an arbor between Guildford Road and Parker Street could add a large amount of canopy. B and C are examples (Source: Pinterest).

In order to achieve a major transformation to the level of shade and vegetation within the street, an arbor could be erected (Figure 16). This could be used to achieve close to 100% shade cover in at least part of Old Perth Road, with comparatively little footprint at ground level. The use of vine and climbing plants for shade cover would reach maturity faster than tree canopy would. The drawback to this approach is the significant cost that would be involved in the design, engineering and installation of the support structures. However, such a structure would be unique in WA and would provide a feature to raise the profile of the street and draw in visitors from outside the local area.
