**Ark Hospitality Group  
Bassendean Hotel Development  
Old Perth Road, Bassendean WA  
Arboricultural Impact Assessment**

3 December 2020

**Arboricultural Impact Assessment Report regarding nine (9) trees located within the vicinity of the proposed development at the Bassendean Hotel, Old Perth Road, Bassendean**

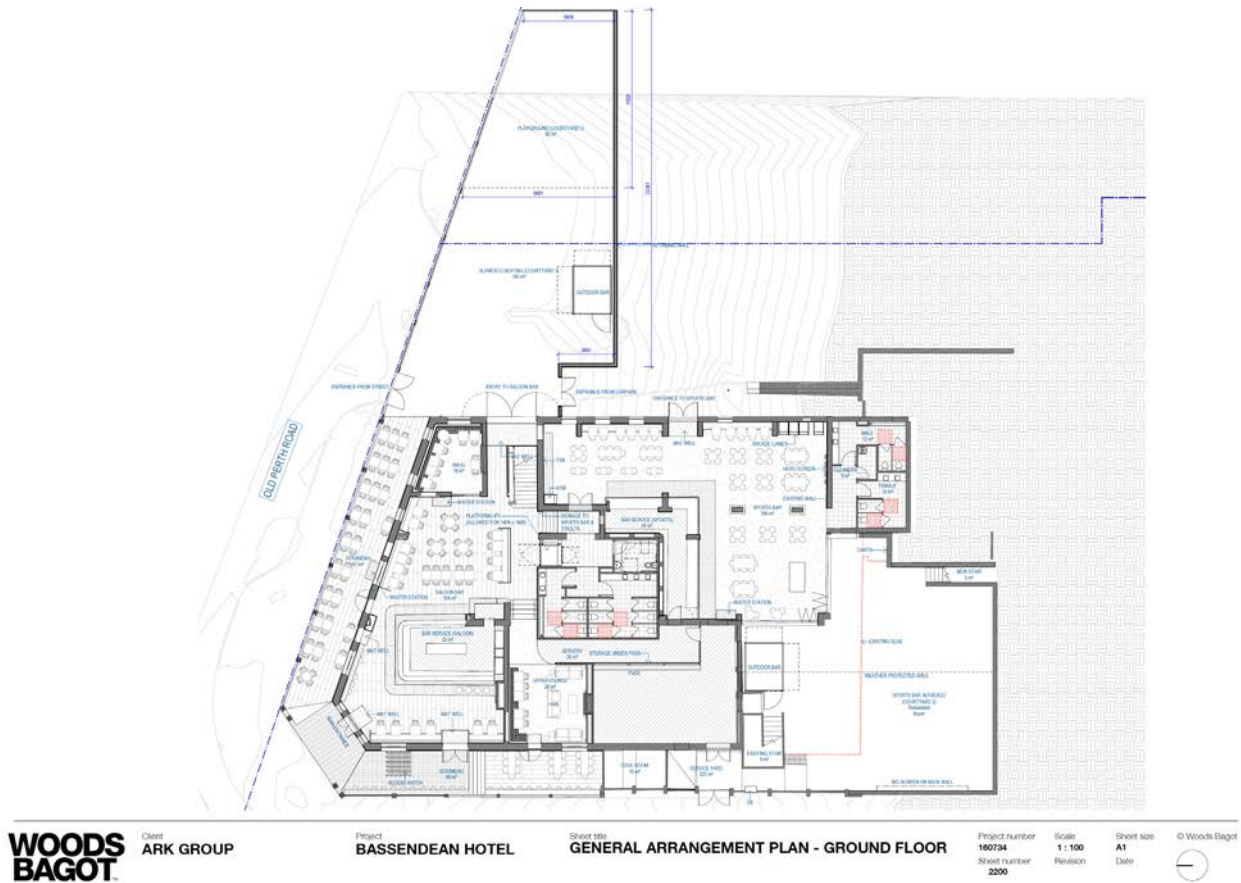
Figure 1. Excerpt from the General Arrangement – Ground Floor Plan. (Client, 26 November 2020).

- 7.2.3 Based on the supplied plans (Figure 1 and Section 6), a significant encroachment into the SRZ of Trees 1, 2, 3 and 4 would be required to accommodate the proposed design. It is recommended that each of these trees is replaced (Section 7.14) with a tree of medium dimensions (at maturation). It is further recommended that replacement tree(s) with a proposed planting location to the north of the alfresco seating area (adjacent to Old Perth Road) be deciduous in nature and of a species approved by the Town of Bassendean.

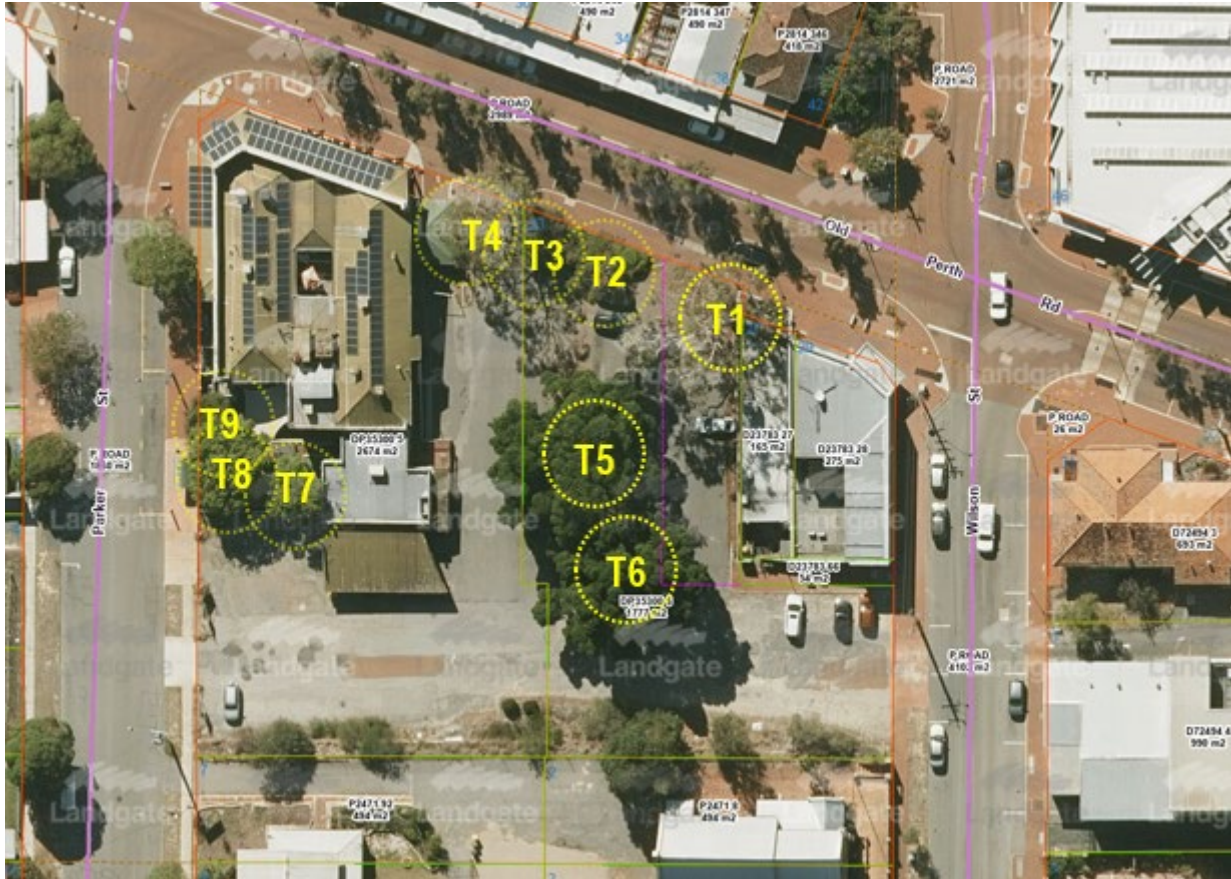
5.2.1 A nominal numbering convention was applied to the subject trees (Figure 3). Trees were not tagged as part of this report.

Figure 3. Site map showing subject trees. Tree attributes are to be obtained from Appendix E – Tree Assessment Data. (Landgate/ArborSafe, November 2020).

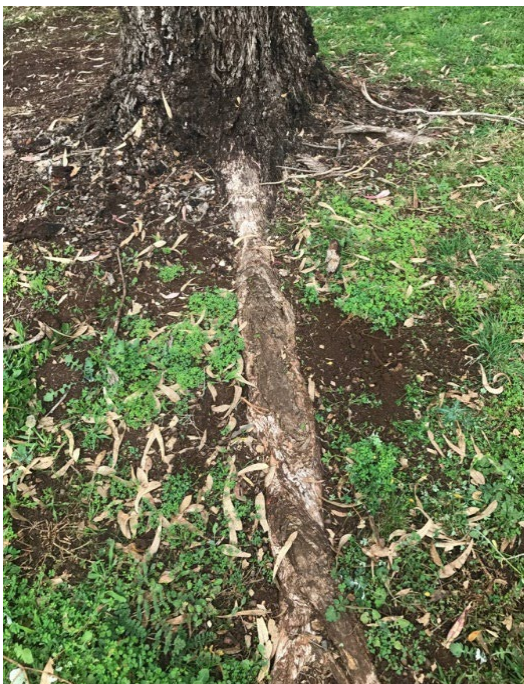
Damage to tree roots (Figure 16 and Figure 17) and the lower portion of a tree's trunk is a common and often unnecessary occurrence that can lead to the entry of decay fungi into a tree's structural framework. Once present, decay may develop in larger structural roots and/or the base of the trunk, which can result in a reduction in tree health and in severe cases even compromise stability.

Figure 16. An example of damage to tree roots caused via mowing. (Luke Dawson, June 2017).

Another advantage to mulching around the trunk and root crown is that it limits damage to both parts from mowing equipment. This in turn reduces mechanical damage and compaction.

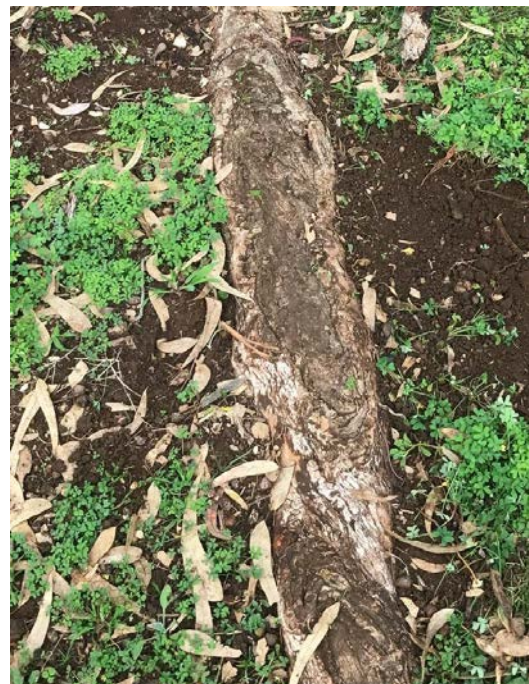
Figure 17. Image showing wound caused to upper portion of surface root by mower. (Luke Dawson, June 2017).
